**MARINE INVESTIGATION REPORT
M15A0045**

PERSON OVERBOARD AND SUBSEQUENT LOSS OF LIFE

**SMALL FISHING VESSEL *FOUR LADIES* 2003
15 NAUTICAL MILES SOUTH OF CAPE SABLE ISLAND,
NOVA SCOTIA
09 MARCH 2015**

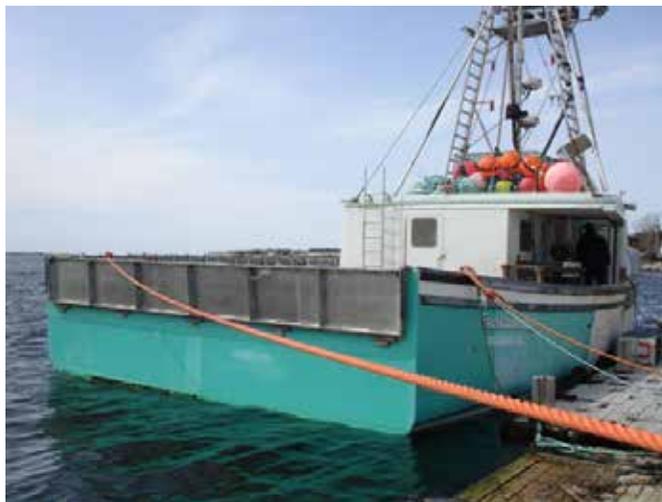
Photo 2. Hinged gate in the upright position

At the stern, a 61 cm hinged gate forms the transom when in the upright position (Photo 2) and extends the working deck when lowered. A cargo boom with a small winch is mounted atop the wheelhouse. The vessel is used primarily for trapping lobster and catching swordfish and is fitted with a trap hauler on the starboard side of the working deck.

The weather had deteriorated as the crew was working, so they departed the area for shallower water, leaving the hinged gate at the stern in the lowered position, as was the common practice for the vessel when lobster fishing.

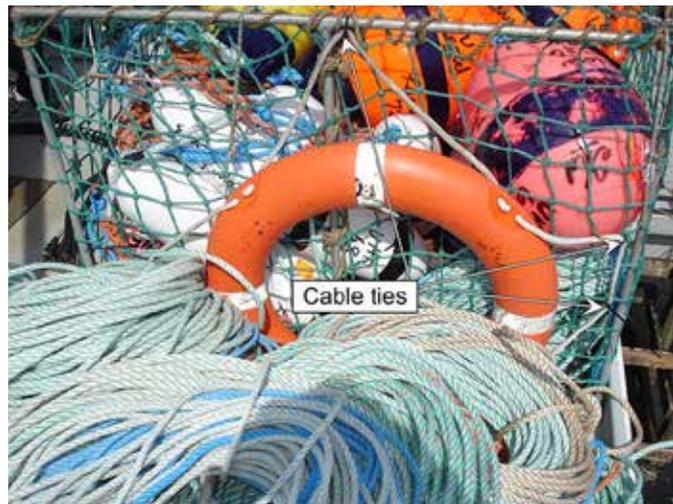
Photo 3. Locations of cable ties

The life rings were located on top of the wheelhouse and their grab lines had been secured to a mesh container using cable ties (Photo 3).

Another aspect that must be considered is the stowage of emergency equipment to ensure ease of access. On the *Four Ladies 2003*, the life rings were not stowed in a location that was readily accessible from the working deck and were lashed with cable ties, making them difficult and time consuming to deploy in the event that they were required.

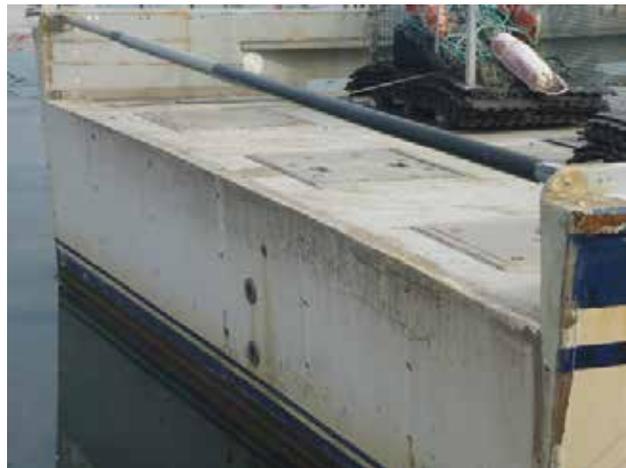
Photo 4. Aluminum stern pole as seen on some lobster vessels

While the majority of fishermen on these types of vessels leave the stern open while fishing lobster, some will place a chain or aluminum pole across the opening to act as a guardrail (Photo 4). Poles can be adjustable and can be placed in numerous orientations across the deck so that the crew members are never nearer the open stern than they have to be. Additionally, crew members can place the pole between themselves and the open stern when preparing traps for setting, which maintains a physical barrier.

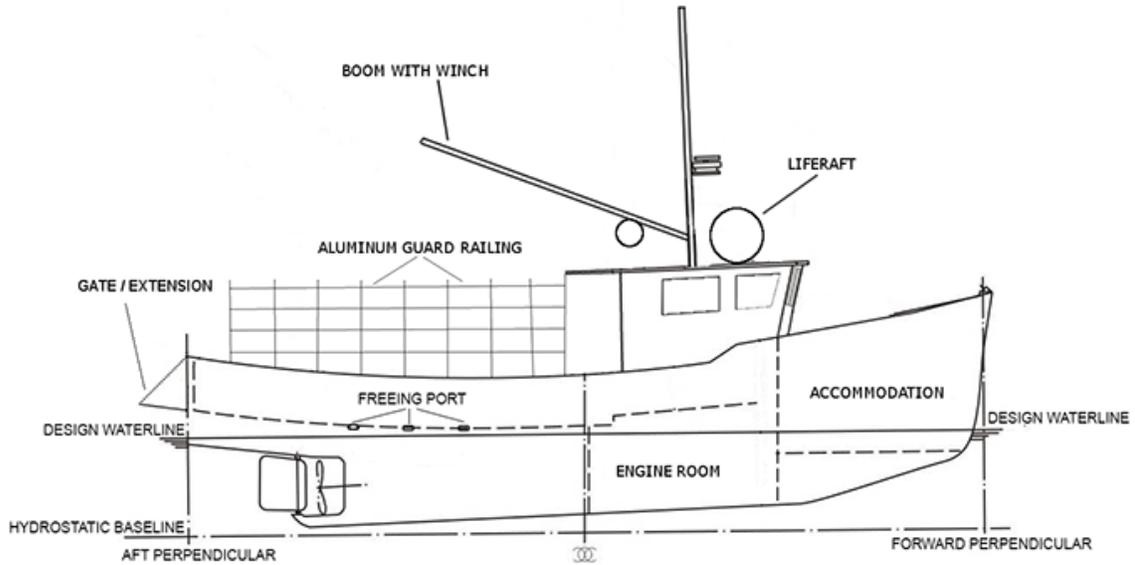
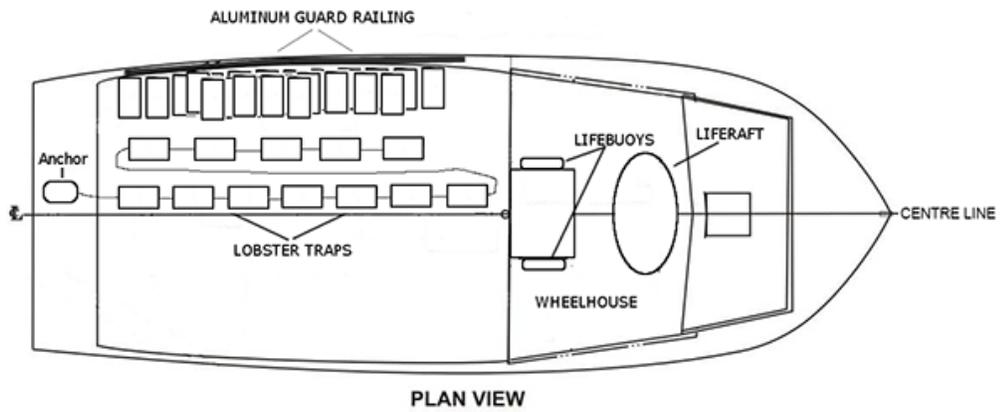
Appendix A – Four Ladies 2003 profile and deck arrangement

- The traps on the first string were stowed along the port side at deck level,
- The traps on the second string were stacked on top of them in a row of 8 and then a row of 4, and
- The traps on the third string were stowed in a row of 7, located amidships, with 5 traps placed along the port side of the row (Appendix A).
