RAILWAY INVESTIGATION REPORT

R16C0012

Non-main-track derailment

Canadian Pacific Railway

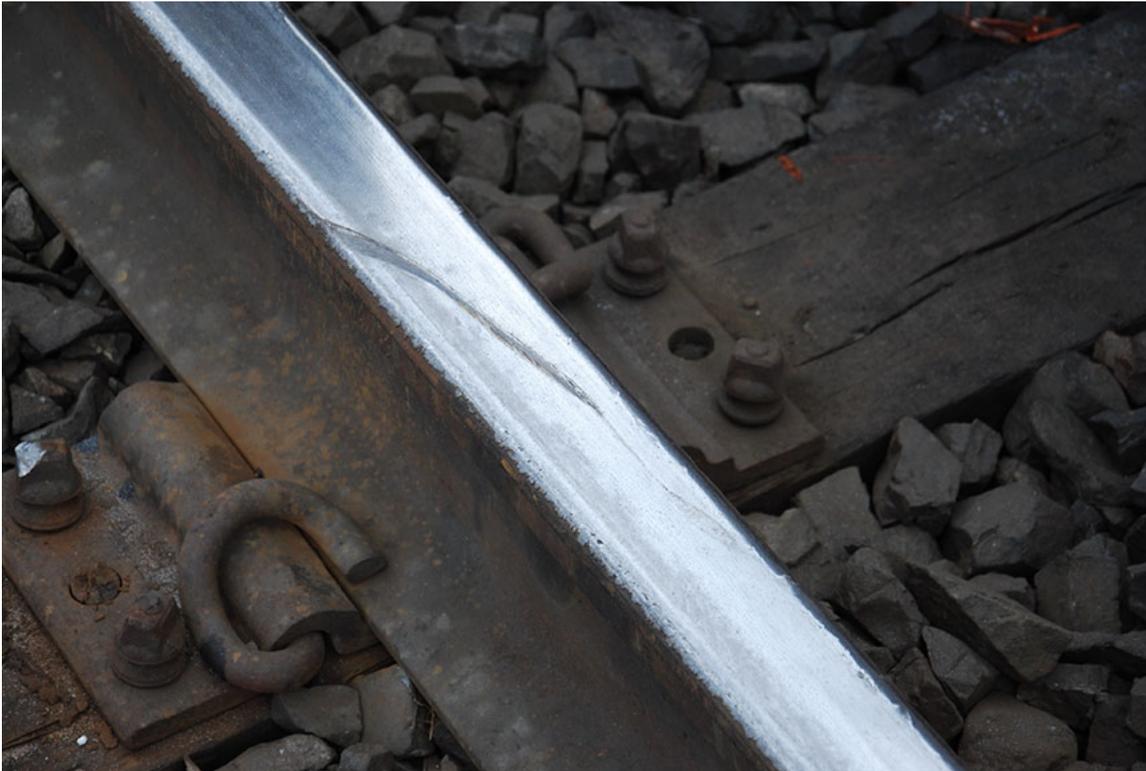
The derailment spanned approximately 1050 feet, and 9 of the 13 derailed cars were pulled over onto their sides. The track sustained minimal damage, consisting of wheel flange marks on the top of the south rail (Figure 3).

Figure 3. Flange mark left by the train on the rail (Mile 0.40, Red Deer Subdivision)

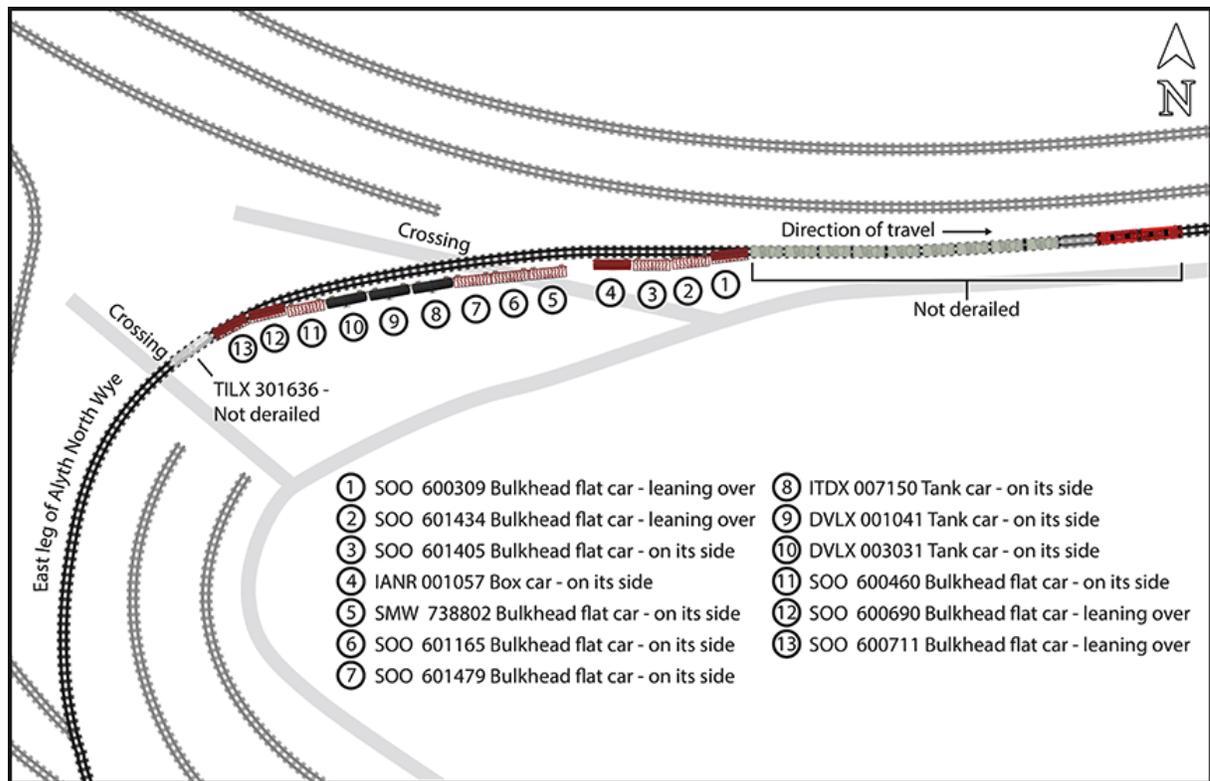
Figure 4. Derailment site diagram

Immediately preceding the 13 derailed cars were 10 cars (9 empties and 1 load) as well as the 2 locomotives (Figure 4). Of the 13 derailed cars, 9 were empty centre beam bulkhead flat

cars, 1 was a loaded box car containing canned green beans, and 3 were empty (residue) tank cars that had last contained molten sulfur. The first 2 derailed cars were upright and leaning over. The next 9 cars were on their sides, and the last 2 derailed cars were upright and leaning over.

The train had separated between the 4th and 5th derailed cars. The remainder of the train was not derailed. Following the derailment, a cut was made one car behind the last derailed car, and the tail end of the train was pulled back into Alyth Yard.
