# Air Transportation Safety Investigation Report A1800107

## LOSS OF CONTROL AND COLLISION WITH WATER

Georgian Bay Airways  
Found Aircraft Canada FBA-2C1 Bush Hawk-XP, C-FKNS  
Lake Muskoka, Ontario  
30 July 2018

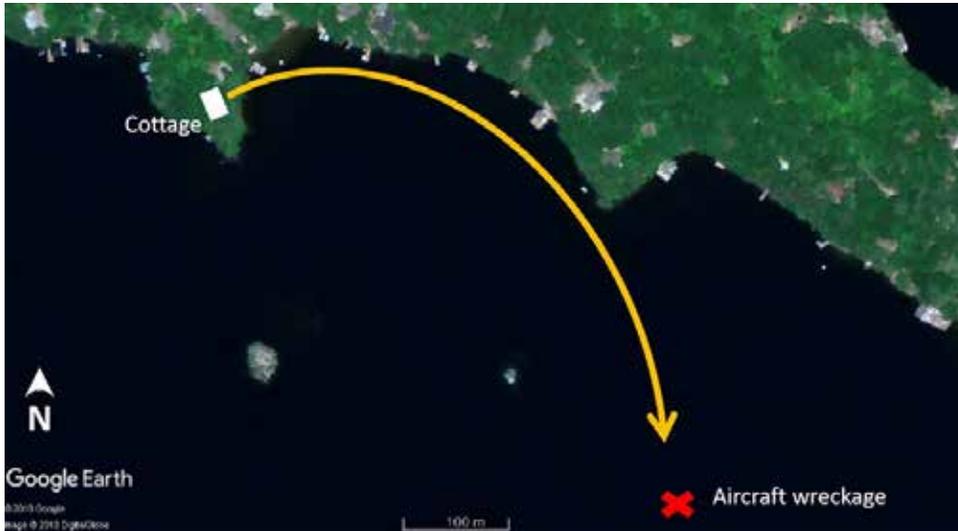
At about 1930, the pilot descended and flew over the cottage, which was on the west point of a small bay (Figure 1), at about 80 knots indicated airspeed (KIAS). He then circled around to fly over the cottage again, flying just above tree-top level. Witnesses saw people standing outside at the cottage, watching the aircraft fly over. The aircraft closely cleared some trees before entering a right turn and

flying along the shoreline of the small bay to the east of the cottage. The bank angle in the right turn became steep<sup>3</sup> as the aircraft headed toward a wooded point on the east side of the bay. The aircraft turned before reaching the wooded point and continued turning to the south in a steep right bank and began to lose altitude as the nose pitched down. The aircraft reportedly did not respond to left aileron input. The aircraft continued to descend, and struck the surface of the water in a steep right-bank, nose-low attitude. It then cartwheeled before coming to rest in the water. Both occupants were wearing 4-point safety harnesses and sustained minor injuries.

**Figure 1. Approximate final turning path of the aircraft after flying over the cottage**  
(Source: Google Earth, with TSB annotations)

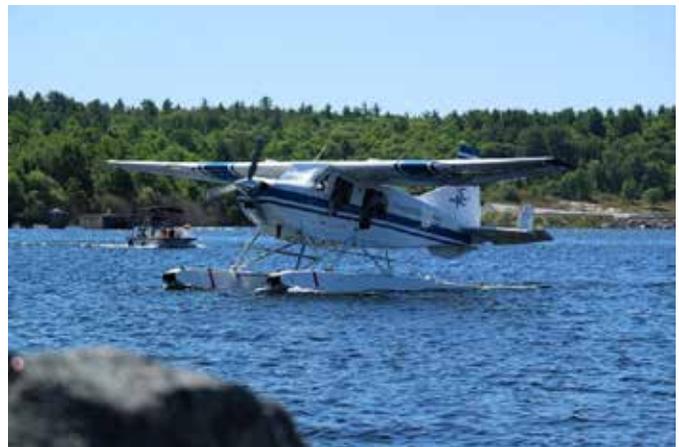
The Found Aircraft Canada FBA-2C1 Bush Hawk-XP (Bush Hawk-XP) is a high-wing, 5-seat, single-engine aircraft. The occurrence aircraft was configured as a seaplane on float landing gear (Figure 2).<sup>7</sup>

After the submerged aircraft was raised out of the water, it was examined on site. There was no indication of a pre-impact aircraft system malfunction or airframe failure. The aircraft was destroyed. All damage to the aircraft was consistent with overload forces from the impact with the water and with the engine operating at impact. The flaps were in the fully retracted position.

Figure 2. Occurrence aircraft (Source: Georgian Bay Airways)
