# Pipeline Transportation Safety Investigation Report P18H0034

## RELEASE OF CRUDE OIL

Trans Mountain Pipeline ULC  
Darfield Pump Station  
Darfield, British Columbia  
27 May 2018

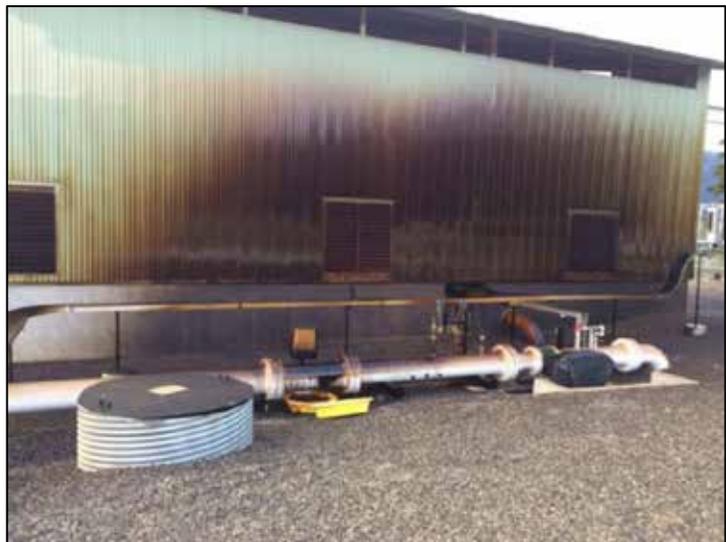
The crude oil had released from a  $\frac{3}{4}$ -inch pipe nipple that was threaded into a 16-inch flow meter downstream of the main pumps at the Darfield Pump Station. The flow meter is located on a section of above-ground piping adjacent to the building that houses the pumping equipment (pump building). Approximately  $4.8 \text{ m}^3$  of product was released. Some of the released product had sprayed onto the west side of the pump building (Figure 2) and a small amount of product was found on vegetation outside the station property.

Figure 2. Oil spray on the side of the pump building (Source: Trans Mountain)

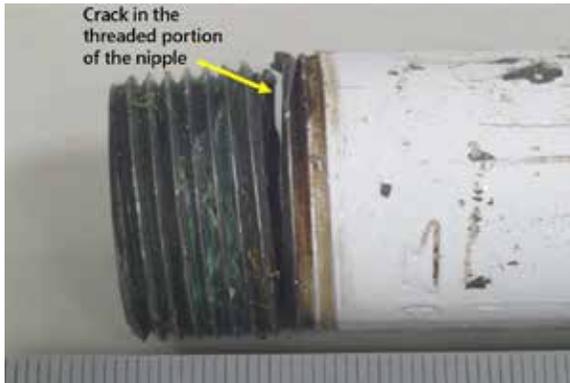
The spool piece,<sup>5</sup> including the ¾-inch pipe nipple from which the oil was leaking, was removed and sent by Trans Mountain to a laboratory for detailed examination (Figure 3). Ratchet and beach marks were present on the fracture surfaces of the threaded portion of the nipple. It was determined that the threaded fitting had cracked due to fatigue (Figure 4).

Figure 3. Crack in the ¾-inch threaded portion of the nipple (Source: Trans Mountain, with TSB annotations)

The crack had started at the last engaged thread of the nipple, a location known to have a high stress concentration. The location of the pressure taps on each side of the flow meter would have subjected the pipe nipple to additional bending forces. The high stress concentration on the threads combined with the additional bending forces likely led to the vibration-induced fatigue failure of the nipple.

Following the occurrence, Trans Mountain developed a revised configuration design for piping associated with flow meters. This revised configuration is intended to reduce the effects of bending loads that can contribute to vibration-induced fatigue at small-diameter threaded connections. The revised configuration was applied at the Darfield Pump Station.

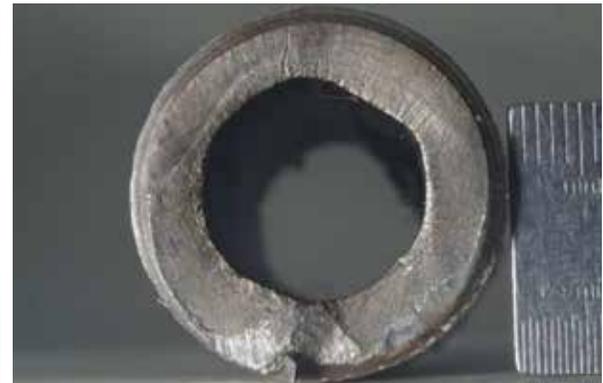
Figure 4. Fracture surface of the threaded portion of the nipple (Source: Trans Mountain)
