MARINE INVESTIGATION REPORT
M02C0030

SINKING AND LOSS OF LIFE

AMPHIBIOUS PASSENGER VEHICLE *LADY DUCK*
OTTAWA RIVER
NEAR THE HULL MARINA
GATINEAU, QUEBEC
23 JUNE 2002

Report Number M02C0030

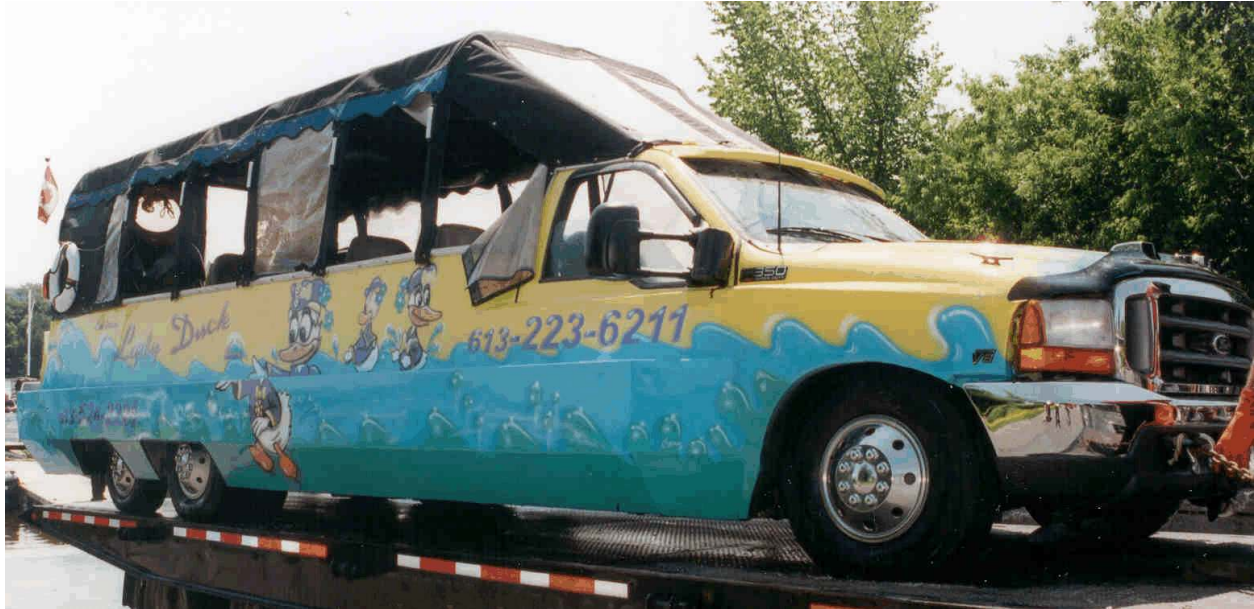
Photo 1. Lady Duck after recovery at the Hull Marina

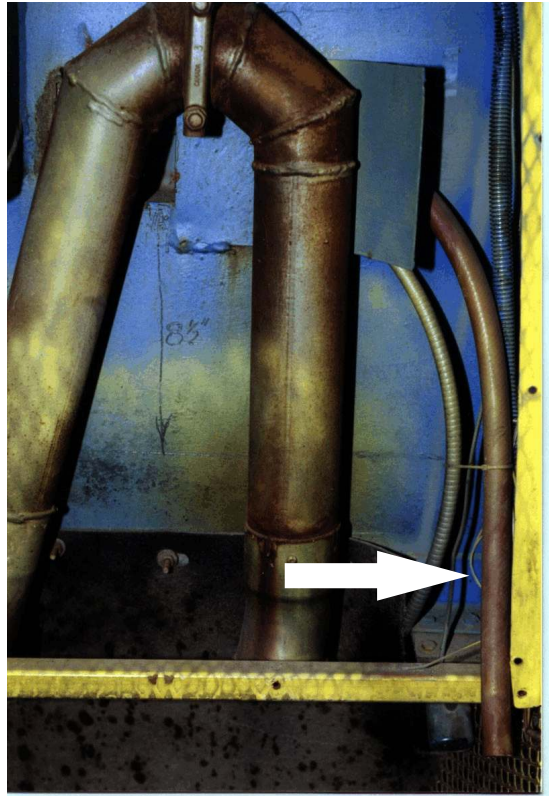
Photo 2. After end of the starboard-side main bilge pump discharge pipe

Each pump was fitted with a 25 mm-diameter (1-inch) flexible discharge hose, led to an 11 mm-diameter (7/16-inch) discharge fitting located 150 mm (6 inches) below the gunwale, creating an operating pressure head of some 1070 mm (42 inches) at the pump. The locations of the overboard fittings on each side near the mid-length of the vehicle were such that they could be seen from the driver's position in the left- and right-hand side rearview mirrors. The on/off energizing switches were located in an overhead panel adjacent to the driving position.

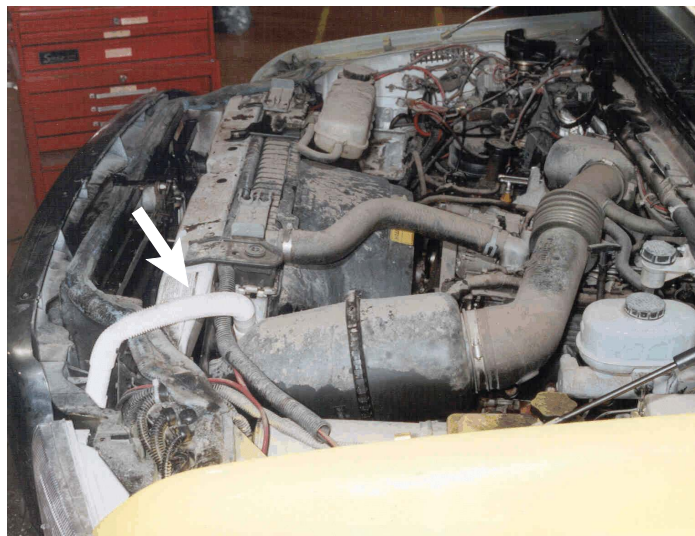
An electrically driven submersible bilge pump (Rule Mate 1100), incorporating a float switch, was located at the forward end of the forward engine compartment. The pump was actuated from a panel located below the steering column by a switch arranged with "automatic," "off" and "manual" settings. The manual switch was spring-loaded and must be held in that position by the driver for the pump to continue operating. A 25 mm-diameter (1-inch) flexible concertina-type discharge hose led up over the top and forward of the visor plate and the hood flexible gasket, some 460 mm (18 inches) above the load waterline. The hose extended some 200 mm (8 inches) below the load waterline at the front of the vehicle and was out of sight of the driver (see Photo 3). When the hood was closed, the discharge hose was compressed where it passed over the top of the forward sealing gasket, partially restricting the flow of any water issuing from the pump.

Photo 3. Discharge hose from the forward engine compartment

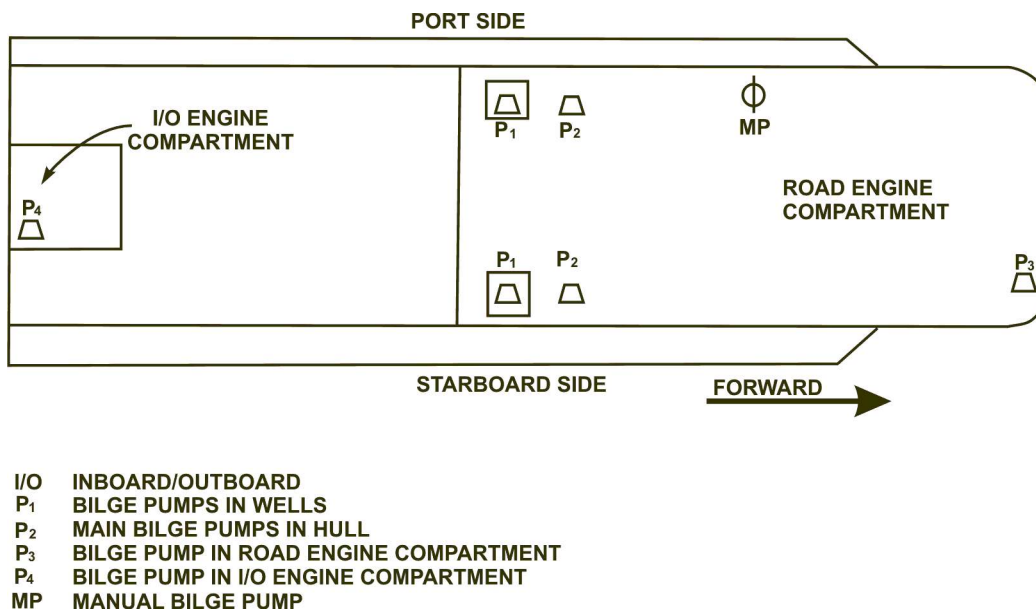
Figure 3 shows the location of the bilge pumps. Table 1 gives a summary description of the bilge pumps and outlines their status. See Appendix A for results of bilge pump examination and testing.

Figure 3. Bilge pump locations

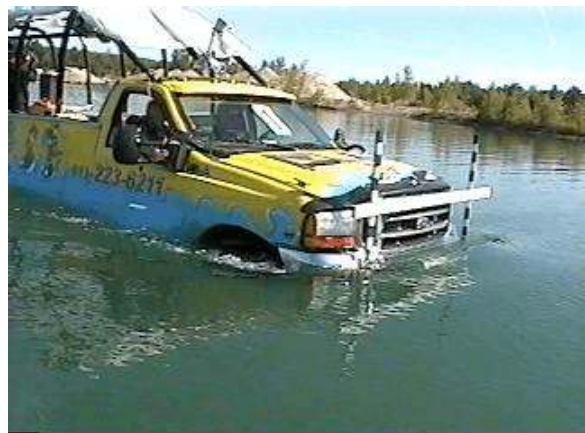
Photo 4. Vehicle speed of approximately 5 km/h in calm water

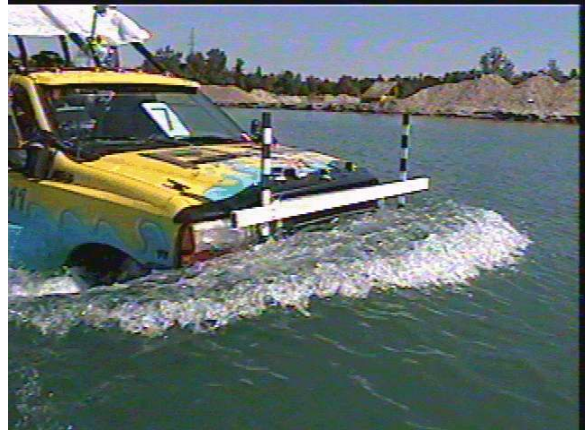
In calm water at a speed of 8 km/h, the bow wave was some 265 mm (10½ inches) high and the effective forward freeboard to the top of the visor was reduced to 205 mm (8 inches) (see Photo 5). At a speed of 9.85 km/h, the bow wave was level with the visor top (see Photo 6). At the maximum speed of 10.25 km/h, the bow wave partially covered the hood with water and heavy spray and overflowed the top of the forward visor. The configuration of the top of the forward visor and its attached gasket was ineffective in preventing entry of water through the space remaining between the top of the gasket and the underside of the hood.

Photo 5. Vehicle speed of approximately 8 km/h in calm water

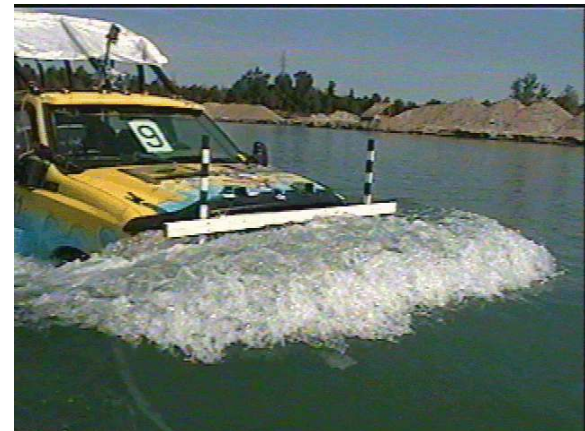
The temporary seals over the hood sides, engine ventilation openings, and forward cowl vents were effective. However, at speeds above 10 km/h, the floodwater continuously overflowed the visor top gasket and accumulated in the forward half of the vehicle. The volume of floodwater from this source was not determined due to the concurrent accumulation of water from the drive shaft bearing and hull leakage. The forward bilge pump and the two main bilge pumps were activated to clear the vehicle of all floodwater.

Photo 6. Vehicle speed of approximately 10 km/h in calm water

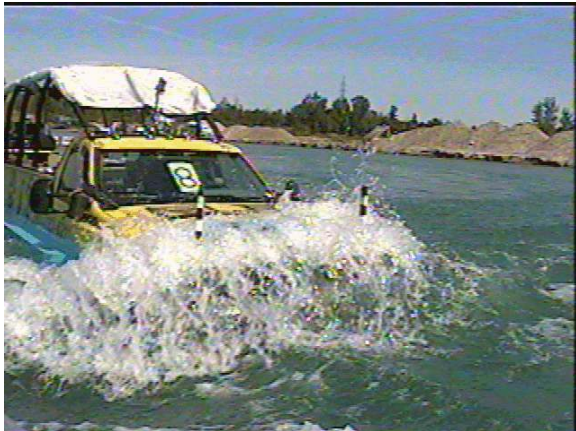
Significantly more floodwater was shipped and retained when in the unsealed condition. In disturbed water, at 8.3 km/h, water overflowed the top of the visor and also downflooded through the ventilator openings, forward cowls and hood sides (see Photo 7). At 9.75 km/h, the rate of downflooding increased considerably, water continuously overflowed the visor top, and a substantial quantity accumulated in the forward half of the hull (see Photo 8). The forward bilge pump, both main bilge pumps, and the two emergency bilge pumps were used to clear the vehicle of this accumulation.

Photo 7. Vehicle speed of 8.3 km/h in disturbed water

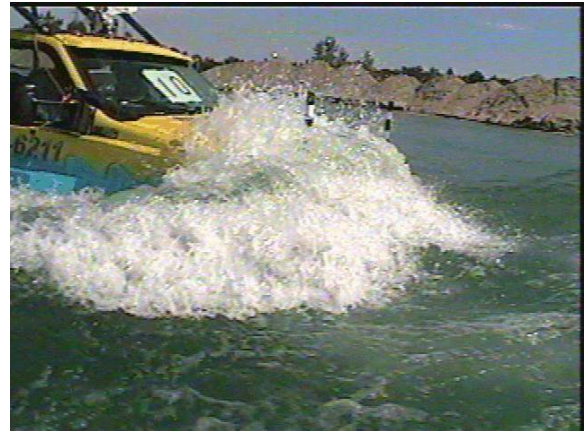
Photo 8. Vehicle speed of 9.75 km/h in disturbed water

In disturbed water conditions, heavy spray and some “solid” water covered the hood, causing significant downflooding through the ventilator openings, forward cowls and hood sides. However, the greatest ingress of water was from the front, past the hood front gasket and over the top of the forward visor plate, where the overflow took on a continuous waterfall effect. At 10.24 km/h, the rate of downflooding and rapid accumulation of water in the forward half of the vehicle was such that it was considered imprudent to continue at this speed for the time needed to complete the trial without the operation of all bilge pumps forward of midships.

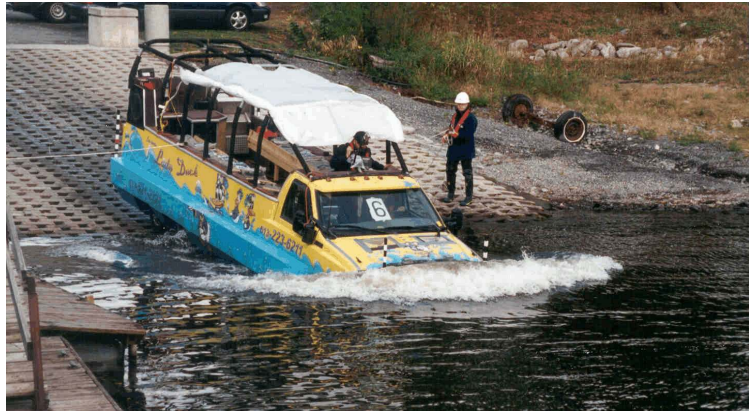
When the vehicle was launched at 8 km/h with all temporary seals removed from the hood, the visor was just submerged, the hood briefly awash and 22 litres of water was shipped (see Photo 9). When the vehicle was launched at 10 km/h, the visor was submerged approximately 80 mm (3¼ inches), the hood and windshield were fully awash, and 32 litres of water was shipped on board.

Photo 9. Vehicle launched at 8 km/h, visor submerged by approximately 25 mm

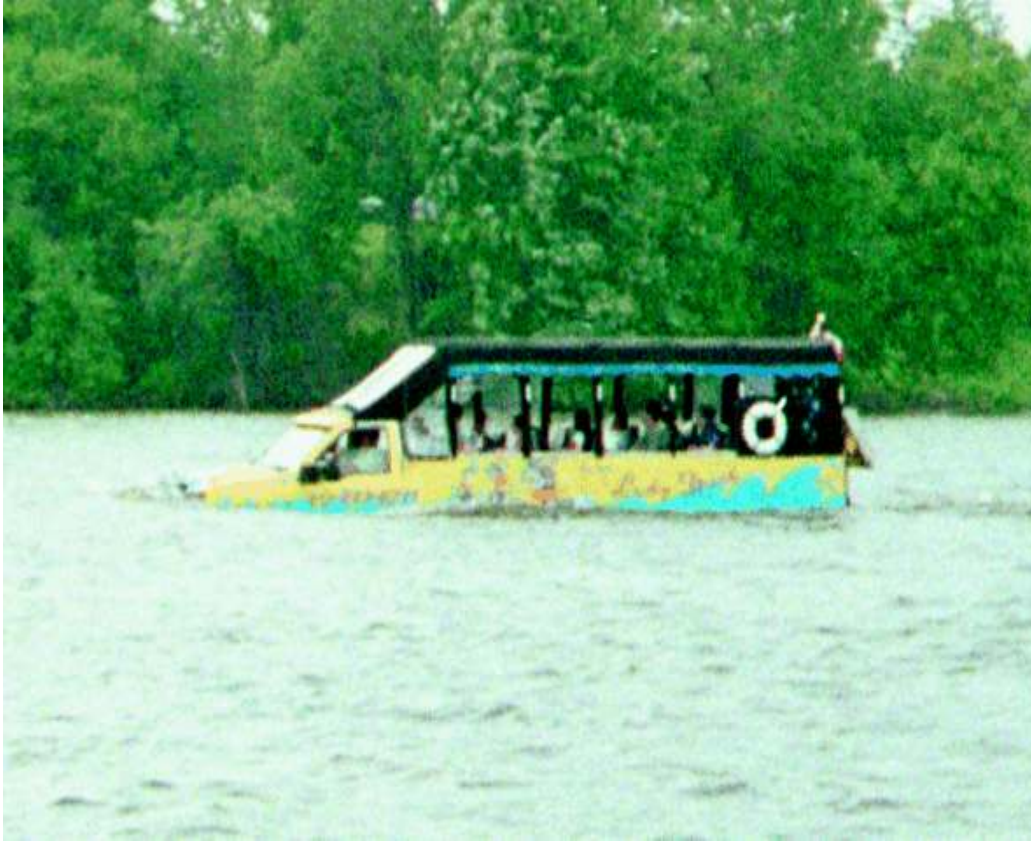
Photo 10. *Lady Duck* approximately five minutes before sinking. Reproduced with permission.

Subsequent photo-geometry and triangulation surveys carried out after the sinking verified the position of the vehicle, at the time the photograph was taken, as being approximately 250 m east of the Macdonald-Cartier Bridge. These surveys and the photograph also led to the determination of the vehicle speed at that time.

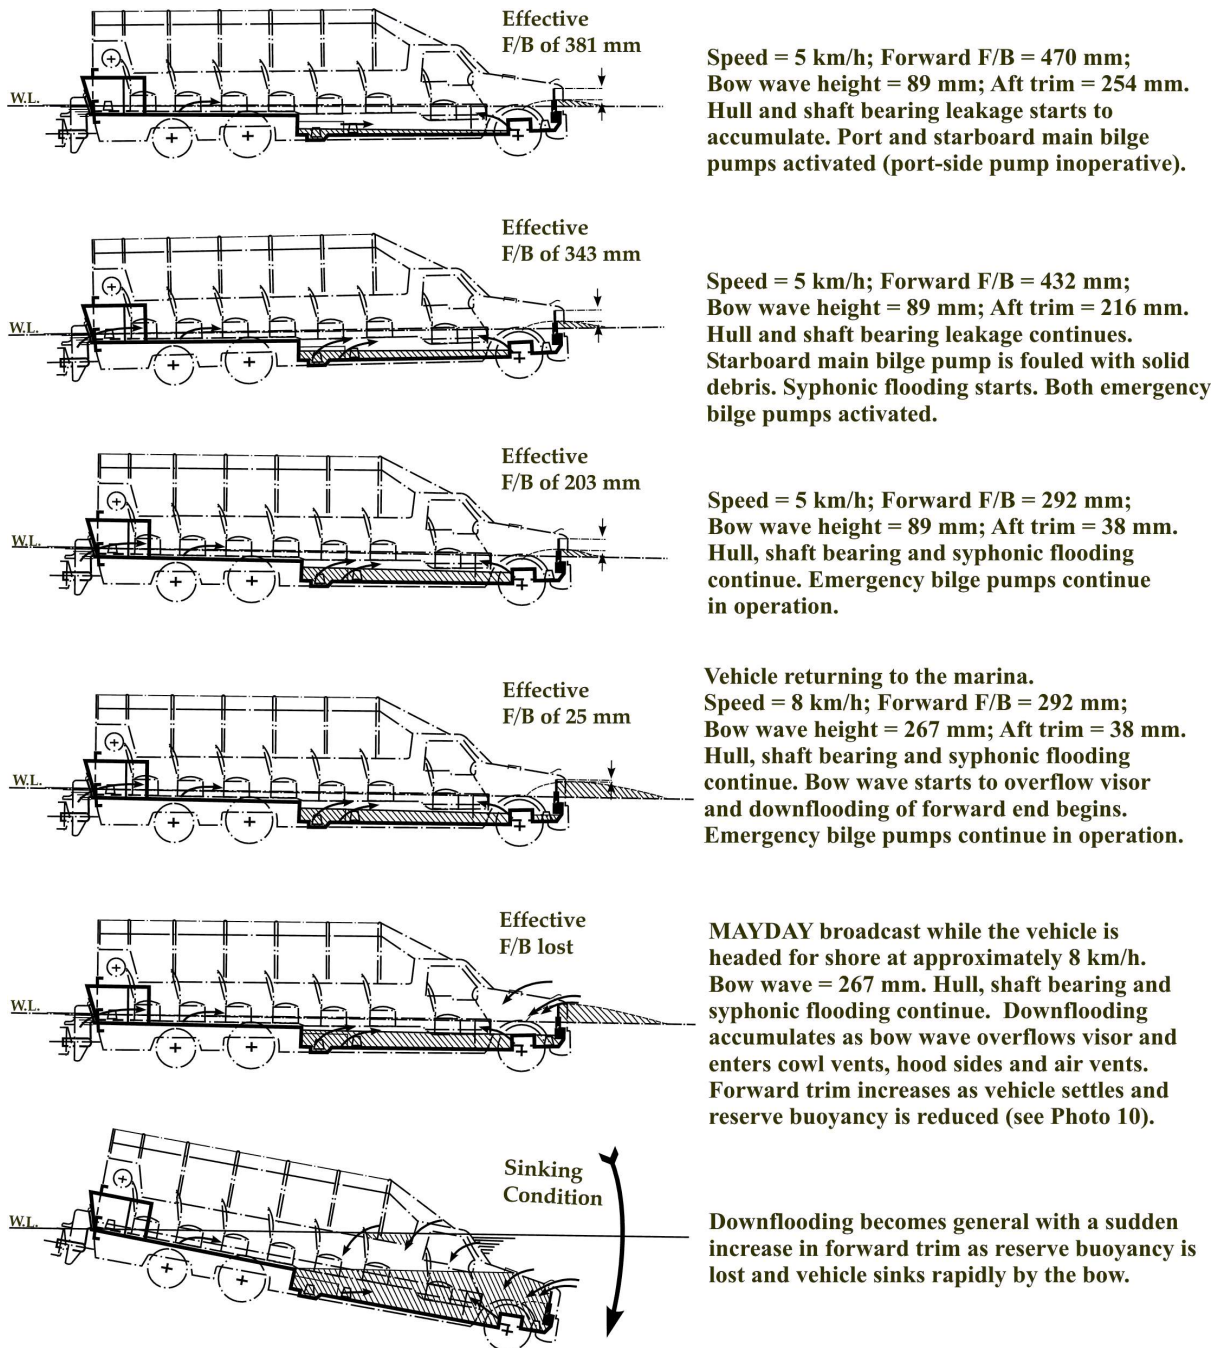
The forward bilge pump, which was best situated to cope with an accumulation of water in the front of the vehicle, was inoperative and the emergency bilge pumps near midships did not stem the total inflow. As the vehicle was headed toward the Hull Marina, the water accumulated in the forward end of the hull and the vehicle continued to trim more and more by the bow, causing the rate of the downflooding to accelerate. This cycle continued until forward reserve buoyancy was lost and the vehicle suddenly sank bow first.

Figure 4. Sinking sequence

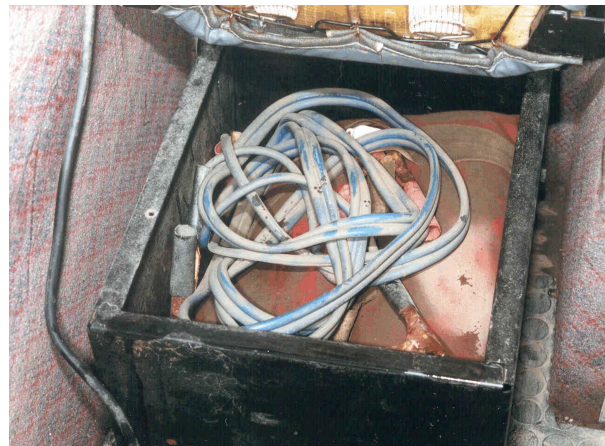
The adult lifejackets were stowed in lockers under each of the passenger seats. Examination after the occurrence revealed that it was not easy to remove the lifejackets from beneath the seats, as they tended to catch on the lip of the

Photo 11. Lifejacket under the seat with booster cables on top

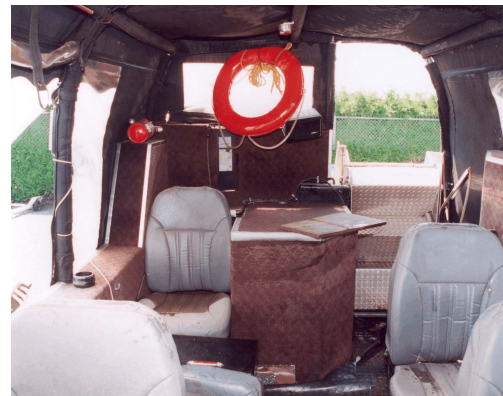
When the passengers boarded, they did so through a boarding ramp on the rear left corner of the vehicle. After all passengers boarded, the ramp was folded up by an electric winch into an opening of 1830 mm high by 685 mm wide (72 inches high by 27 inches wide) that forms a watertight seal for operation in the water. Once the ramp was secured, the opening, which was also an exit in the event of abandonment, was reduced to 788 mm high (31 inches) and 685 mm wide (27 inches) at its widest point, decreasing in width to 533 mm (21 inches) near the top of the exit (see Photo 12).

Photo 12. View from inside the vehicle of rear exit with boarding ramp in retracted position

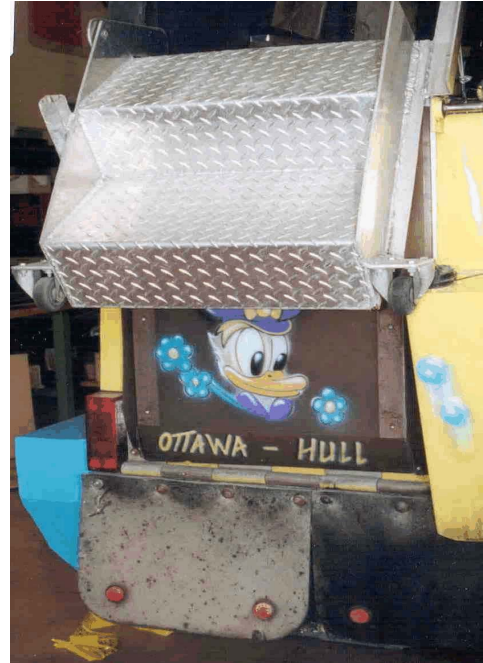
The ramp was articulated in that, when the ramp was retracted, its bottom two stairs folded upside down against the exterior of the vehicle. Once the vehicle was in the water, the boarding ramp could not be lowered (see Photo 13).

To access this rear exit for emergency egress, passengers had to make their way along a 584 mm-wide (23-inch) aisle and then make two turns to move between the rearmost seat on the port side and the front left side of the I/O engine compartment. The narrowest point of this route was 514 mm (20¼ inches). Once at the exit, passengers had to climb approximately 1016 mm (40 inches), with no permanent foothold to aid them, to the top of the retractable stairs to reach the available opening. There were several sharp metal corners on the top of the retractable staircase and winch assembly. The two bottom stairs of the ramp folded upside down against the exterior of the vehicle; the first of the two presented an almost slide-like property to anyone attempting to egress through this exit. Once passengers were at the top of the retractable stairs, there was no platform to step onto to facilitate egress into the water. Passengers had to find a posture to jump without any support structure to aid them in that movement, while ensuring that they cleared the hazard presented by the exterior stairs and the I/O motor.

Photo 13. After boarding ramp in retracted position
