TP 185E
Issue 4/2007

AVIATION SAFETY LETTER

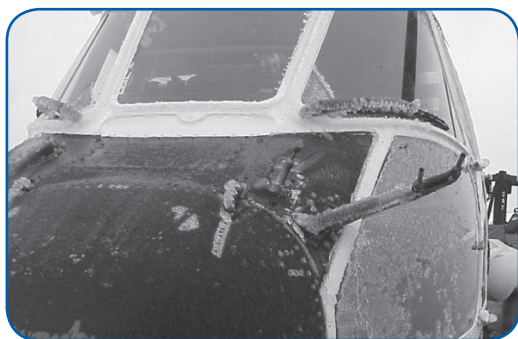
Front left of Puma with ice accretion

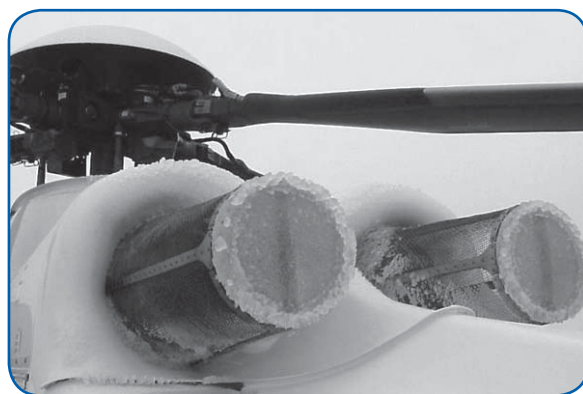
Air intakes iced-up with clean blades

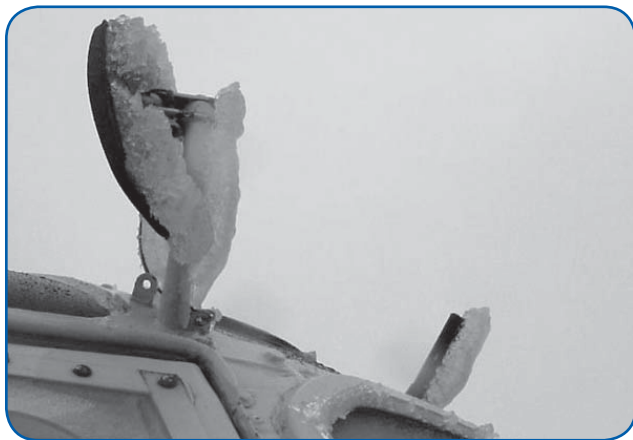
Ice build-up on the mirrors of Puma

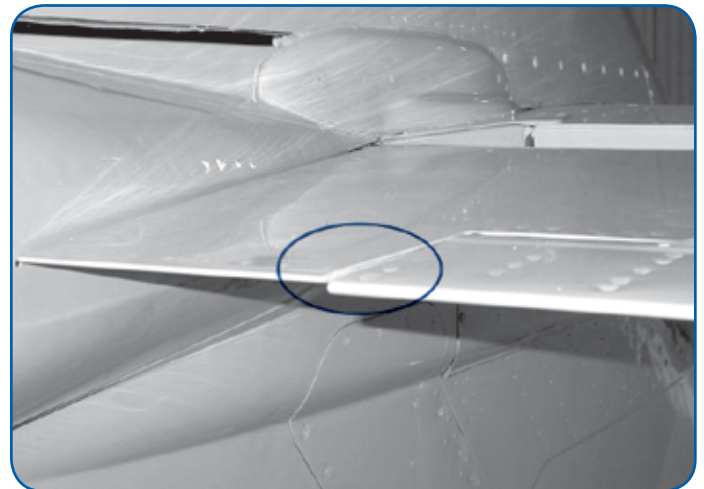
On June 2, 2005, a Raytheon 800XP aircraft was on its first flight following painting and reassembly at an aircraft repair facility. The aircraft departed Peterborough, Ont., for Buffalo, N.Y. During the initial climb, as the aircraft speed neared 190 knots indicated airspeed (KIAS), the aircraft ran out of nose-down trim authority. The speed was kept below 190 KIAS, and the crew hand-flew, diverting to the Lester B. Pearson International Airport in Toronto, Ont., to inspect the aircraft. During the approach to Toronto, the rudder began to vibrate and seize, and the flight crew declared an emergency. The aircraft landed at approximately 13:48 Eastern Daylight Time (EDT) without further incident. An inspection revealed that the elevator trim controls were incorrectly rigged.

Circle shows the trim tab with the rigging pin in place. The trim tab should be flush with the elevator, not 1/4 in. down

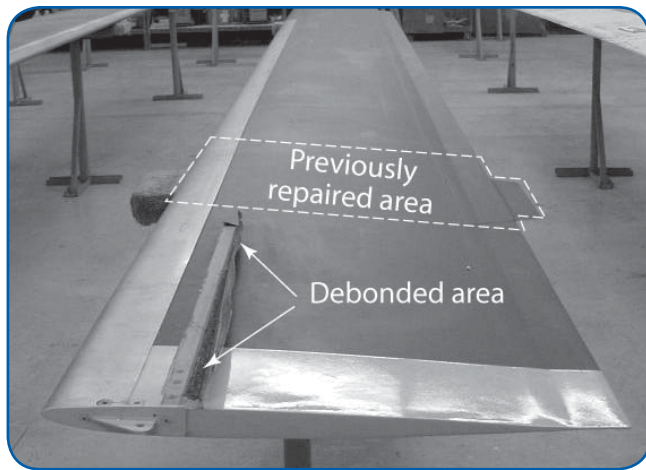
Post-flight inspection revealed that one of the main rotor blades had sustained damage. A small section of skin near the blade tip, aft of the spar doubler, on the lower surface of the rotor blade had debonded. The skin was raised and curled, but had not separated from the blade (see photo, next page). The debonded skin measured 25 in. by 2 in. between stations 263 and 288. In early 2005, the same blade had been damaged while the helicopter was parked in a hangar. The blade was then shipped to an authorized rotor blade repair shop. While paint was being stripped from the rotor blade in preparation for repair, deep corrosion pitting was discovered on the lower skin surface between stations 243 and 262, just inboard of where the debonding later occurred on the occurrence flight. Because the pitting pattern exceeded the allowable limits, the repair shop proposed a repair procedure to Bell Helicopter and received approval. The repair procedure included removing the damaged skin and replacing it with a bonded external doubler. The trailing edge trim tab was also replaced. The skin-to-inner core bonding procedure required using a bladder and heater blanket tool. This tool ensures proper curing of the adhesive by applying heat and pressure to the area being repaired. This type of repair is performed regularly to repair damaged rotor blades. The bladder and heater blanket tool that was used covered the rotor blade from its tip to a point inboard of the repair area, which included the area where the debonding took place on the June 10 flight. Following the repair using the bladder and heater blanket tool, the blade was in service for approximately four flight hours before the lower skin debonded on the occurrence flight at the spar doubler between stations 263 and 288.

*Debonded lower surface of rotor blade and repair area
(blade resting upside down)*

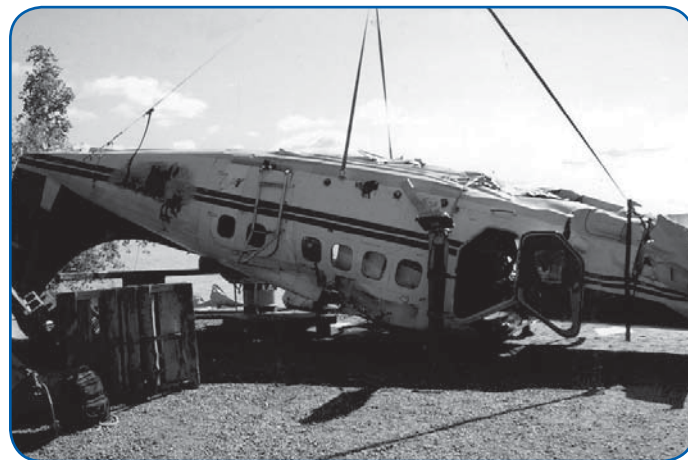
pitch up until it stalled at about 50 ft above the water, and the left wing dropped. The aircraft struck the water in the East Bay of Great Slave Lake in a nose-down, 45° left bank attitude. On impact, the left wing and left float detached from the aircraft, and the aircraft came to rest on its left side. The crew was able to evacuate the passengers before the aircraft submerged, and local boaters assisted in the rescue. There were no serious injuries to the crew or passengers. The aircraft suffered substantial damage.

Aircraft wreckage during recovery

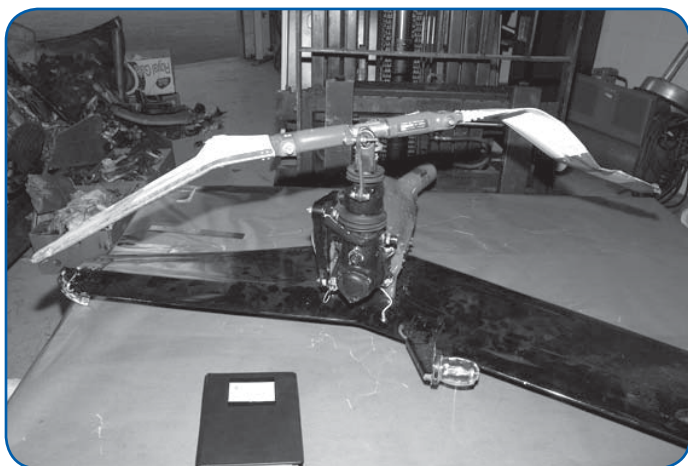
The fuel cell compartments ruptured from impact forces, and a fire ensued. The geological survey crew assisted the pilot from the burning helicopter and performed emergency first aid until the air ambulance arrived at 18:40. The pilot, the sole occupant on board the helicopter, was seriously injured. There were no injuries to persons on the ground. The helicopter was destroyed by impact forces and the intense post-crash fire.

Tail rotor during post-accident examination

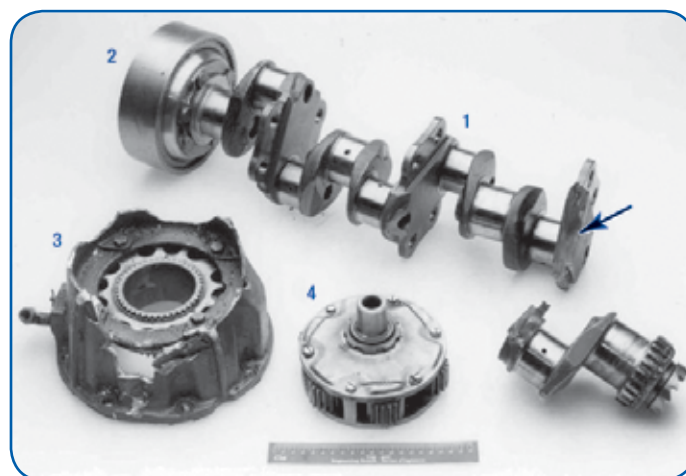
Shown here are parts comprising the crankshaft (item 1) and parts of the engine to propeller reduction gearbox (items 2, 3, and 4). The failure location at the forward fillet radius to the number six connecting rod journal bearing is shown by the small arrow.
