TR-03-2002

Resistance of Exterior Walls to High Velocity Projectiles

TECHNICAL REPORT
February, 2002

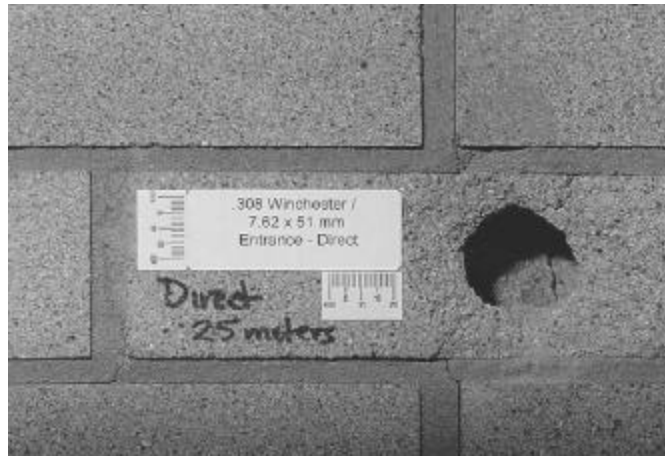
Figure 3 - Damage to clay brick caused by .308 Winchester

The .308 Winchester bullet produced a chip approximate 80 mm wide by 55 mm high from the brick. In addition, a 35 mm diameter hole was produced to a depth of about two thirds the brick thickness. The mortar was cracked around the perimeter of the brick. Figure 3 shows the damage caused by the .308 bullet.

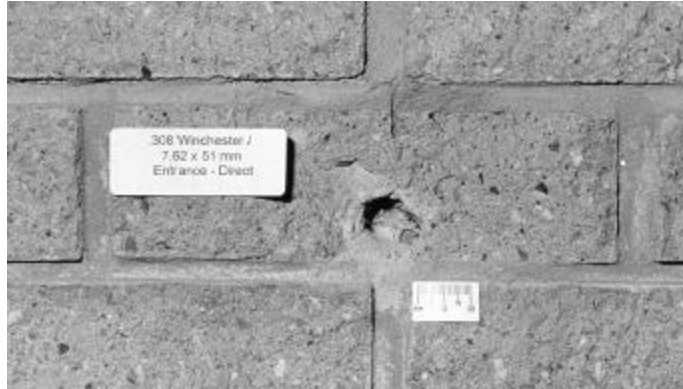
Figure 4 - Damage to concrete brick caused by .308 Winchester

The .308 Winchester bullet removed a region approximately 100 mm wide by 55 mm high. The hole was 25 mm by 20 mm to a depth of approximately half the brick thickness. This damage is shown in Figure 4.

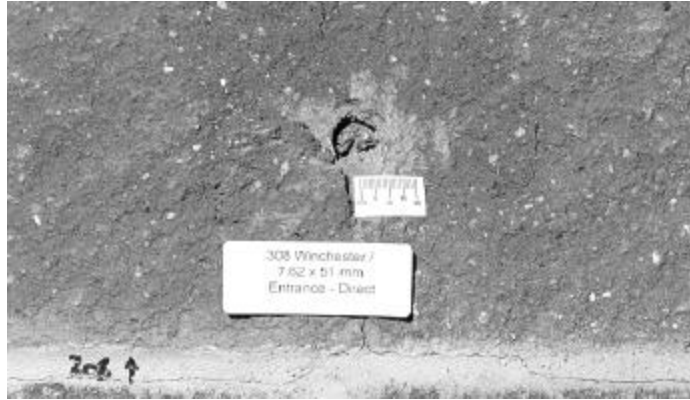
Figure 5 - Damage to red concrete masonry units caused by .308 Winchester

The .308 Winchester bullet displaced a portion of the block approximately 40 mm in diameter. It left a hole approximately 21 mm in diameter and 13 deep as shown in Figure 5. The unit was also cracked from top to bottom with the fracture plane running through the hole.

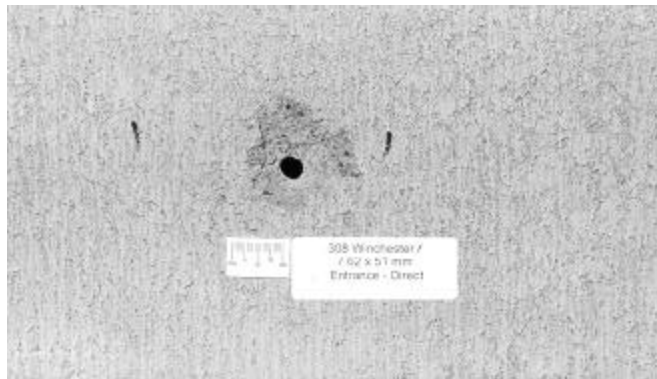
Figure 6 - Damage to the 140 mm concrete block wall caused by .308 Winchester

The .308 Winchester bullet penetrated both the front and rear face shells of the concrete block, passed completely through the foam insulation, and came to rest against the clay brick. It left a chip approximately 28 mm in diameter and hole approximately 10 mm in diameter. The entrance hole is shown in Figure 6.
