Transport
Canada

TP 185E
Issue 1/2008

AVIATION SAFETY LETTER

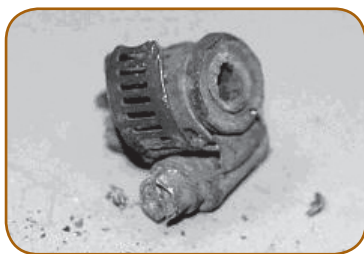
A piece of detached, heat-damaged tubing, complete with clamp and remnants of a burned rubber hose, was recovered from an unburned area of the wreckage trail. The tubing was submitted to the TSB Engineering Branch to determine if it was a fuel system component (see Figure 1) and the mode of failure. Examination of the fracture surface of the fitting did not identify any signs of a progressive failure; however, the fracture surface displayed fire damage. As the tubing, clamp, and hose were recovered from an area of the wreckage trail that was not exposed to the post-impact fire, the fire damage likely occurred prior to impact (see Figure 2).

Figure 1: Heat-damaged tubing, hose and clamp recovered from the wreckage trail

Visual and dimensional comparison of the tube fragment indicated it was the inlet post of a NAVMAN fuel flow transducer. Information provided by NAVMAN revealed the fuel flow transducer was designed for marine applications, and not for use in aircraft. At present, there is no FAA or Transport Canada (TC) regulation that precludes the installation of non-aviation parts in critical systems in amateur-built aircraft.

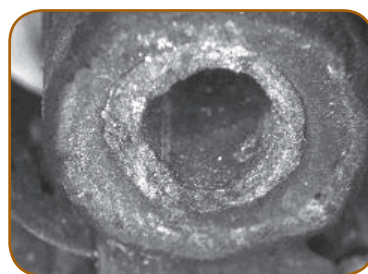
damage, the precise location of the transducer was not determined. The engine fuel system utilized a fuel pressure regulator that bypassed surplus fuel back to the fuel tanks; therefore, the transducer would most likely have been mounted between the fuel pressure regulator and the carburetors within the engine compartment so as to accurately record the amount of fuel actually being consumed. The transducer was designed to be mounted on the suction side of a fuel pump, rather than on the pressure side. It was manufactured from a composite glass FORTRON material. It had a published maximum operating temperature of 50°C and a component failure temperature of 509°C. Fuel flow transducers used in aircraft applications are normally mounted within the engine compartment, and transducer housings are usually made of stainless steel. The engine compartment would see temperatures of several hundred degrees Celsius during normal operation, particularly near the turbo-charger, and if the transducer was mounted in the engine compartment, it could have been exposed to temperatures that exceeded its maximum designed environmental temperature range.

Figure 2: Close-up of heat-damaged fracture

The airframe and engine were fire damaged to the extent that no component testing or leak checks could be accomplished. While the occurrence is consistent with the aircraft having sustained a fuel-fed in-flight engine fire, the exact reason for the fire could not be determined.

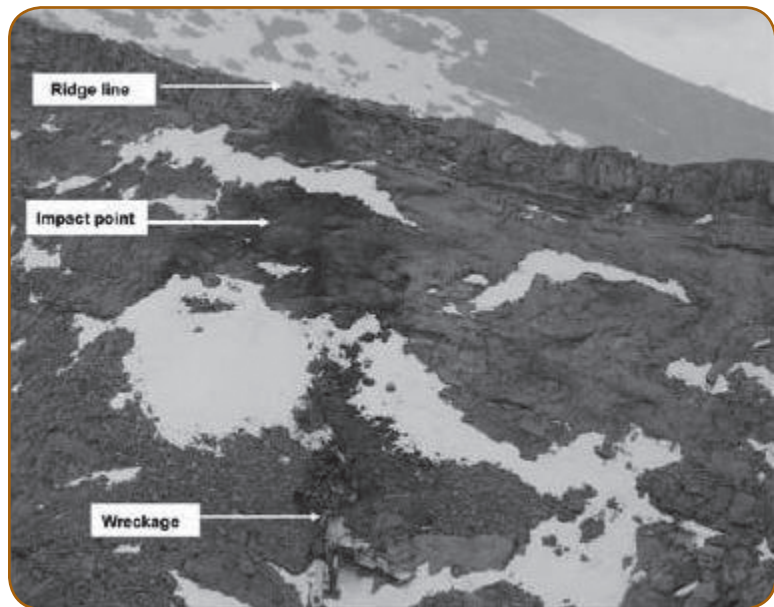
View of the accident site

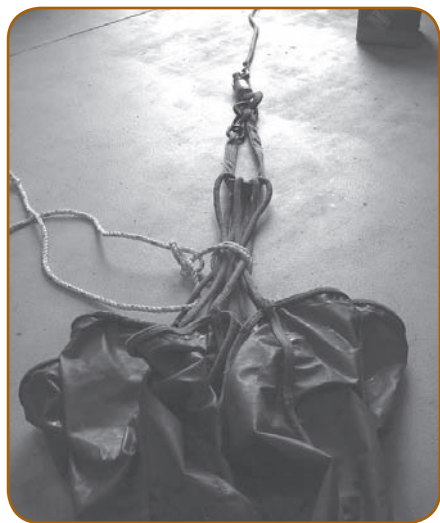
1. The rope used to snug the top of the bonnet most likely slid up the beackets, allowing the bonnet to open and fly into the flight path of the helicopter, carrying the longline with it. The longline came into contact

with the tail rotor and disabled it, rendering the helicopter uncontrollable.

Bonnet with sling attachment

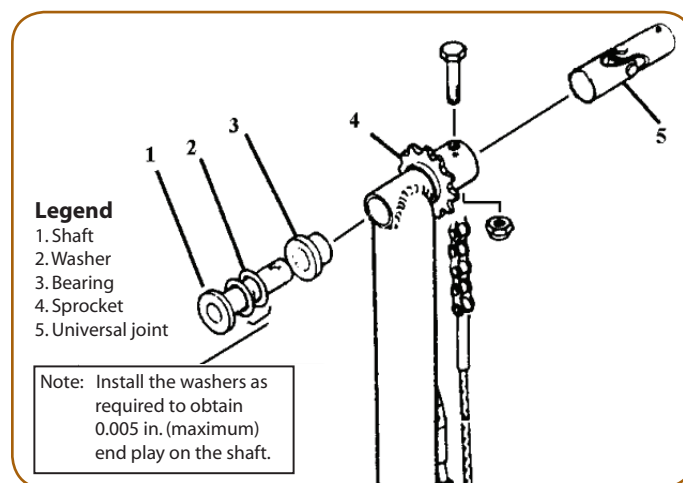
Figure 1: Aileron control system

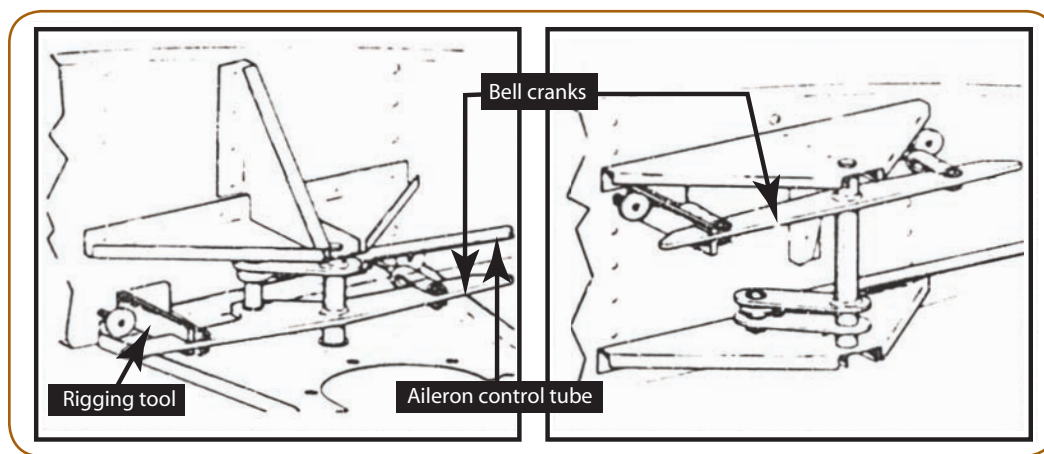
During the annual inspection, the aircraft maintenance engineer (AME) found that the aileron bell crank brackets were cracked and needed to be replaced.

Figure 2: Aileron bell cranks on the Piper PA28-140

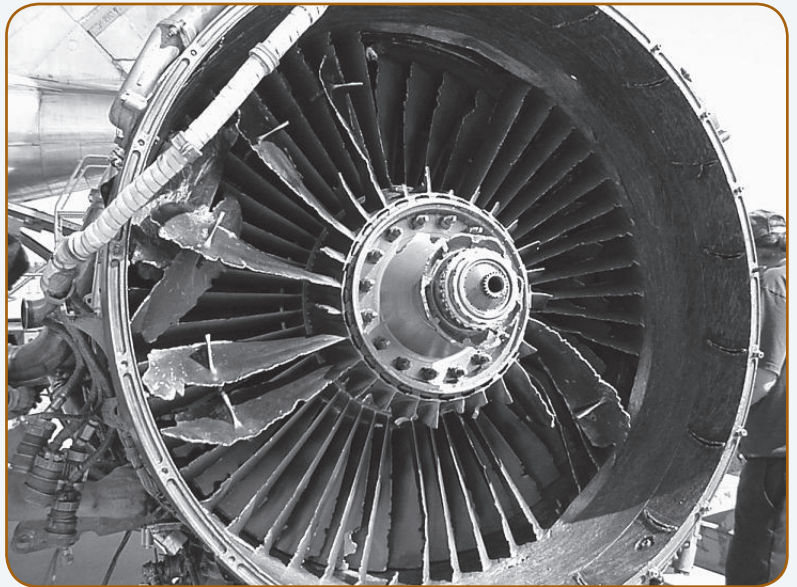
A Canada goose strike with a B-727-200, resulting in the destruction of the engine. Photo by Bob Johnson.
