AVIATION INVESTIGATION REPORT A05F0047

LOSS OF RUDDER IN FLIGHT

AIR TRANSAT
AIRBUS A310-308 C-GPAT
MIAMI, FLORIDA, 90 nm S
06 MARCH 2005

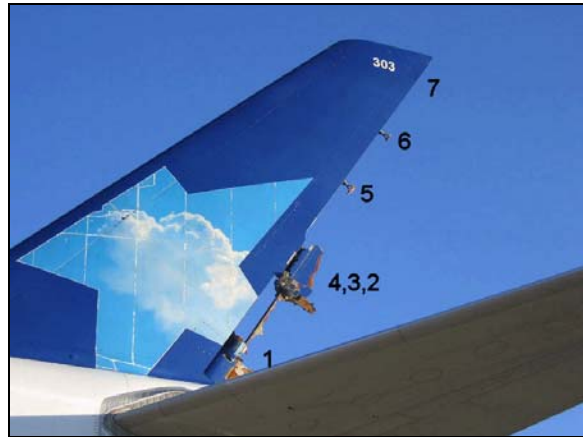
As will be discussed later in this report, subsequent analysis found that the rudder loss during flight was progressive, and by the time the aircraft landed, most of the rudder had separated from the aircraft. Photo 3 shows the empennage after landing in Varadero. The separated pieces fell into the ocean and none were recovered. Rib 0 remained attached, as did the length of rudder spar up to hinge point 4. A small piece of rudder side panel from each side remained attached to the spar in the region between hinge points 2 to 4, and also in the corner where the spar meets rib 0. The leading edge fairings between hinge points 2 and 4, and below hinge point 1, were still attached. The leading edge fairing between hinge points 1 and 2 had separated and some pieces were found jammed between the rudder and the VTP. At hinge points 5 and 6, small pieces of the rudder spar remained attached to the hinge arm. At hinge point 7, the VTP-side hinge bracket had fractured and separated, so none of the rudder remained.

Photo 3. Left-side view of VTP and rudder residuals

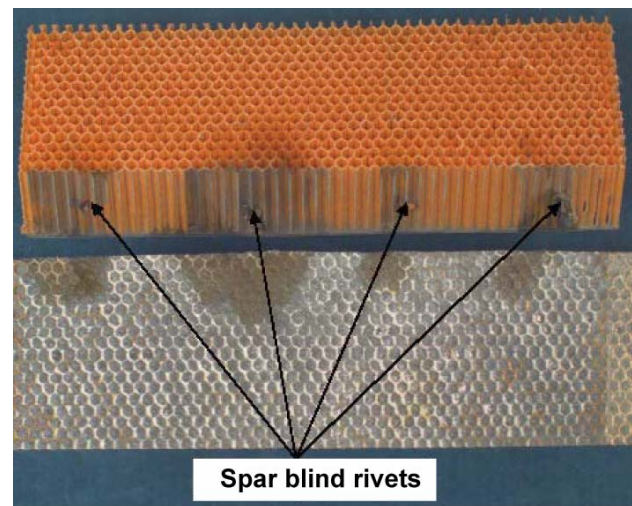
The rudder from aircraft MSN 361 was damaged at the trailing edge by unintentional contact with a maintenance dock during maintenance. Subsequent inspection found a disbond on the left inner-face sheet near the front bottom corner, approximately 830 mm long by 350 mm high. Stress analysis determined that the disbond was not caused by the impact with the maintenance dock. This internal disbond had not been detected by the AOT-1 (all operators telex – see Section 1.14.1) external tap test. Further examination revealed that hydraulic fluid had seeped into the left side panel around the blind fasteners at the front spar as shown in Photo 5, and that this fluid had weakened the bond between the honeycomb and the face sheet. In addition to the hydraulic fluid contamination, this rudder exhibited signs of water ingress around some trailing edge fasteners and at the leading edge immediately aft of the z-section.

Photo 5. MSN 361 honeycomb showing stain caused by hydraulic fluid ingress

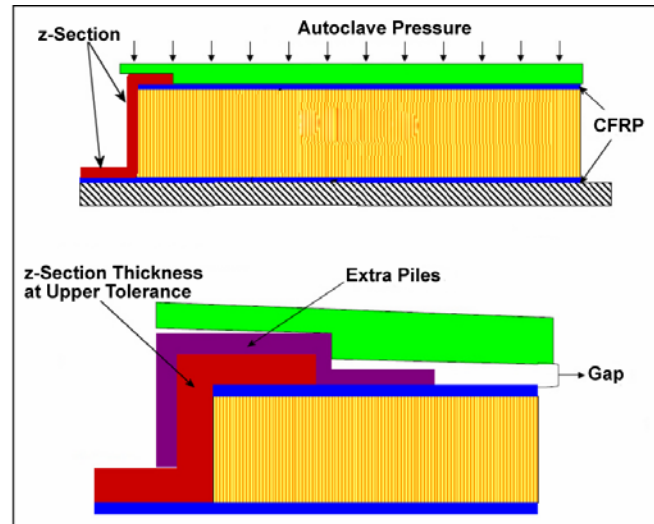
The front and bottom edge of each rudder side panel is trimmed with a z-section. Specimens of the inner skin bond taken near the z-section along the front edge of the left side panel of the occurrence rudder had a meniscus whose appearance was consistent with insufficient bonding pressure within a width of 20 mm. The investigation revealed that this condition could be caused by insufficient caul plate pressure during cure, either resulting from mispositioning of the z-section or accumulation of tolerances of the components. In Figure 6, the upper sketch shows correct orientation during cure. The lower sketch shows how dimensional tolerances can result in low bonding pressure next to the z-section.

Figure 6. Low bonding pressure next to the z-section

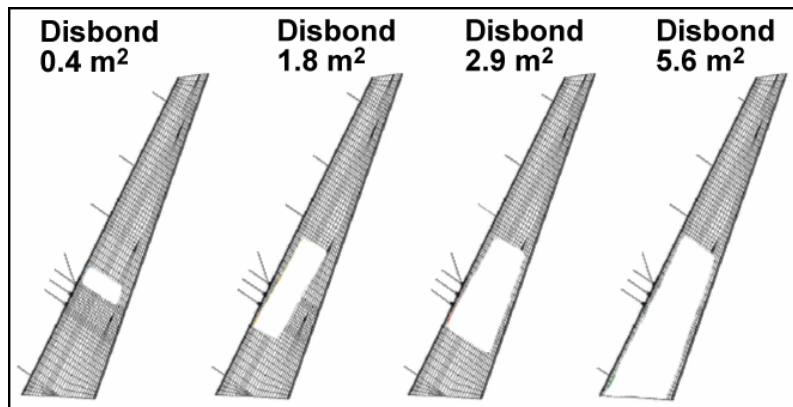
- Disbond** – The scenarios involved varying degrees of disbond between the honeycomb core and the inner face sheet, as shown in Figure 7. Single-sided disbonds were studied on the left panel, the right panel, and both panels. Simulating a

Figure 7. Disbond scenarios studied in flutter analysis

- disbond between the core and the face sheet was accomplished in the analysis by reducing the stiffness of the face sheet to 0 or 20 per cent of its original value in the affected area. The analysis found that there was an increase in flutter tendency with greater disbonds, and that double-sided disbonds were more critical than single-sided ones. There was no significant difference between left-side and right-side disbonds. No flutter was observed when stiffness was reduced to 20 per cent. When it was reduced to 0 per cent, the double-sided 2.9 m² disbond scenario and the single-sided 5.6 m² disbond scenario resulted in violent flutter below 150 KCAS. A more detailed examination of the single-sided 5.6 m² disbond scenario, within the range between 0 and 20 per cent stiffness, found that the flutter speed decreased as the stiffness was reduced, and that this decrease was steady and continuous down to about 5 per cent stiffness where flutter started. Below 5 per cent stiffness, the frequency and damping decreased rapidly leading to flutter conditions.
