AVIATION INVESTIGATION REPORT

A02C0114

IN-FLIGHT ENGINE FIRE / FORCED LANDING

CAMPBELL HELICOPTERS LTD.
BELL 205A-1 HELICOPTER C-FMQN
TOBIN LAKE, SASKATCHEWAN
02 JUNE 2002

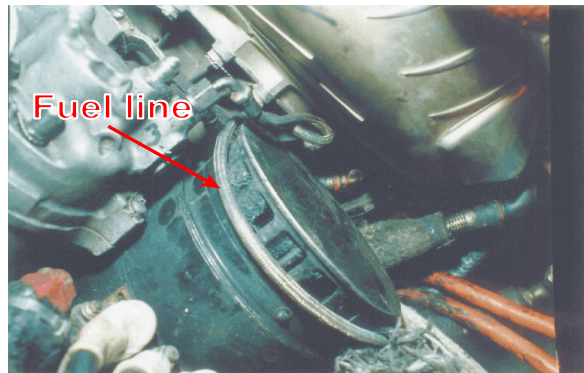
Inspection of the engine revealed extensive damage to the engine and surrounding engine bay area. The blown fire bottle plug and fire retardant material found in the engine bay indicated that the fire retardant had been discharged. The variable inlet guide vane actuator (VIGVA) hose, which provides fuel pressure to open the variable guide vanes, was found pinched between the top of the starter/generator and the impeller housing assembly (see Figure 1). Further inspection of the pinched fuel hose revealed a hole through the steel braiding and inner lining (see Figure 2). Inspection of three similar helicopters, found that both lines coming from the VIGVA were routed behind and underneath the starter/generator, clear of any interference.

Figure 1.- Subject fuel line was installed on another similar engine to show routing.

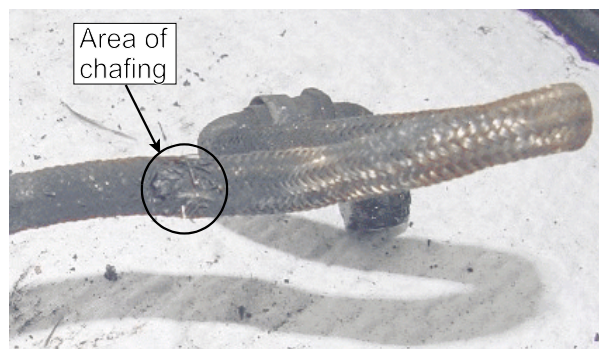
Figure 2. Subject fuel line.

The starter/generator and fuel hose assembly were forwarded to the TSB Engineering Branch Laboratory for analysis. The analysis revealed soot on the shoulders of the hold-down nut receptacles, on the attach flange of the starter/generator, at the 12, 10 and 8 o'clock positions. The starter/generator is normally held in place by six hold-down nuts. Analysis of the cooling fan indicated that the fan blades had been abraded away. No indication of a catastrophic failure of the fan blades was found. Analysis of the fuel hose indicates that the steel braid strands failed as a result of chafing.

1. The fuel line to the VIGVA was pinched between the top of the starter/generator cooling fan housing and the diffuser housing.
2. Three starter/generator hold-down nuts at the 12, 10 and 8 o'clock positions were not fastened, allowing the starter/generator to vibrate.
3. Because the fuel line was pinched against the vibrating starter/generator, it chafed through, allowing fuel to enter the starter/generator, which resulted in an engine fire.

Transport Canada is conducting a review of the applicable Bell 205A-1 instructions for continuing airworthiness to determine if action is necessary regarding the instructions for the installation of starter/generators and fuel lines.
