AVIATION INVESTIGATION REPORT

A02Q0098

IN-FLIGHT SEPARATION OF RIGHT WING

GILLES LÉGER SUPER CHIPMUNK C-GLSC

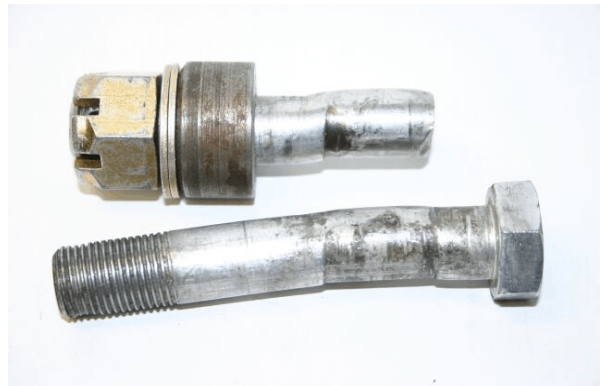
The builder-pilot could not find any original attachment bolts (original reference 06256 then 05179), which were specifically made by de Havilland. These bolts had a diameter of 0.731 inch and were tempered to 150 ksi.² The bolts used by the builder (AN10-23) were 0.625 inch in diameter. The hardness standard for these bolts is established at 125 ksi, and the bolts from the accident aircraft were measured at 26 to 28 on the Rockwell scale, which corresponds to 123 ksi to 129 ksi. Therefore, the bolts were in compliance with the AN standard. However, an O-shaped mark on the bolt head indicates a strength of 145 ksi to 165 ksi, according to the National Aircraft Parts catalogue. It was determined that, using bolts tempered to 125 ksi, the strength of the fitting was reduced to 61 per cent of the original strength; using bolts tempered to 150 ksi reduced it to 72 per cent. Bushings were machined to adapt the size of the holes to the bolts. Photo 1 shows the failed bolt from the right main spar. The lower bolt is from the left spar. Its deformation indicates that it was about to fail.

Photo 1. upper bolt broken: right wing
lower bolt deformed: left wing

All the structural elements related to the wing attachments were thoroughly examined at the TSB Engineering Laboratory. The report found that the lower bolt from the right main spar failed first. The initial upward movement of the wing tore the front attachment fitting, and the wing then folded aft, tearing the root of the upper fitting of the main spar from the wing.

Observations made about the bolt indicate that it failed under combined shearing and tension caused by stretching when it was deformed.

Theoretically, the two wings should have been equally strong and, therefore, should have separated at the same time. However, the aerodynamic stresses on different areas of the aircraft can be different if the flight is not in a perfectly straight line. Given the major deformation observed on the bolt from the lower left spar, the bolt was about to fail, which would have resulted in separation of the left wing as well. However, the separation of the right wing instantaneously removed loading from the left wing.

1. The aircraft was subjected to stresses exceeding its structural envelope, and the bolt securing the right lower spar failed in overload.

2. The four bolts securing the main spars to the fuselage had been replaced with bolts of lesser diameter and strength. The strength of the replacement bolts was approximately 61 per cent to 72 per cent of that of the original bolts.

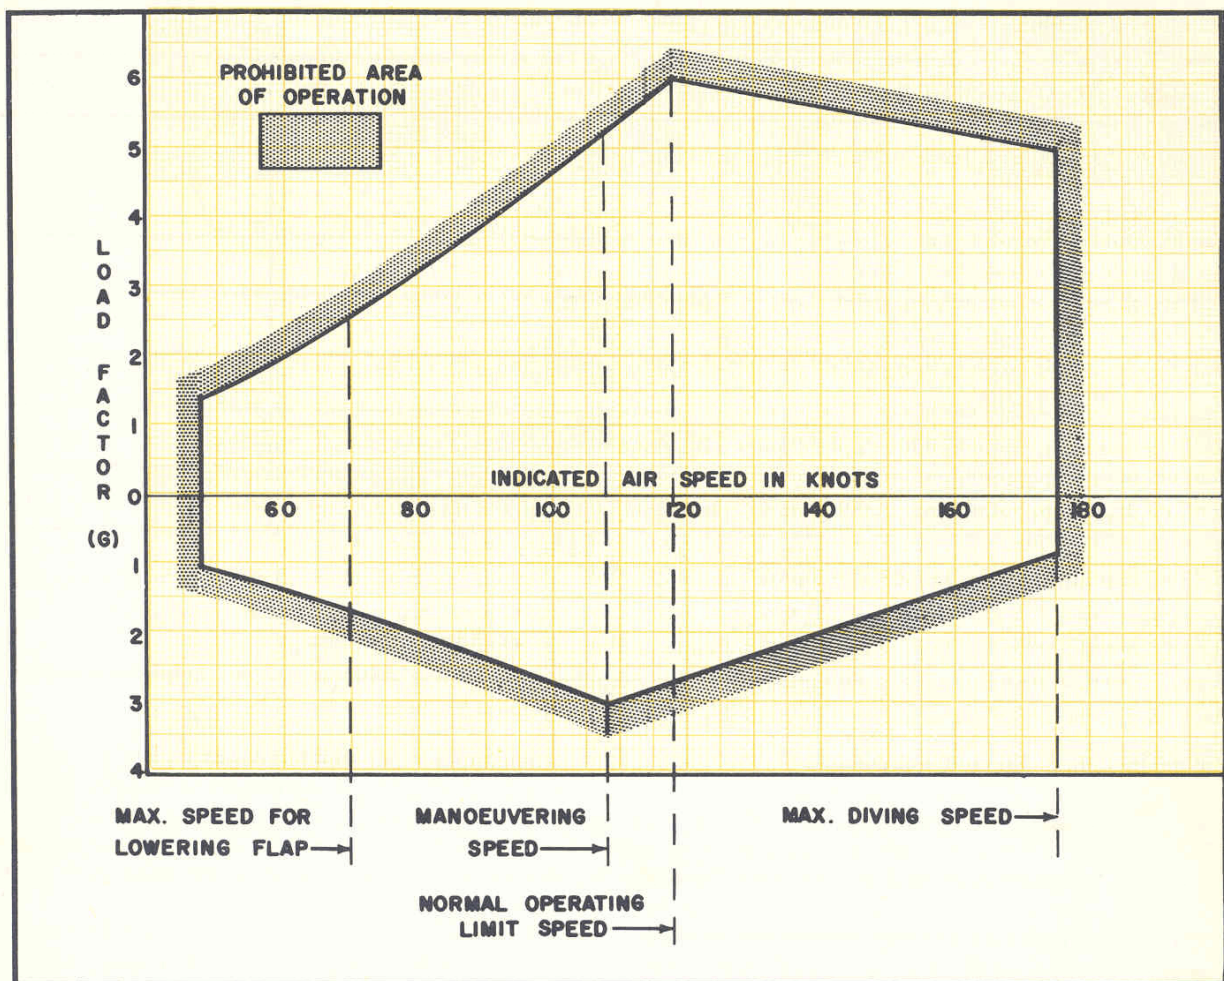
Figure 4-2 Operating Flight Strength Diagram

The builder had an excerpt from the Chipmunk manual indicating that, at a maximum weight of 1930 pounds and an indicated airspeed of 136 mph, the DHC-1B could withstand a load factor of 9 g. The document also indicated that, at 230 mph, the maximum load factor was reduced to 6.75 g. However, the document was accompanied by a graph indicating that the highest load factor could be reached at 136 mph (120 knots) and that it was limited to 6 g. According to the graph, the load factor decreases to 4.9 g at the maximum indicated airspeed of 202 mph (175 knots). It was not possible to determine from which manual precisely the excerpt was taken (see Appendix A).

Pursuant to Section 523.303 of the regulations, except where otherwise indicated, a safety factor of 1.5 must be applied to maximum loading. The resulting value is referred to as ultimate load.³ Theoretically, based on the graph at Appendix A, the unmodified wings of the original Chipmunk mounted on the Super Chipmunk could have withstood an ultimate load of 7.2 g before breaking or being permanently deformed. The ultimate load would be calculated as follows: 1930 pounds x 6 g x 1.5/2400 pounds. However, the relationship between the increase in the maximum allowable weight and the load factor is not necessarily linear, and testing it normally required to confirm the strength factor. Since the aircraft was not intended to be certificated for unlimited aerobatics, no strength tests or calculations were required by the regulations. Therefore, the builder was not required to provide a new flight parameter graph. The Super Chipmunk documentation describing the aircraft characteristics indicates that the aircraft will withstand a positive load factor of 9 g and a negative load factor of 6 g.
