AVIATION INVESTIGATION REPORT

A03P0199

COLLISION WITH TERRAIN

CESSNA 172M C-GDPD

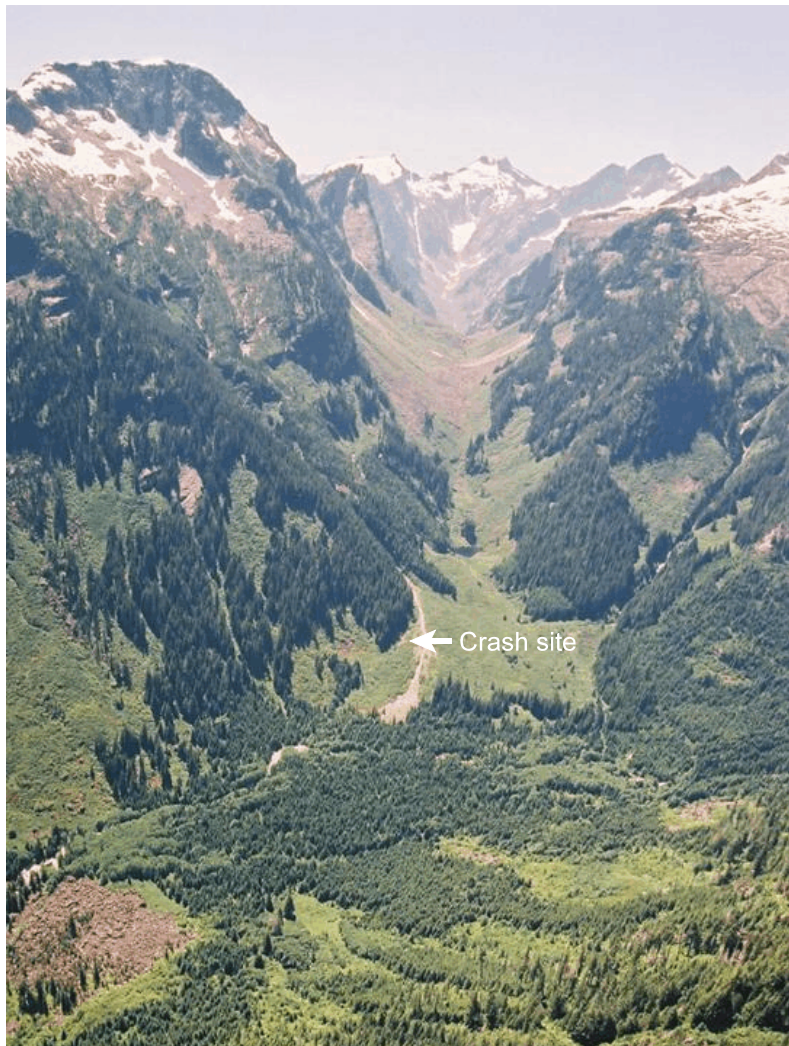
The mountain peaks in the vicinity of the accident site vary in height between 6400 feet and 7400 feet above sea level (asl), and there was some snow at higher elevations, particularly on the north-facing slopes. The wreckage was located at approximately 2100 feet asl on a northwest-facing slope at the juncture of two U-shaped glacial valleys: Tretheway Creek valley and a slightly narrower, unnamed valley. The wreckage was situated about 1000 feet south and 300 feet above Tretheway Creek. The mountainside in the immediate area of the accident site was covered with low, light-green vegetation typically found in sub-alpine avalanche chutes; the predominant vegetation elsewhere in the area was dark, coniferous forest.

During impact, the left wing, engine, firewall, and nose landing gear detached from the fuselage and the battery was ejected from the aircraft. Pieces of the left wingtip and navigation light were found embedded in the ground 130 feet west of the main wreckage and at approximately the same elevation. A series of impact marks and aircraft parts extended horizontally across the hillside between the wingtip pieces and the main wreckage. A section of propeller blade tip found near the beginning of the wreckage trail exhibited leading-edge damage, chordwise scratching, and torsional damage indicative of applied power. The propeller fractured 20 inches inboard from the tip; the cause was overload. The ELT remained attached to the aft fuselage wall via its mount, but the antenna

Photo 1. Aerial photograph of crash site, facing southwest
