## AVIATION INVESTIGATION REPORT

A04A0099

### COLLISION WITH TERRAIN

**PIPER PA31-350 (NAVAJO) C-FTNS  
SAINT JOHN AIRPORT, NEW BRUNSWICK  
19 AUGUST 2004**

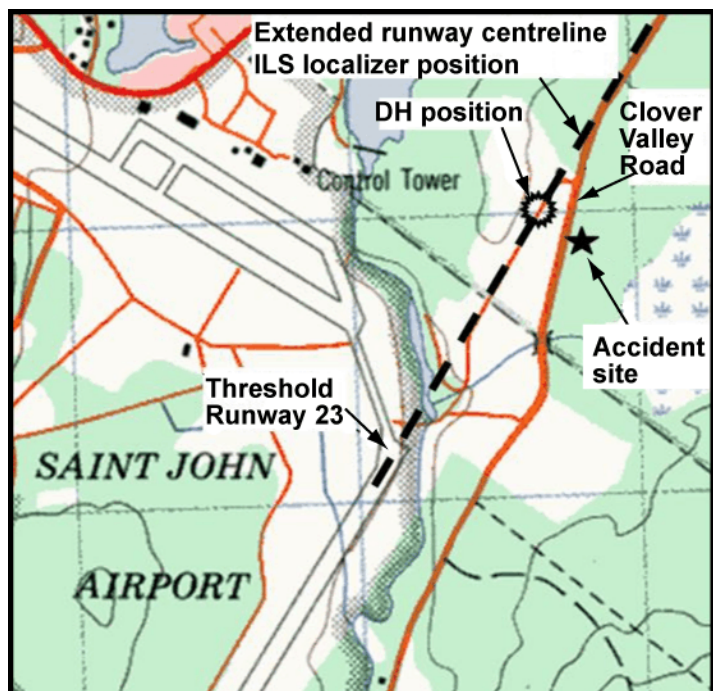
Figure 1. Accident site location

The aircraft struck some alder tree-tops, left tire marks on the paved surface of the Clover Valley Road and then entered an area of alder trees and marshy terrain. From the tree and ground marks, it was determined that the aircraft track was about 182°M when it struck the ground, while the extended centreline of the runway was on a track of 230°, a difference of about 50°. It was also determined that the aircraft was approximately 10° nose down and in a three-degree right bank when it struck the tree-tops and crossed the road. The right main wheel contacted the paved road surface, leaving a heavy tire mark. The impact was almost abeam of the DH position. The initial contact contributed to a subsequent left rolling moment and a left-banked attitude of approximately 11° as the aircraft entered the alder trees beyond the road.

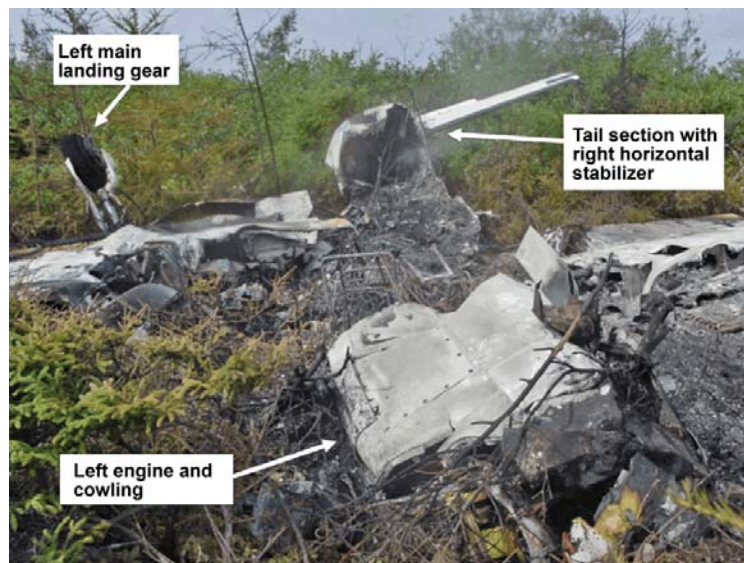
Figure 2. Aircraft wreckage

The aircraft continued forward, eventually rolling over and coming to rest inverted 650 feet southeast of the localizer. The wreckage trail was approximately 110 feet long. The cockpit and cabin were not initially compromised. A fuel-fed fire broke out a few seconds after the aircraft came to rest (Figure 2). The fire was well developed by the time the two pilots exited through the aft cabin door. The fire consumed about 90 per cent of the fuselage. Both wings sustained severe fire damage, but the empennage remained relatively undamaged.

Both engines were still enclosed in their cowlings and were in good condition except for some impact damage. Both propellers were still attached to the engines, and all the blades were bent rearward about mid-span, suggesting low propeller rpm during impact. Because of the softness of the marshy terrain, it was difficult to determine accurate rpm figures.

Despite the severity of the burn damage to the airframe, continuity of all flight controls and engine controls was confirmed. No pre-impact airframe or engine anomalies were discovered during the wreckage examination.
