AVIATION INVESTIGATION REPORT

A04A0110

RUNWAY EXCURSION

BOEING 727 C-GMSX

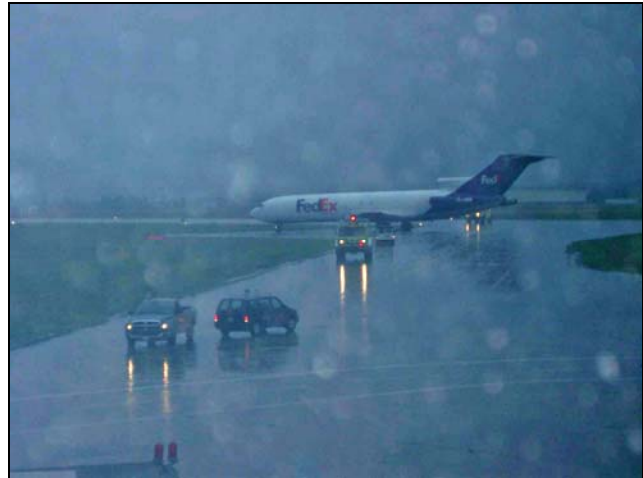
Photo 1 shows the aircraft moments after the landing. There was significant precipitation and standing water, which would have been conducive to aircraft hydroplaning. The Transport Canada Aeronautical Information Manual (AIM) notes that, when hydroplaning occurs, "it is known that a 10-knot, crosswind will drift an aircraft off the side of a 200-foot wide runway in approximately 7 seconds under hydroplaning conditions."

Photo 1. Aircraft moments after runway excursion

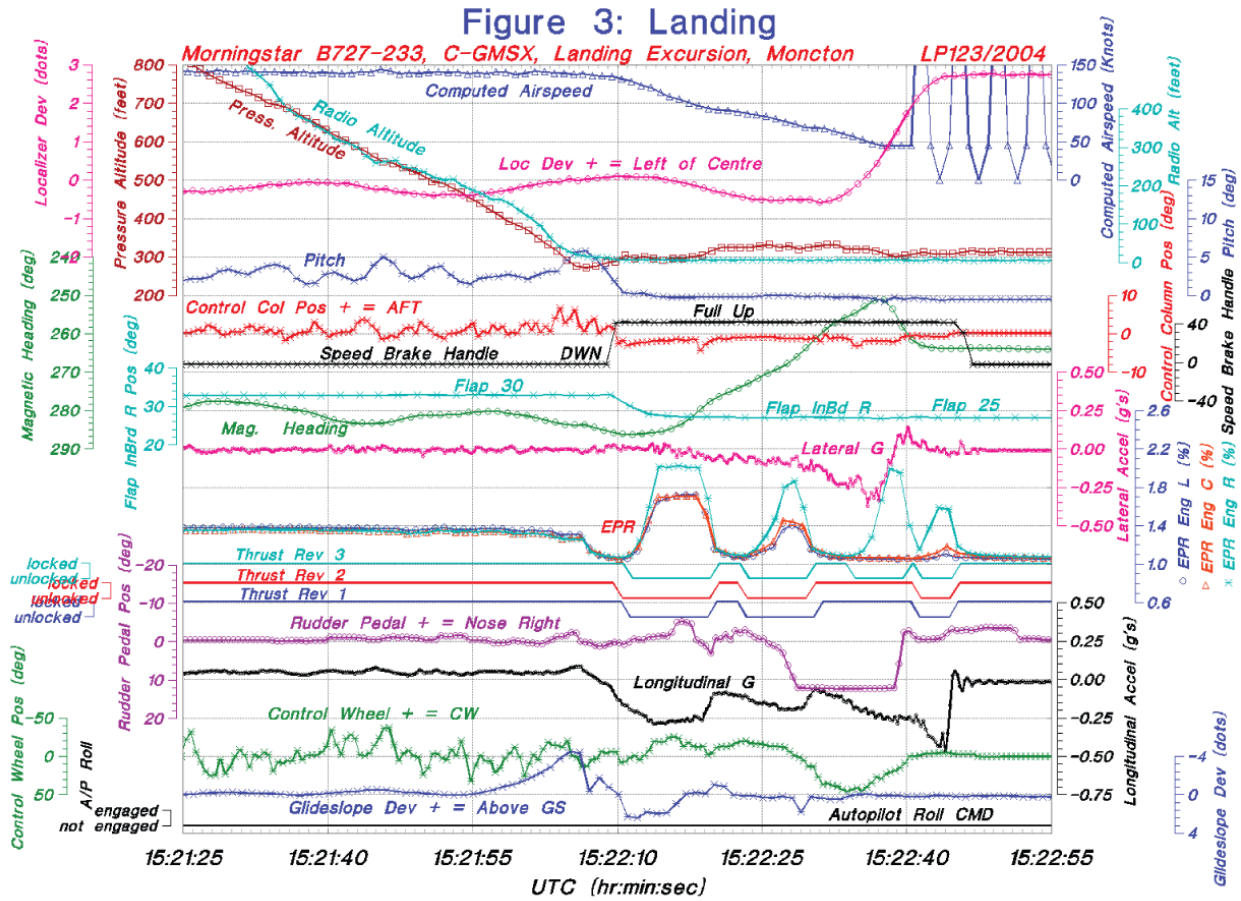
Appendix B – Flight Data Recorder Plot of Landing

At 1220, the aircraft intercepted the ILS glideslope, and the crew completed the landing checks. The surface wind was 210°M at 8 knots. The aircraft was cleared to land. Runway 29's visual range was 3500 feet and decreasing. The surface wind equated to a crosswind from the left at about 8 knots. Flight data recorder (FDR) data show that, except for minor localizer and glideslope deviations, the approach was stable with runway environment acquired at 700 feet agl. At decision height, the aircraft was on the glideslope, slightly right of the runway centreline. During transition to landing, the aircraft regained the centreline briefly, drifted to the right, then corrected again to the centreline. There was also a modest deviation below the glideslope before touchdown.

The aircraft landed approximately 1400 feet from the runway threshold at 135 knots indicated airspeed (KIAS) on a heading of 284°M, four degrees left of the runway heading of 288°M. Immediately following touchdown, the speed brakes were manually deployed, the wing flaps were raised from 30° to 25°, and the thrust reversers were deployed, all in accordance with the operator's standard operating procedures (SOPs). Three seconds after touchdown, the aircraft began to weathercock to the left. Reverse thrust reached a maximum engine pressure ratio (EPR) of 1.7 on the number one and two engines, and an EPR of 2.0 on engine number three. The higher EPR on the number three engine had been apparent on previous landings, indicating that the number three thrust lever was likely out of adjustment. However, the mismatch value was approximately twice as much on the incident landing, suggesting that it was used to counter the weathercocking tendency.

The initial application of reverse thrust was maintained for four seconds. However, the aircraft continued to drift toward the right side of the runway and the aircraft heading continued to decrease. The thrust levers were stowed and redeployed twice more in an attempt to regain directional control and counter the drift to the right, but the aircraft remained right of the centreline. During this time, the pilot applied full right rudder and a significant amount of right control wheel input with no significant result. At about 70 KIAS, with the aircraft heading about 250°M, tire friction began to take effect, and the aircraft departed the left side of the runway.
