AVIATION INVESTIGATION REPORT

A04Q0196

LANDING BESIDE THE RUNWAY

PIPER PA-31-350 C-GBYL

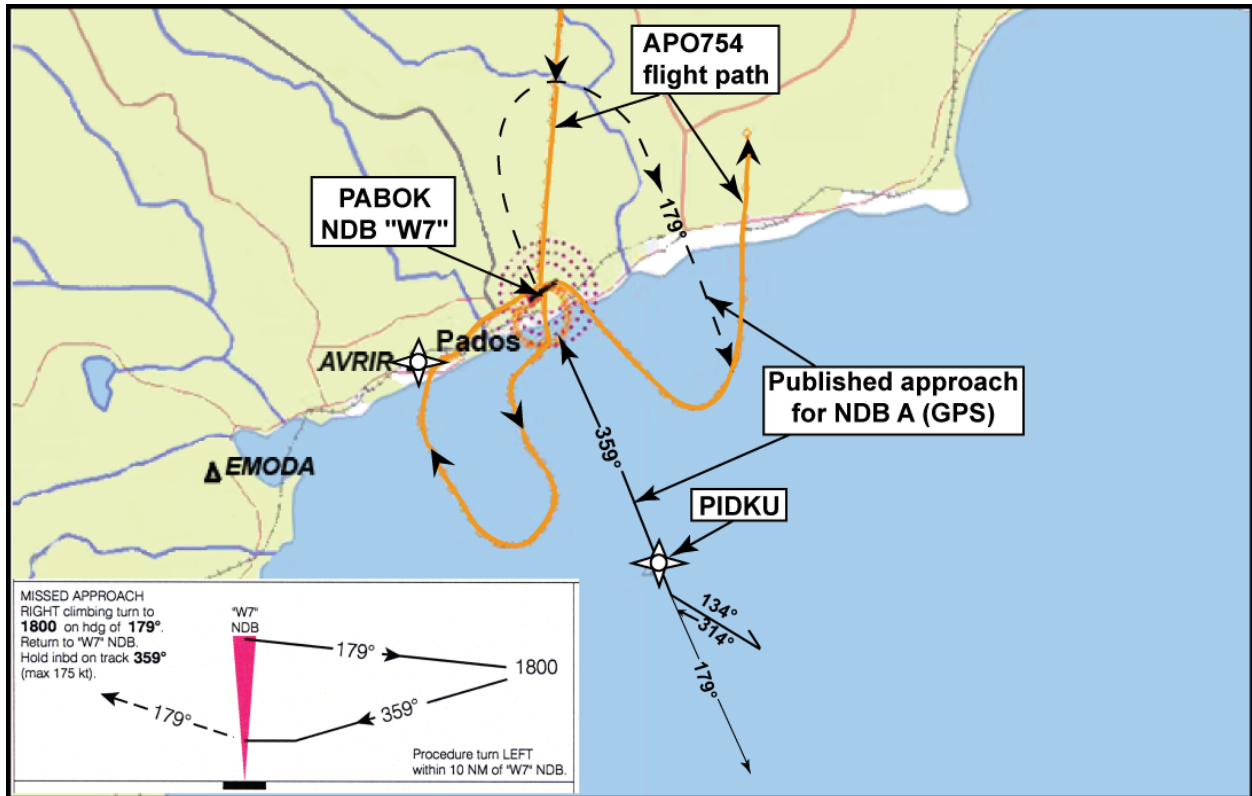
Appendix A – Approach to the Du Rocher-Percé Aerodrome (Pabok)

Considering the proximity of the weather station, it is reasonable to believe that the weather at Rocher-Percé was similar to that observed at Gaspé. Consequently, to land at Rocher-Percé, the pilot would have had to execute an instrument approach according to the NDB A procedure. However, the pilot followed an improvised flight path that suggested the use of a GPS for guiding the aircraft. By departing from the approved approach procedures in the prevailing instrument flight conditions and relying on minimal external references, the pilot reduced the

1. Upon his arrival at Du Rocher-Percé, the pilot executed an improvised instrument approach, which suggests the use of a global positioning system (GPS) although neither the pilot nor the aircraft was certified for a GPS approach.
2. On the first approach at Gaspé, the pilot did not follow the published missed approach procedure, which reduced the obstacle clearance.

The following illustrates the aircraft's flight path compared with the published NDB A (GPS) approach path.

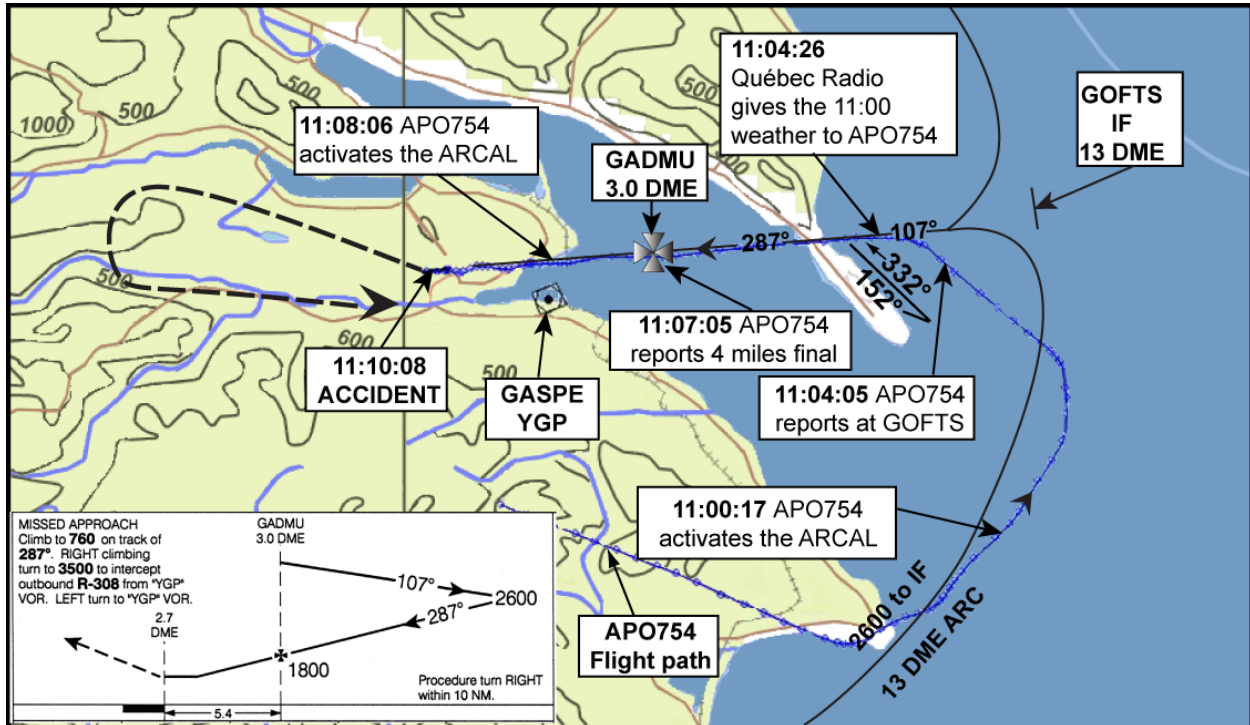
Appendix C – Second Approach to the Gaspé Airport

About 1 ½ miles from the runway, the aircraft was correctly configured and the pilot had activated the aerodrome lighting. However, he had selected medium-intensity lighting. About one mile from the runway threshold, the aircraft was slightly to the left of the localizer course and was heading several degrees to the left. The deviations from the runway centreline could be partly attributed to the inherent difficulty in a LOC (BC) approach for a pilot to stay on the back course.¹² Further, searching for visual references upon approaching the runway certainly distracted the pilot from monitoring the instruments. As he was nearing the runway, the deviation from the localizer course and the heading changes increased, making the approach unstable. Because of the reduced visibility and obscurity, and because the pilot was sitting in the left seat and did not have his peripheral vision, he did not see the approach lights and ended up to the left of the runway when he reached the threshold. As the only crew member, the pilot's workload was high in such conditions. It is conceivable that a co-pilot would have been able to inform the pilot of any deviations in the approach.

Once the pilot finally saw a row of runway lights, he mistook the left row of lights for the right row. Since only one row of runway lights was visible, it was impossible for him to confirm the exact position of the runway and he should have initiated the missed approach procedure. For an undetermined reason, he assumed that the runway was below the aircraft even though he could not see the left row of lights, and he decided to land.

The following illustrates the aircraft's flight path during the second approach to the Gaspé Airport compared with the LOC (BC)/DME RUNWAY 29 approach path.
