AVIATION INVESTIGATION REPORT

A04P0033

IN-FLIGHT BREAKUP

**BEAR CREEK CONTRACTING LTD.
ROBINSON R22 (HELICOPTER) C-FILW
KUMEALON INLET, BRITISH COLUMBIA
20 FEBRUARY 2004**

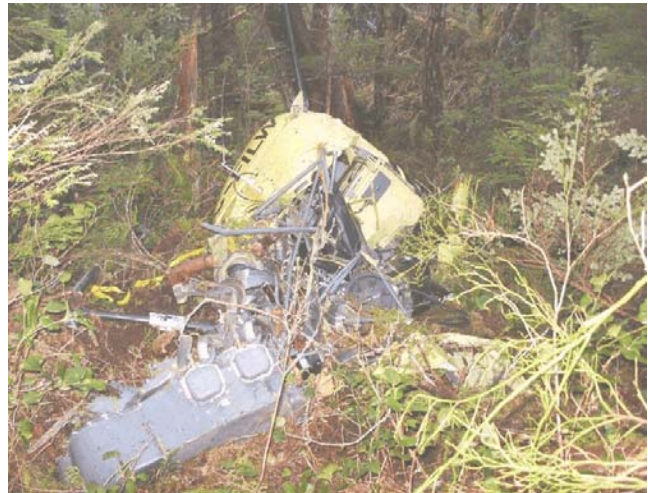
Photo 1. Accident site

The area in the vicinity of the accident site was examined for main-rotor blade strikes to trees. None was found, but the tree branches immediately above the main wreckage impact area were damaged. That damage was not consistent with that found when rotating blades strike a tree.

The wreckage debris trail, the damage to the trees, the resting location of the pilot's body, and the damage to the helicopter were indicative of an in-flight breakup.
