## AVIATION INVESTIGATION REPORT

A99Q0062

### LOSS OF CONTROL

MYRAND AVIATION  
CESSNA 335 C-GMZV

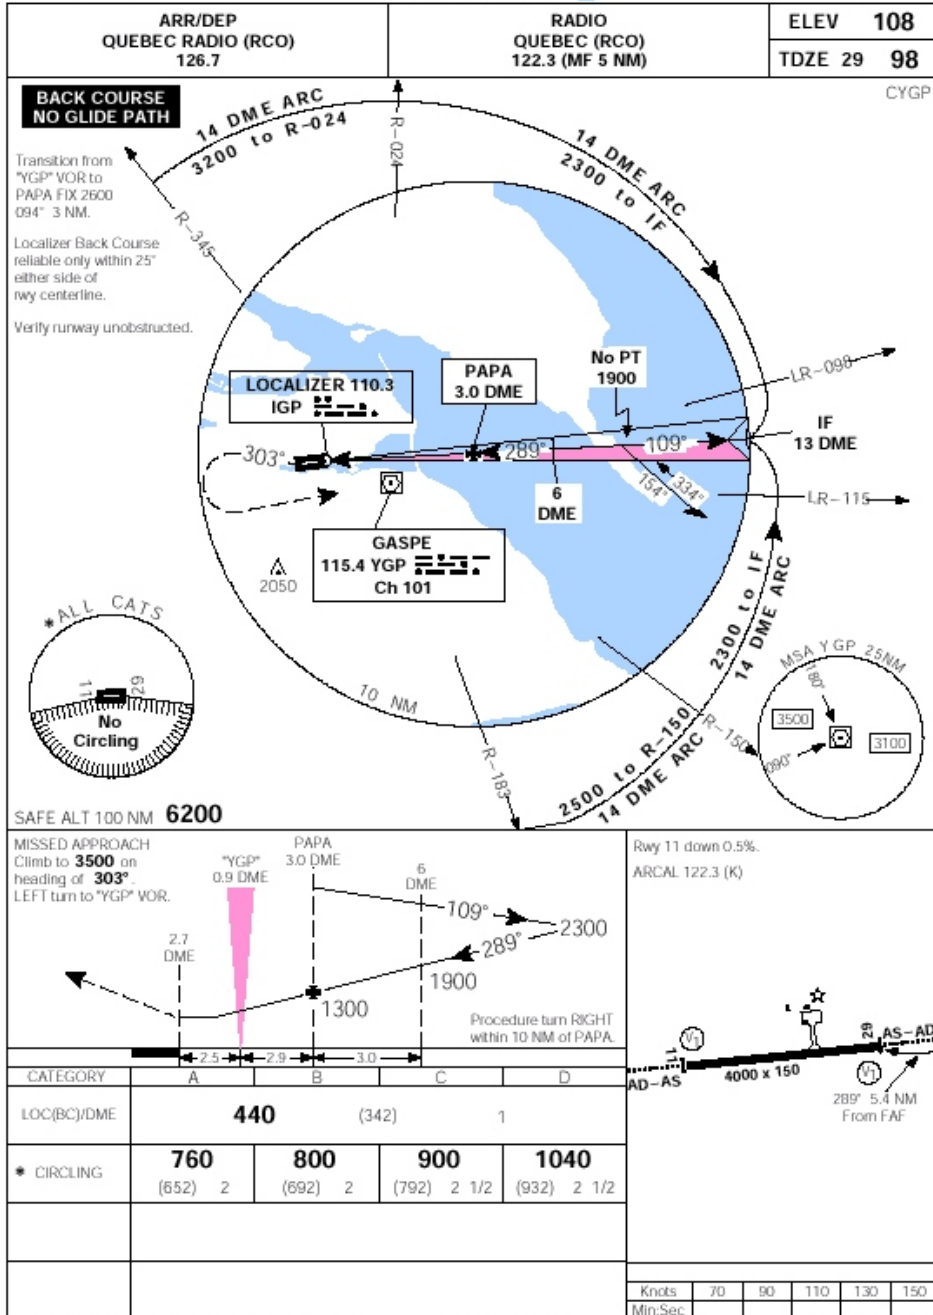
# Appendix A—LOC(BC)/DME Approach Chart for Runway 29 at Gaspé Airport

According to the instrument approach chart LOC(BC)/DME RWY 29, the minimum altitude is 440 feet above sea level (asl), 336 feet above ground level, and the minimum horizontal visibility must be 1 nautical mile (nm). The pilot advised the Québec FSS specialist that he was going to make a back course (BC) approach on runway 29 at Gaspé. This approach brings the aircraft

successively to an altitude of 2300 feet asl on the 14 nm DME (distance-measuring equipment) arc and to 440 feet asl, the decision height that must be maintained until 2.7 nm DME, the threshold of runway 29. If the crew has not established visual contact with the runway or the runway lights at this height and distance, they must make a missed approach. A missed approach involves climbing to 3500 feet asl on a magnetic heading of 303 degrees and then making a left turn to the Gaspé VOR (very high frequency omnidirectional radio range). (See Appendix A.) All the navigation systems required for the approach were serviceable on the day of the accident.
