AVIATION INVESTIGATION REPORT

A99P0056

MID-AIR COLLISION

108 MILE AIRPORT, BRITISH COLUMBIA

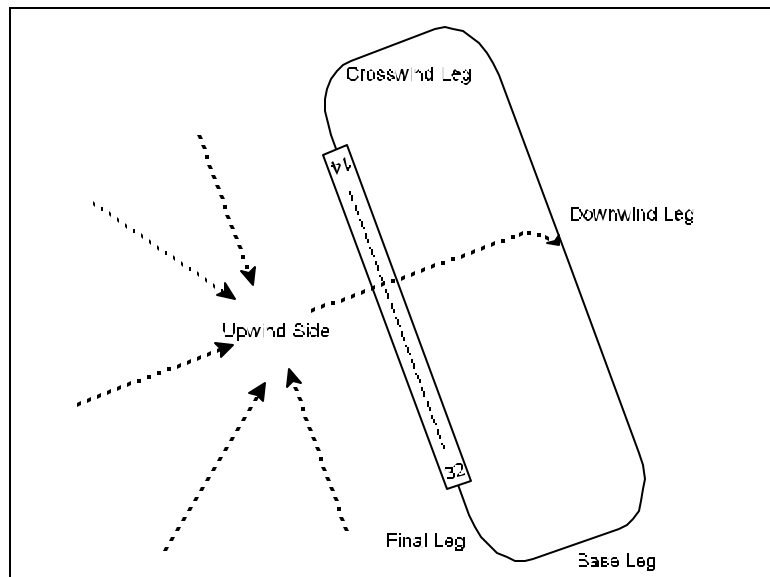
Figure 1. Standard Right-Hand Circuit at 108 Mile Airport

Canadian Aviation Regulations require that all turns be to the left while operating in the circuit, unless a right-hand circuit has been specified in the *Canada Flight Supplement (CFS)*. The CFS specifies right-hand circuits for runway 32 at 108 Mile Airport during daylight hours.

The pilot of C-FBVW was conducting left-hand traffic patterns to runway 32 at 108 Mile Airport, whereas the CFS states right-hand circuits should be flown to runway 32. By not following the published circuit procedure, this pilot increased the risk of an in-flight collision. Additionally, while in the downwind leg, and during the final turn, his ability to see the conflicting traffic would have been impaired by visual interference from the cockpit dash, the aircraft's engine section, and the passenger. The result was that the visual search procedure used by the occupants of C-FBVW was ineffective.
