AVIATION INVESTIGATION REPORT

A99W0144

RISK OF COLLISION

5 AUGUST 1999

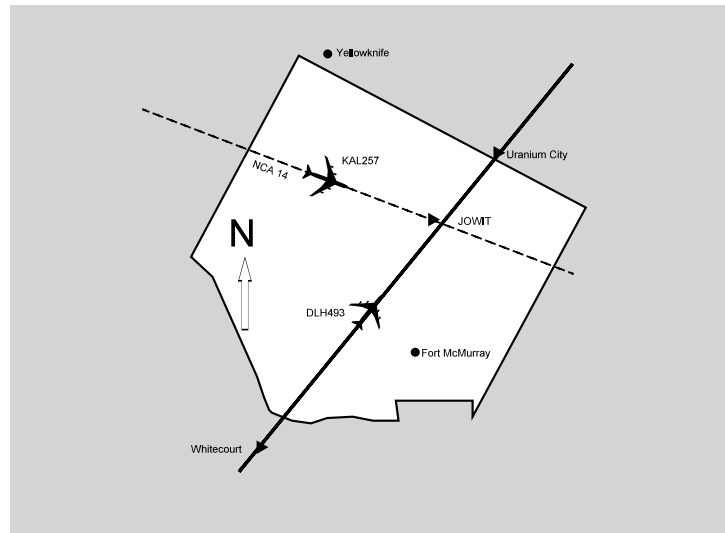
Figure 1. Bison sector

The Edmonton Area Control Centre (ACC) comprises a number of Specialties; the Bison sector is one of four sectors located in the Northern High Specialty. The Northern High Specialty was staffed with four controllers, one for each sector. Because of the light traffic at that time of day, no supervisor was scheduled for the Northern High Specialty. The staffing requirement for the Bison sector is a minimum of one controller. Traffic conditions were described as light, and complexity as normal.

Both radar and non-radar procedures are used to control aircraft in the Bison sector. Edmonton ACC procedures require that information on aircraft proceeding into surrounding non-radar sectors be entered into the Northern Airspace Display System (NADS). It is the Bison sector controller's responsibility to confirm that all estimates received and departures authorized for his aircraft have been entered. NADS controllers may assist sector controllers in the provision of non-radar control service to IFR aircraft, but the separation of aircraft remains the sole responsibility of the sector controller.

KAL257 was on northern control area track 14 (NCA 14), which begins in a non-radar sector and transits into the Bison sector. The information for KAL257 would have been already entered into the NADS system. DLH493 was transiting from the Bison sector to a non-radar sector north of Bison. This information would have to be entered into the NADS prior to entering the non-radar sector. Once the information for both aircraft is in the NADS, the system has the capability to alert the controller to any conflicts. The Bison sector controller did not recall when DLH493 was entered into NADS and
