AVIATION INVESTIGATION REPORT

A99P0105

COLLISION WITH TERRAIN

**A.A.L. AIR ALPS (GLACIER AIR)
EUROCOPTER AS350BA (HELICOPTER) C-GDWF
SQUAMISH, BRITISH COLUMBIA 3 NM W
15 AUGUST 1999**

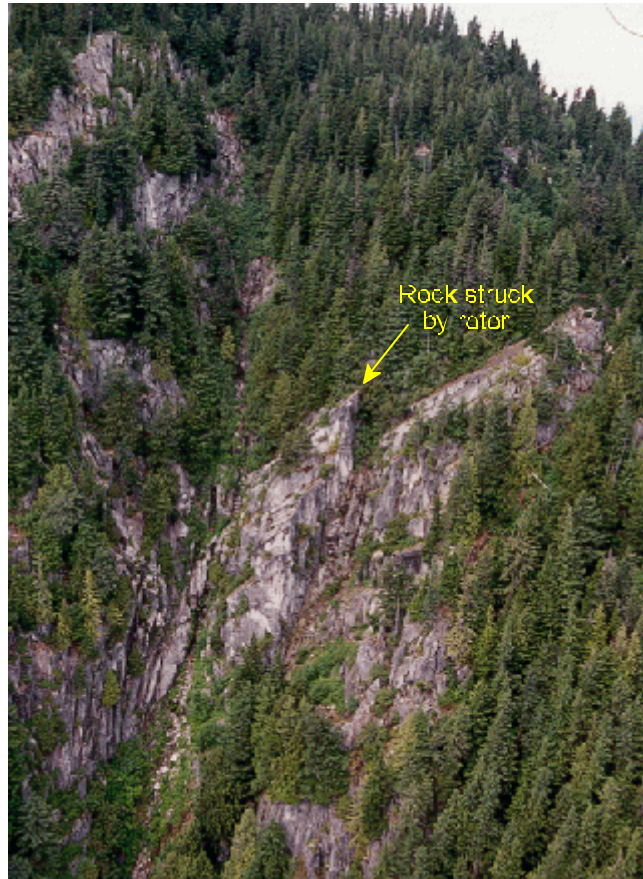
Figure 1 - Crash site area

The accident site (latitude 49°47'48" N, longitude 123°14'36" W) was not on the normal or expected route for transit to or from the glacier or Lake Lovely Water, nor were there any apparent tourist attractions in the ravine. The initial impact was on a rock formation in a steep, narrow ravine in mountainous terrain below the tree line at about 3800 feet asl. The immediate terrain was too steep to retain the main parts of the wreckage, and the heavier parts tumbled down the ravine, coming to rest about 300 feet below. The mouth of the ravine spans about 300 feet. At the accident location, it spans about 100 feet. The rock formation that the accident

helicopter hit protrudes into the ravine; from some angles, the extent of its protrusion is difficult to assess.

Accident site scaring and damage to the main rotor blades indicate that the rotor blades struck a rock formation while the helicopter was manoeuvring, likely descending, at slow speed. These indicators also suggest that the initial impact was made as the blades were advancing on the left side of the aircraft. The initial impact forced to the main rotor destroyed the rotor system, making the helicopter uncontrollable. Because no indication was found of any malfunction or pre-existing mechanical defect, further analysis focusses on operational aspects of the accident flight.
