AVIATION INVESTIGATION REPORT

A99P0006

CONTROLLED FLIGHT INTO TERRAIN (CFIT)

DOUGLAS DC-3C C-GWUG

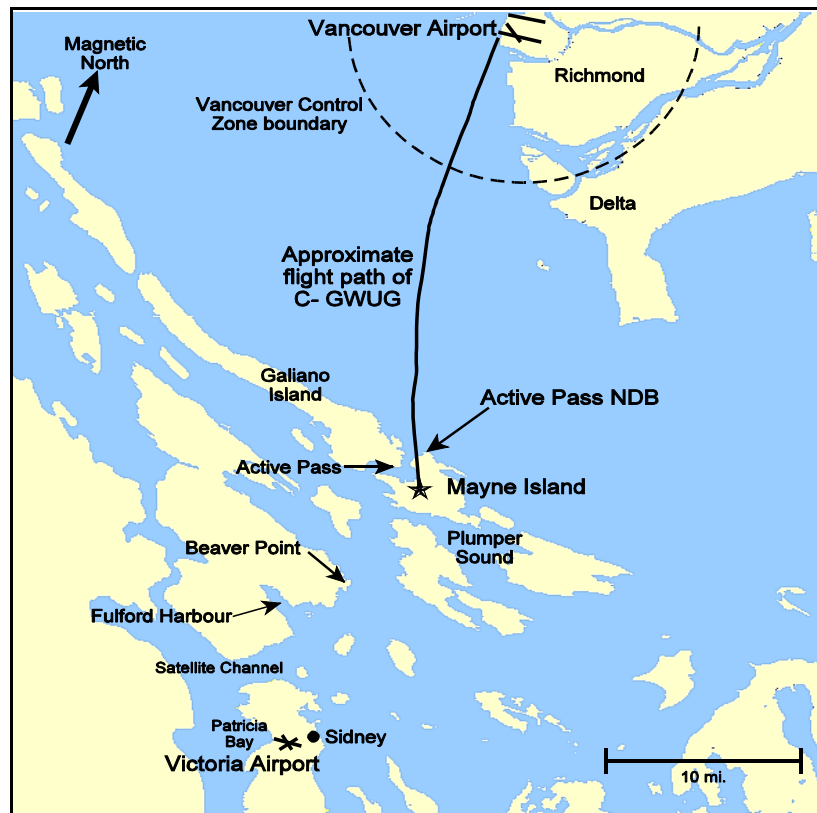
Figure 1 - Aircraft routing and crash site

Vancouver tower cleared KFA300 for take-off at 0622 Pacific standard time (PST)² from runway 26L. After take-off, the aircraft turned left on a track toward Active Pass, as seen in Figure 1. During the departure climb, the captain requested an altitude of

At 0633:04, the aircraft descended to 800 feet asl for about nine seconds. The last radar data show the aircraft at 900 feet asl and 130 knots. The last radar-depicted position of the aircraft is on a bearing of 189 degrees (true) and 21.8 nm from the Sea Island radar source, coincident with the crash location.
