AVIATION INVESTIGATION REPORT

A99P0108

MIDAIR COLLISION

PENTICTON, BRITISH COLUMBIA

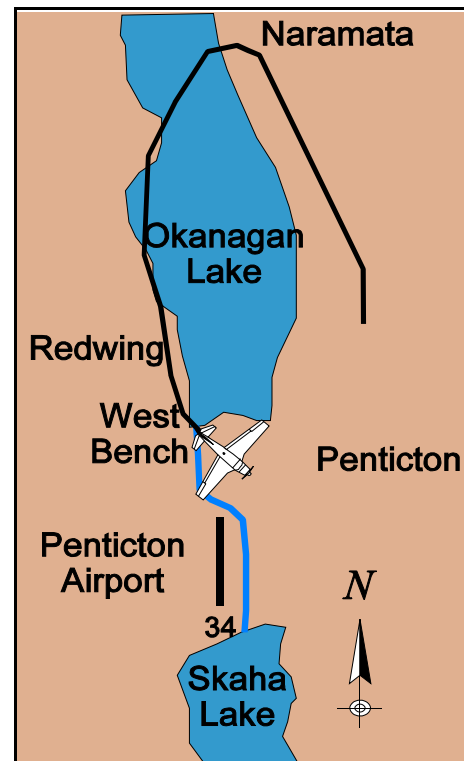
Figure 1 – Mooney M20C flight path

As the aircraft flew south along the west shoreline, witnesses reported that it flew by the Redwing subdivision and the West Bench area at a low altitude, close enough for people on the ground to see the people inside. A witness viewed the aircraft from the east and described the flight profile to be below the level of a landmark on the hillside. The landmark is about 400 feet above the elevation of the airport. Near the southwest corner of Okanagan Lake, abeam the West Bench area, the aircraft entered a left turn. This turn took the aircraft on a southeasterly heading parallel to and north of a section of the canal that passes through the city and connects Okanagan Lake with Skaha Lake on the south side of Penticton. On this heading, the flight path intersected the departure path of runway 34, close to the Penticton non-directional beacon (NDB).

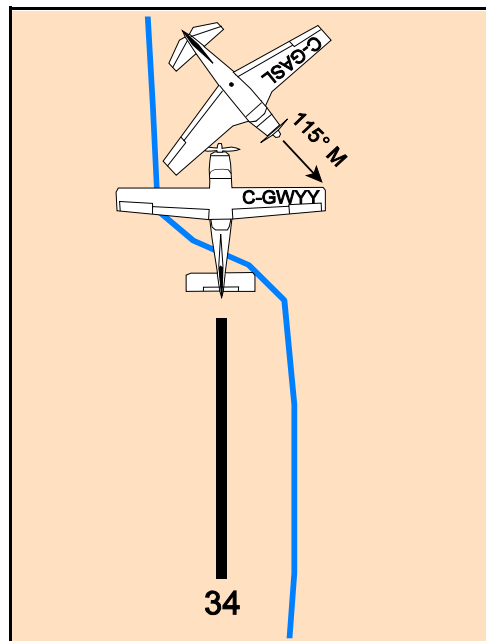
Figure 2 – Collision Flight Paths

1. The Cessna departed runway 34. The wind was calm. The aircraft maintained the runway heading of 340°M. The recommended climb speed range is 85 to 100 knots. The landing gear was retracted, and the flaps were extended to 9°. The propeller rotates in a clockwise direction when viewed from the pilot's seat.

- The Mooney was flying on a heading of 115°M at the point of collision, based on a heading of 340°M for the Cessna and the initial propeller strike angle of 45° to the leading edge of the right wing of the Mooney. Scratches on the bottom of the severed right wing section form an angle of about 18° clockwise from the longitudinal axis of the aircraft, which forms one side of the angle as viewed from above. This angle indicates the combined collision vector of the two aircraft. A diagram of the same vector, constructed by connecting the two measured propeller strikes in the right wing, forms an angle of 16° .
