AVIATION INVESTIGATION REPORT

A99C0208

ENGINE POWER LOSS / FORCED LANDING

PIPER PA-31-350 C-GHMK

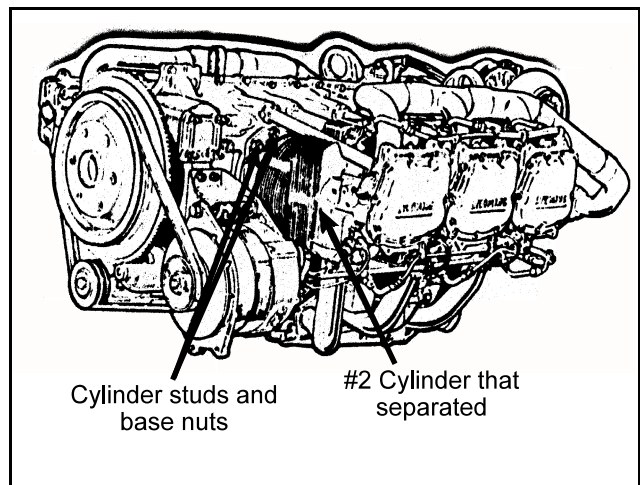
Figure 1 - Engine diagram

The left engine's number two cylinder had separated from the crankcase at the cylinder studs and was found adjacent to the engine, still connected to the oil sump by its oil return line. The connecting rod and piston were not found, and the fuel injector line was severed. The subject cylinder is mounted immediately aft of the propeller governor control and immediately forward of the number four cylinder. The lower left cowling remained in place but was destroyed by fire; however, it was able to contain the separated cylinder. Half of the

cylinder skirt was missing, and the remainder of the skirt was badly damaged. The left propeller was found in a mid-range pitch setting, while the right propeller was found fully feathered. The right propeller was feathered by the pilot just before the aircraft touched down. Recovered at the site, next to the left engine, were two ½-inch base nuts with fractured stud material in them, one ¾-inch base nut with fractured stud material in it, and one ½-inch base nut with no fractured stud material in it.

Although the number two cylinder separated from the crankcase, it was contained in the engine area by the propeller governor, the number four cylinder, and the lower engine cowling. Because there is very little clearance between the propeller governor control and the number two cylinder, the number two cylinder was in a position to interfere with the operation of the propeller governor control after it separated, preventing full travel of the propeller lever. With the separation of the number two cylinder, engine oil and raw fuel from the severed fuel injector line likely sprayed onto the hot exhaust stack, resulting in the smoke and fire that eventually destroyed the aircraft.

Although it was the number three cylinder that was missing a base nut, the through stud is shared by the lower rear hold-down point of the number two cylinder. The missing base nut of the through stud indicates that the base nut did not have sufficient clamping force; however, it could not be determined if the base nut did not receive the required torque during installation or if the base nut lost its clamping force during engine operation. The insufficient torque led to insufficient clamping force by the lower rear base nut of the number two cylinder. Without the

required clamping force of the lower ½-inch hold-down point of the number two cylinder, the remaining studs took on the load of the cylinder and eventually failed in fatigue. Analysis of the fractured studs and through studs by the TSB Engineering Branch indicated signs of fatigue failure.
