AVIATION INVESTIGATION REPORT

A99P0136

COLLISION WITH BOAT

WEST COAST AIR LIMITED
DE HAVILLAND DHC-2 BEAVER C-GSUE
VANCOUVER HARBOUR, BRITISH COLUMBIA
26 SEPTEMBER 1999

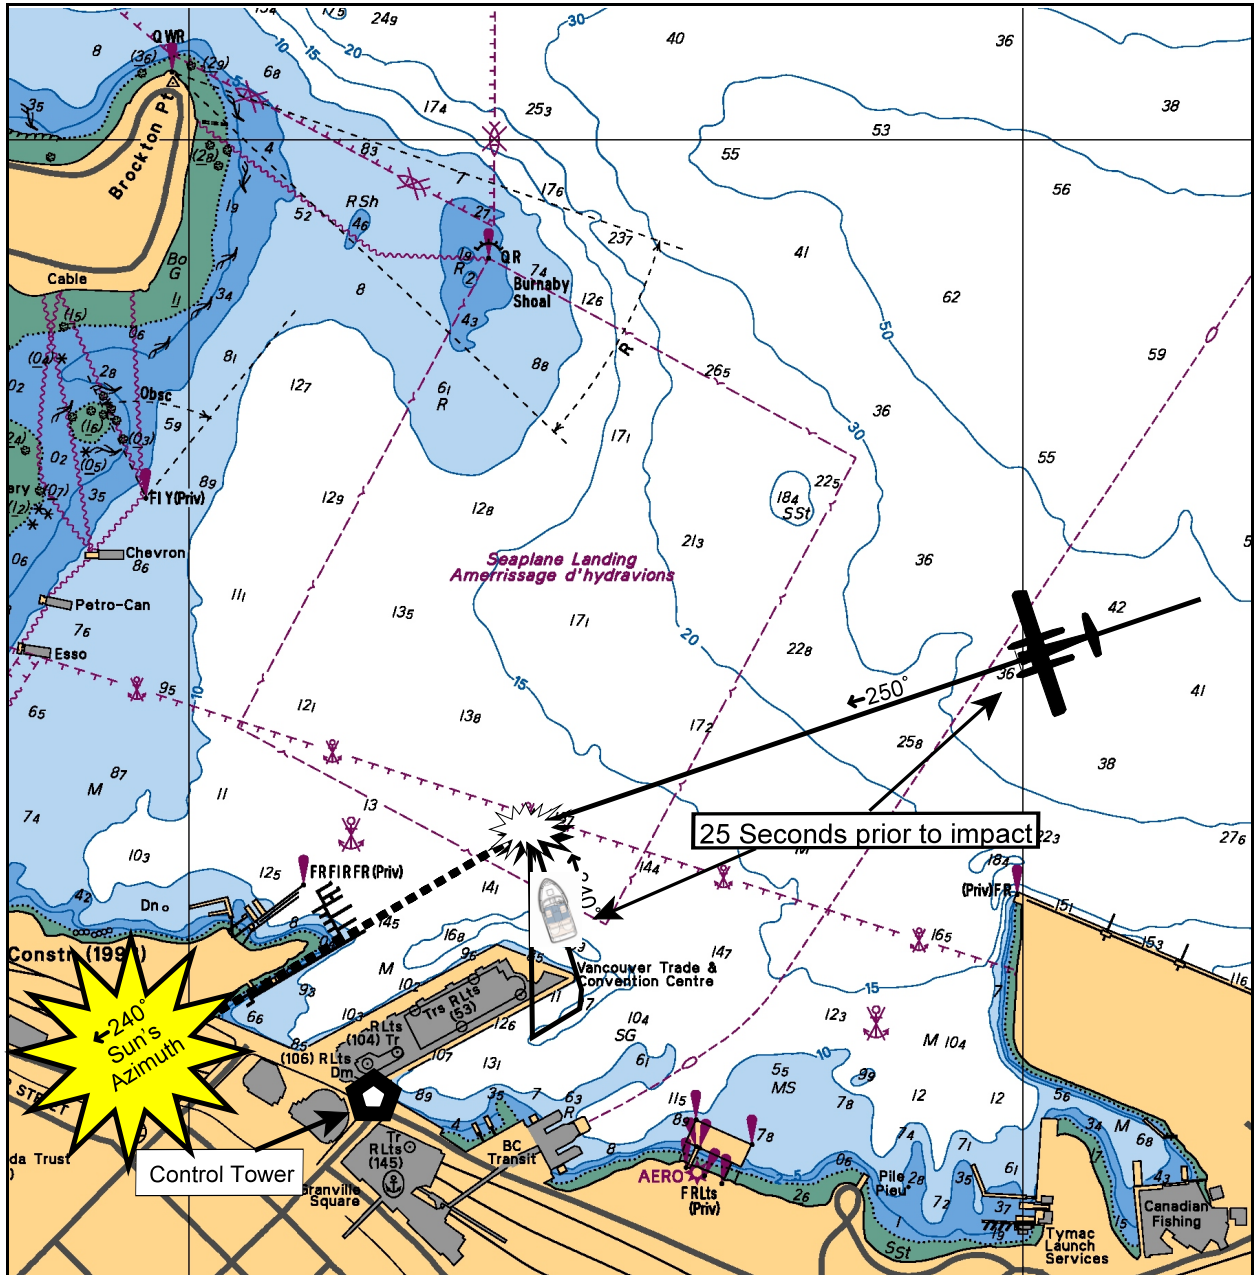
Appendix A - Vancouver Harbour / Collision Diagram

Weather at the time of the occurrence was reported as CAVOK² on the Vancouver Harbour tower automatic terminal information service (ATIS),³ with a wind from 250° at 5 to 10 knots. Temperature was 15° Celsius. Landings were being carried out toward the west. The sea was mostly calm, with light ripples on the water. The sun's position at the time was approximately 240° in azimuth and 21.5° above the horizon. Sunlight was reflecting off the water's surface, creating a large area of bright glare. Witnesses who viewed the collision from boats on the water assessed the glare to be extreme, accentuated by the light ripples on the water's surface. The aircraft's final approach course was about 250°, and the glare patch on the water coincided with the position of the boat as the aircraft descended down the last few hundred feet toward the water (see Appendix A).

The diagram at Appendix A illustrates the collision paths of the two objects. Positions for the boat and aircraft are depicted at 25 seconds before impact. Thereafter, speed of the aircraft is depicted as 80 knots for the first 8.33 seconds, 60 knots for the second 8.33 seconds, and 40 knots for the final 8.33 seconds. A uniform speed of 8 knots is depicted for the boat.

From the pilot's perspective, the boat was located within the area of sun glare on the water during the 25-second period prior to impact. To distinguish the light-coloured boat out of the area of glare would have been difficult. In addition, the cabin structures on the left side likely obstructed the pilot's view of the boat at various stages during the approach. These factors accentuated some of the limitations of the human eye. The obstructions or limitations likely would have been overcome by continually moving the eyes and head, thus changing the location of the blind spots. However, in the moments preceding landing it may not be practical for the pilot to be continually changing his eye and head position in an attempt to clear all the blind spots as attention is focussed on flying the aircraft.
