**AVIATION INVESTIGATION REPORT
A99H0005**

OPERATING IRREGULARITY

HALIFAX INTERNATIONAL AIRPORT, NOVA SCOTIA

15 OCTOBER 1999

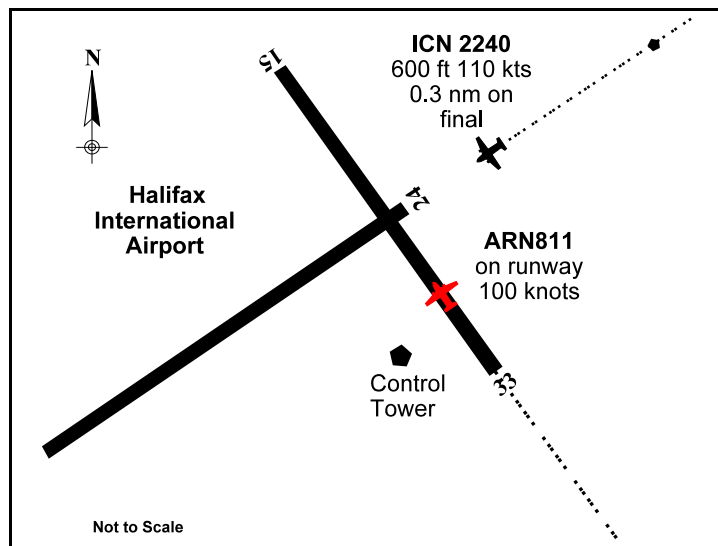
Figure 1 - Halifax International Airport with relative positions of the two aircraft.

Having decided that there was insufficient room to allow ICN 2240 to land, the airport controller instructed ICN 2240 to execute a missed approach. ICN 2240 was approximately 0.3 nm from the threshold of runway 24 (see Figure 1). The pilot acknowledged the instruction and in the same transmission requested permission to land on runway 24 beyond the intersection with runway 33. At 0727.23, the airport controller cleared ICN 2240 to land on runway 24. Radar data indicated that ICN 2240 was now over the threshold of runway 24 and had not commenced a climb in response to the airport controller's instruction to pull-up but had maintained an altitude of approximately 200 feet above the runway. ICN 2240 passed through the intersection of runways 24 and 33 and touched down approximately 2500 feet from the threshold of runway 24.
