AVIATION INVESTIGATION REPORT

A99A0036

CONTROLLED FLIGHT INTO TERRAIN

PROVINCIAL AIRLINES LIMITED
DE HAVILLAND DHC-6-300 TWIN OTTER C-FWLQ
DAVIS INLET, NEWFOUNDLAND 2 nm NNE
19 MARCH 1999

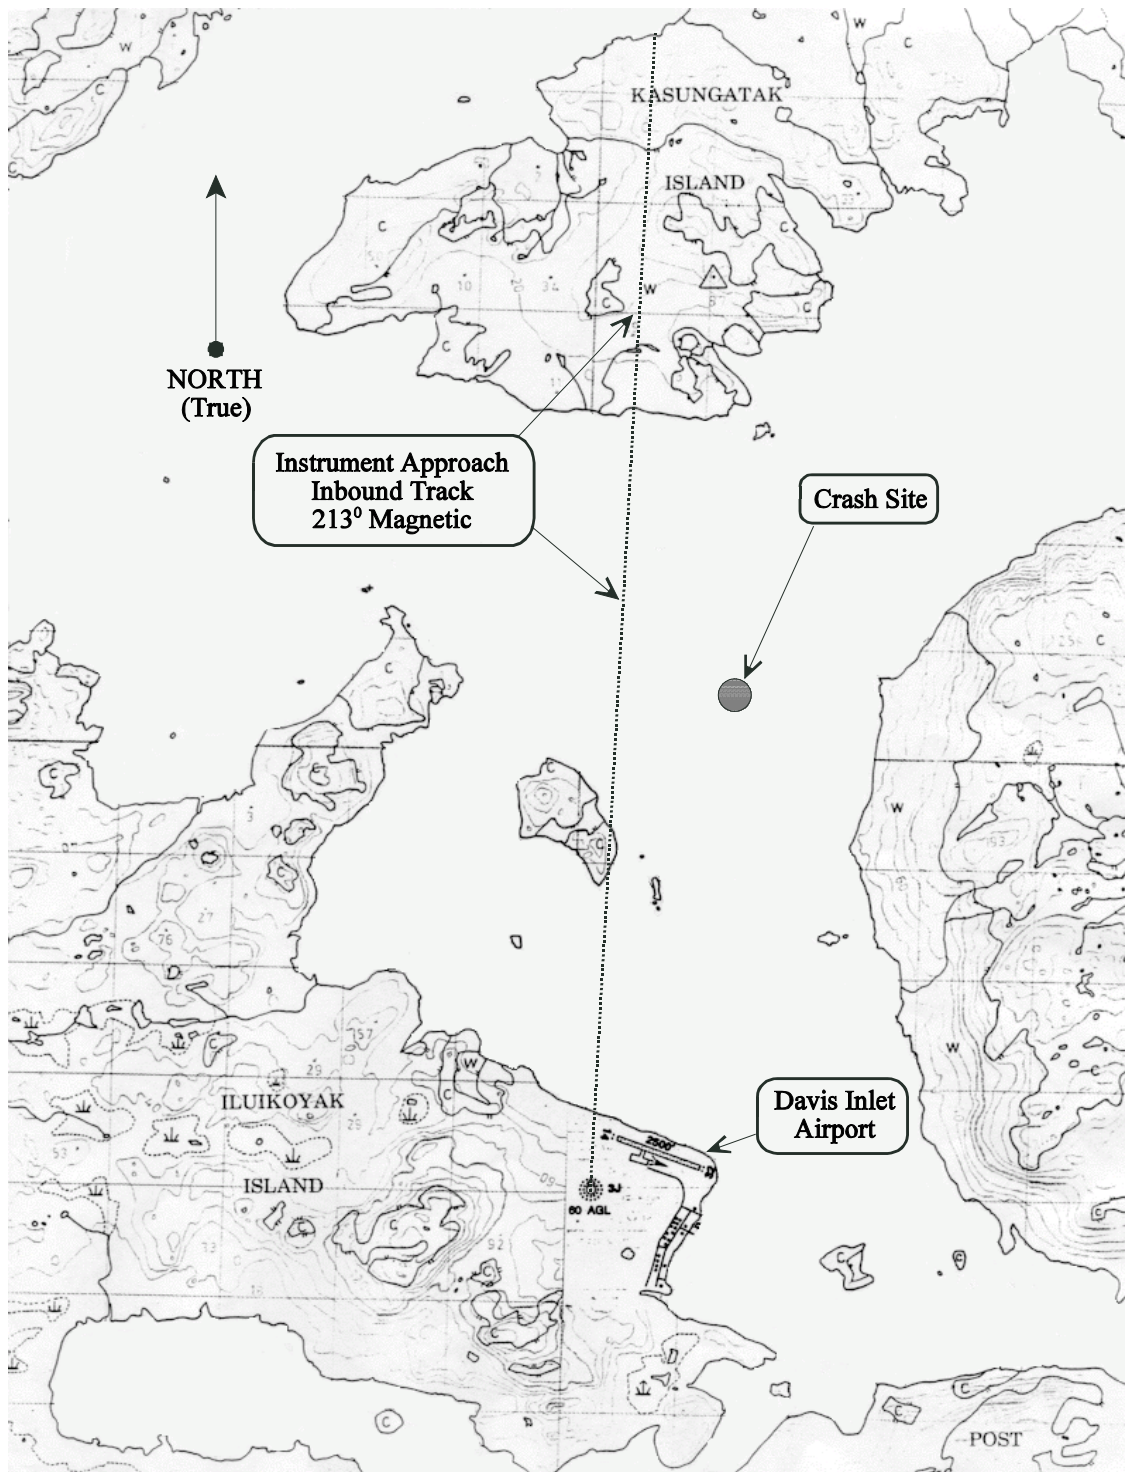
Appendix B—Accident Site

The aircraft struck snow-covered ice on a heading of 222 degrees magnetic in a slightly nose-down, wings-level attitude. The wreckage trail was approximately 600 feet long by 180 feet wide: the nose landing gear was near the beginning of the trail; the instrument panel was at the end of the trail; and the fuselage, engines, left wing, empennage, and cargo were strewn along the trail between these points. The wreckage pattern observed was consistent with a controlled, shallow descent.
