RAILWAY INVESTIGATION REPORT
R07D0111

CROSSING COLLISION

VIA RAIL CANADA INC.

PINCOURT/TERRASSE-VAUDREUIL, QUEBEC

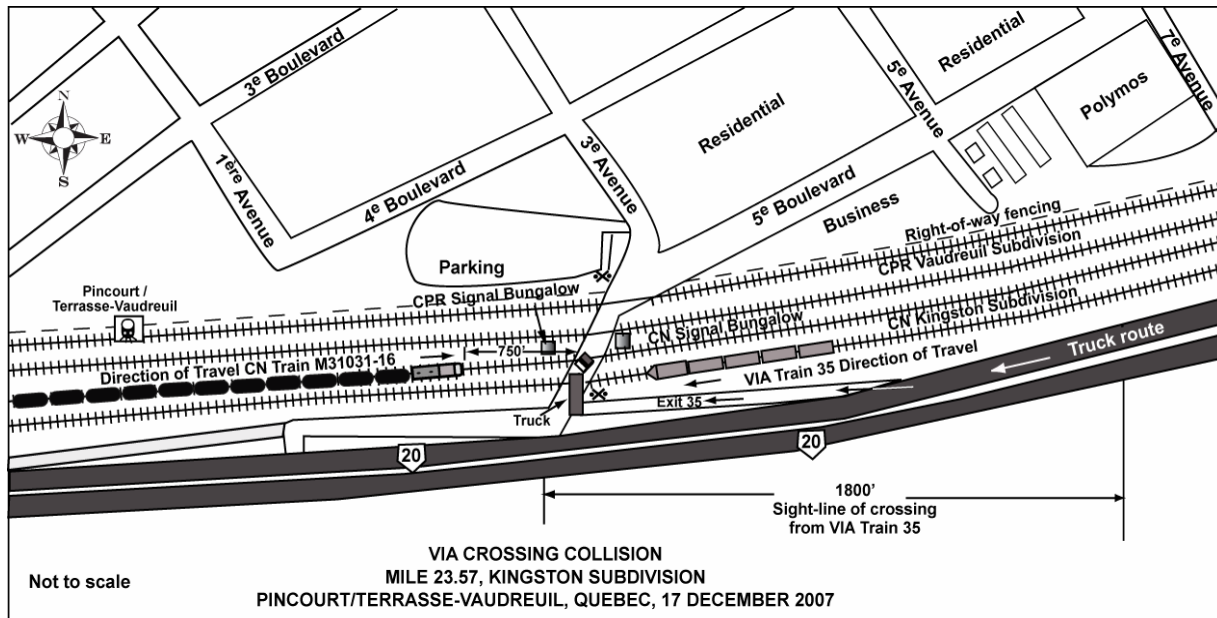
Figure 2. Diagram of accident site

As VIA 35 rounded the curve, the crossing came into view approximately 1800 feet to the west. The VIA locomotive engineer observed a northbound tractor-trailer (the truck) stopped on the crossing, while eastward CN train M31031-16 (CN 310) appeared to be stationary on the north track, west of the crossing (see Figure 2).

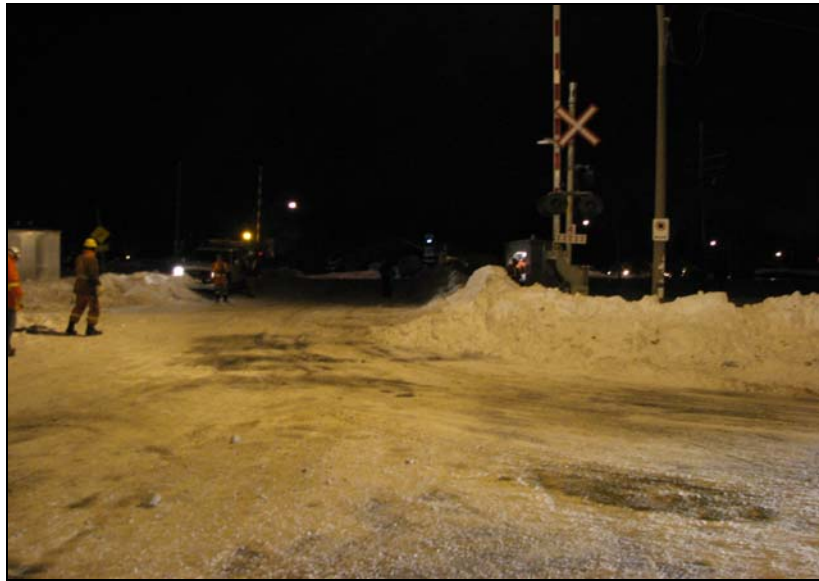
lane, the rear undercarriage of the trailer got stuck on a large snow bank on the southeast corner of 3^e Avenue and the Exit 35 roadway, while the rear tires of the tractor began to spin on the icy crossing surface.

During snow-clearing operations, most of the snow was pushed to the side of the road and formed snow banks that were up to four feet high. The 3^e Avenue roadway width was reduced due to the presence of snow banks. The crossing surface was snow covered and icy. Tire marks were observed on the side of a snow bank located on the southeast corner of Exit 35 and 3^e Avenue near the CN crossing mast and gate (see Photo 1).

Photo 1. Snow banks on the southeast corner of the crossing

1. VIA 35 struck the tractor-trailer that had become stuck on the crossing when the rear undercarriage of its trailer hung up on a snow bank. The configuration, the reduced width, and the icy surface condition of the roadway contributed to the immobilization of the tractor-trailer.

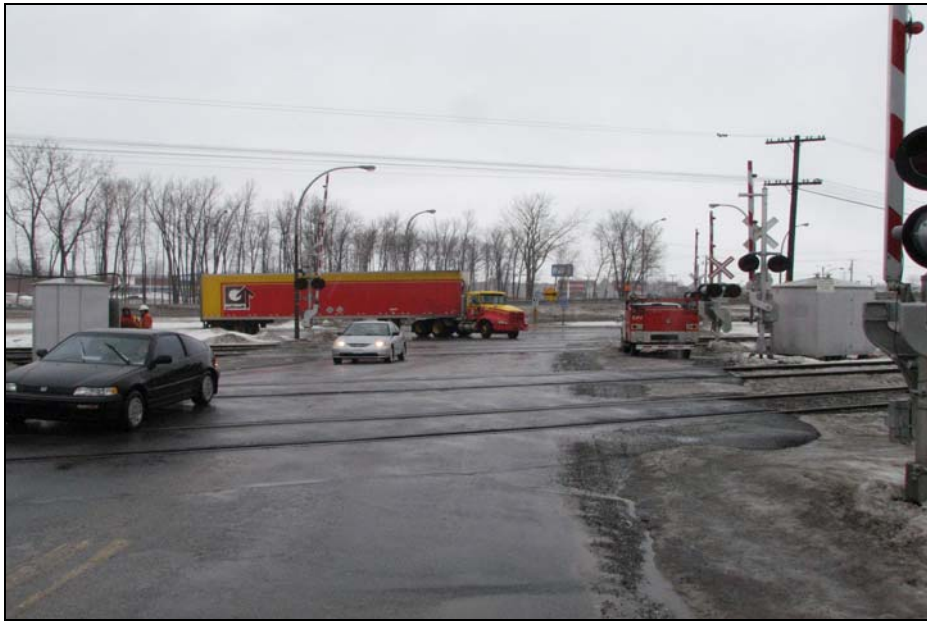
The crossing is the primary access to the commuter train station and the town of Terrasse-Vaudreuil. Both CN and CPR tracks are located between the residential area of Terrasse-Vaudreuil and Highway 20. The crossing is identified as Mile 23.57 of the CN Kingston Subdivision and Mile 18.07 of the CPR Vaudreuil Subdivision. Westward traffic accessing Terrasse-Vaudreuil via 3^e Avenue from Highway 20 must take Exit 35, continue to a stop sign then turn right. The 3^e Avenue runs north/south and intersects the Exit 35 ramp and the tracks at a 70-degree angle. To make this turn, even in ideal conditions, a tractor-trailer must pull wide into the opposing lane of 3^e Avenue (see Photo 2).

Photo 2. Right turn onto 3^e Avenue from Exit 35

The asphalt roadway surface has a saw-tooth profile. Northward from Exit 35, the roadway has an ascending gradient on the approaches and a descending gradient over the tracks to accommodate the superelevation of the right-hand curve. The crossing is equipped with AWDs, which include flashing lights, bells, gates and constant warning time track circuits. The AWD system was functioning as intended. The crossing has two gates; one on the southeast corner maintained by CN, and the other on the northwest corner maintained by CPR.

TQ is planning to reconfigure Highway 20 between Montréal and Dorion, Quebec. The work will include an underpass tunnel for 3^e Avenue to pass under the railway tracks and is scheduled to commence in 2012.

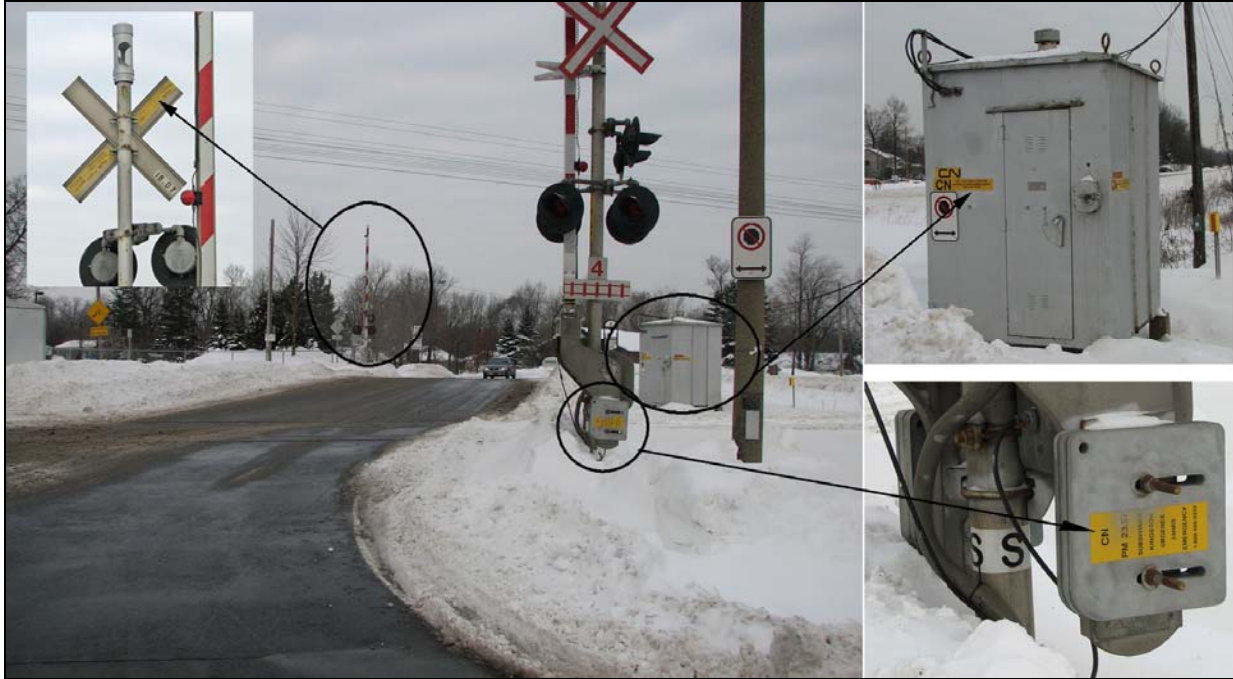
CN places an emergency contact phone number (1-800-465-9239), the mileage and subdivision of the crossing location on a sign (4 inches by 24 inches) located on the back of crossbucks at passive public crossings and on the gates and signal bungalows at automated public crossings. CPR places an emergency contact phone number (1-800-716-9132) and the five-digit TC crossing number on a similar sign located on the back of crossbucks at all public crossings (see Photo 3).

Photo 3. Location of emergency contact information at the crossing, looking northward

2. The lack of standardization and conspicuity of railway emergency contact information signage at crossings does not allow uninformed drivers to immediately identify emergency contact information and alert railways.

Transport Canada implement standards to improve the visibility of emergency contact signage at railway crossings in Canada.
