MARINE INVESTIGATION REPORT
M02L0061

CREW MEMBER LOST OVERBOARD

BULK CARRIER *KENT*
NEAR VERCHÈRES, QUEBEC
16 JULY 2002

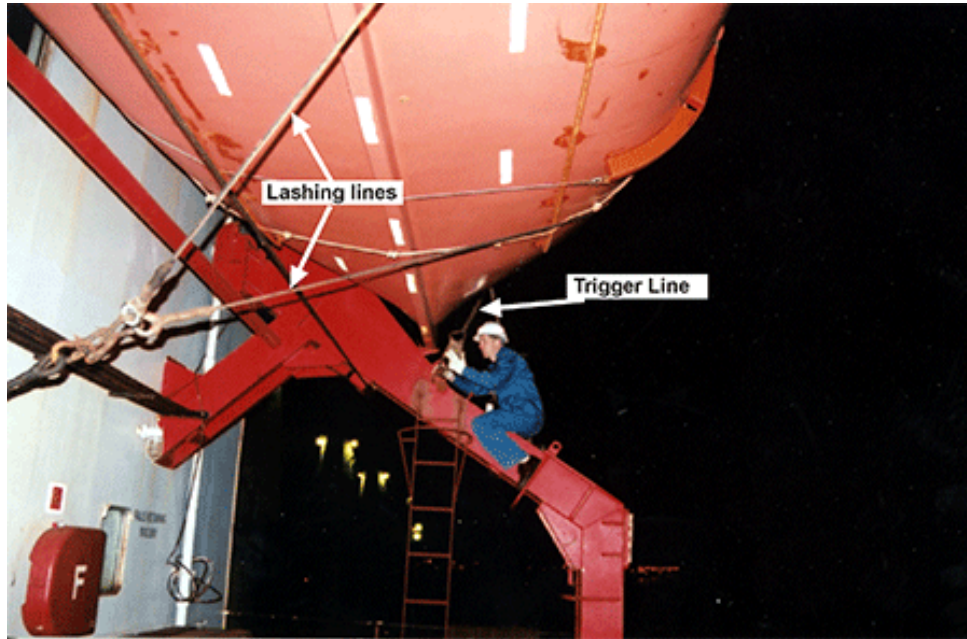
secure the forward trigger line to the trigger mechanism on the cradle (see Photo 1). The seaman climbed the aft cradle ladder and attempted to do the same with the aft trigger line. When the seaman realized there was not enough slack in the line to permit the connection, he descended the ladder with the intention of lengthening the turnbuckle at the other end. Shortly after reaching the deck he heard a noise, and turned to see the roller gravity davits with the suspended lifeboat, sliding down the cradle.

Photo 1. Simulation of the position of the bosun prior to being struck

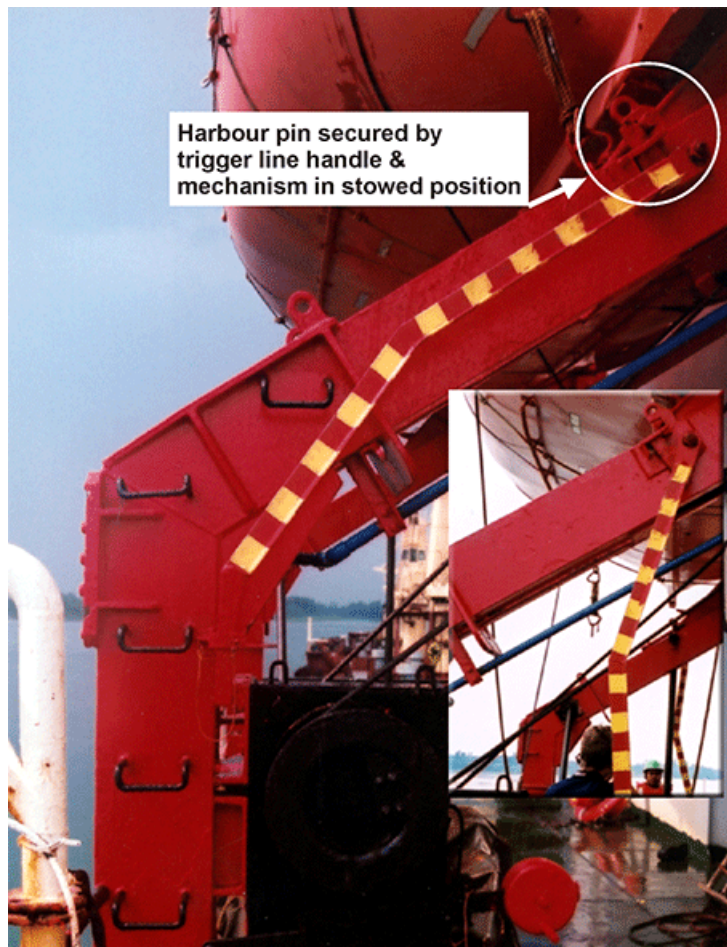
With a lifeboat on its roller gravity davits in the stowed position, the trigger line release handles are in line with the davit cradles (see Photo 2). In this "locked" position, the harbour pins are secured across the roller track to prevent the descent of the gravity davits holding the lifeboat. In the released position, the trigger line release handles are pulled down to the vertical, simultaneously releasing the trigger line and allowing the harbour pin to be swept aside as the gravity davits, with the suspended lifeboat, descend the davit cradle roller tracks (see inset in Photo 2).

Photo 2. Trigger in locked position and release (inset)

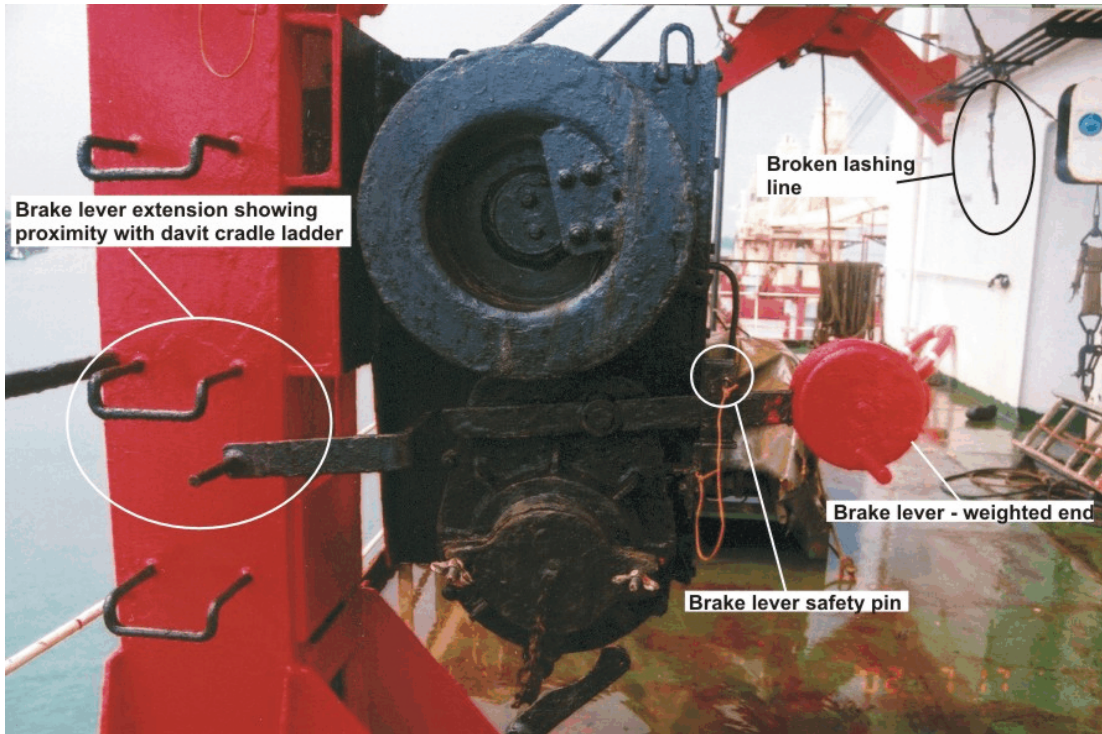
- When the weighted inboard end of the brake lever mechanism was lifted into the “brake off” position, it remained stuck in the off position after the lever was released, instead of falling into place to reset the brake.

- With the safety pin on the brake lever mechanism in place to avoid accidental release, a gap of 12 mm existed between the safety pin and the lever. This gap allowed the lever to be lifted sufficiently to disengage the brake and release the lifeboat.

- Parted ends of a broken lashing line showed signs of advanced corrosion and wear. Close examination by the TSB Engineering Branch established that the number of wires within the port lashing line had been reduced to 37 per cent of the original wire count (from 144 to 54).⁴

- The outboard end of the brake lever (opposite the weighted end) was extended such that the handle was near the vessel’s side to control, within view, the lowering of the lifeboat down the ship’s side to the waterline. The handle was in very close proximity to (6 cm below and 5 cm out from) the second rung of the aft cradle ladder (see Photo 3). It was further noted that if this handle was pushed down, it would have the same effect as lifting the brake lever at the inboard (weighted) end, that is, to disengage the brake.

Photo 3. Winch braking system (broken lashing line at upper right)

The winch brake, although operable, was in poor condition. In particular, the auto-stop safety feature of the brake lever counter-weight did not work. Once the brake lever was lifted into the "brake-off" position, it stayed there, requiring additional physical force to re-engage the brake completely by depressing the lever (instead of the counterweight dropping into place by itself).

The safety pin, which would normally prevent the brake lever from being released accidentally, was positioned in such a way that it did not provide a positive lock. The 12-mm gap allowed the lever to be moved enough to release the brake with the safety pin still in place.

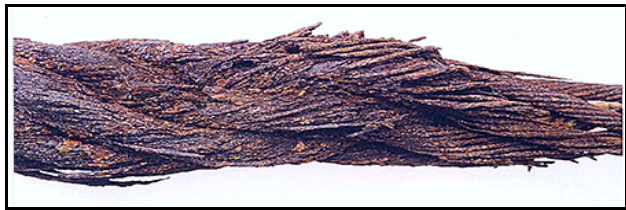
The steel wire cable lashing line was corroded well beyond its serviceable life. Although plastic protected wire cable can hide the condition of a steel wire, in this case, even a cursory inspection would have revealed the deteriorated condition of the cable. The failed cable, together with a similar piece of lashing from the starboard lifeboat davits, was examined by the TSB Engineering Branch⁸ (see photos 4 and 5). It was concluded that only 37 per cent of the steel wires within the port cable were carrying the load and 55 per cent were effective in the starboard cable. Severe corrosion caused the starboard cable to fail under testing at a load of 1638 kg, and the port side would have likely failed at a load of approximately 1119 kg.

Photo 4. Port lashing cable

2. The wire rope used as the lashing line was in a severe state of corrosion and well beyond a serviceable state.
3. The davit cradle ladder rungs were located in very close proximity to the faulty winch brake lever, and as the seaman descended the aft davit cradle, he probably stepped on the winch brake lever extension, instead of the ladder rung, and released the lifeboat.

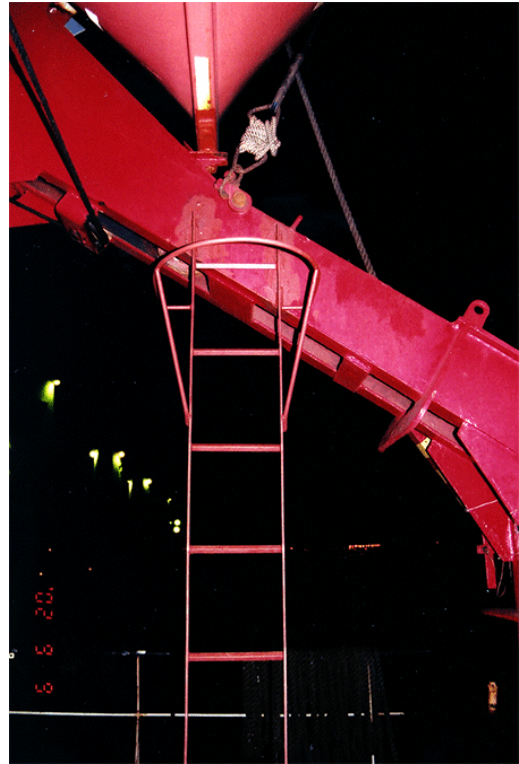
Photo 6. New ladder

1. Permanent vertical ladders were installed under and beside the securing point of the trigger lines, thus giving direct but protected access to the trigger-line securing arrangement (see Photo 6). The existing cradle arm ladders were removed.
2. Clearance between the winch brake release lever and its safety pin was removed, so that the lever cannot be moved when the pin is in place.
3. Working procedures were established that require the lowering, recovery and securing of the lifeboat to be done with at least two persons and an officer present.
4. A report of the incident was promulgated fleet-wide to provide information and stimulate feedback.
