AVIATION INVESTIGATION REPORT  
A02O0272

RISK OF COLLISION

NAV CANADA  
TORONTO AIRPORT CONTROL TOWER  
TORONTO/LESTER B. PEARSON INTERNATIONAL AIRPORT  
TORONTO, ONTARIO  
25 AUGUST 2002

Report Number A02O0272

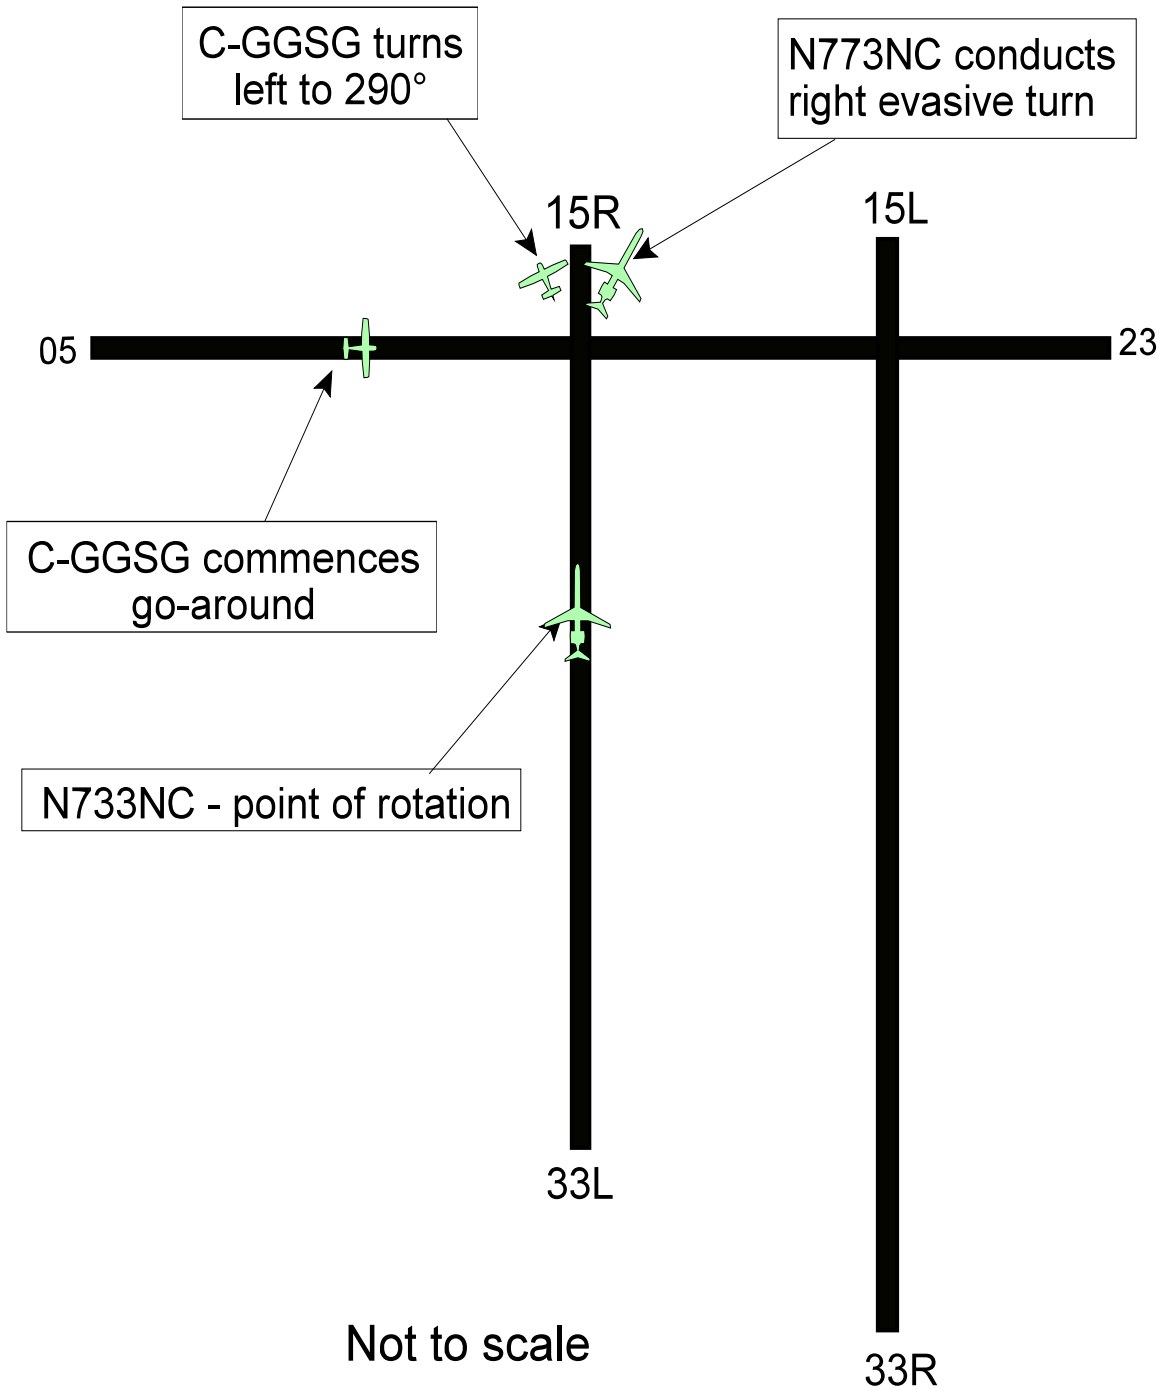
# Appendix A - Toronto/LBPIA Site Map and Conflict Depiction

also reminded the pilot to hold short of Runway 33L. Eight seconds later, the pilot announced that he was going around because of a landing gear problem. The controller immediately instructed the Cessna pilot to commence a hard left turn to a heading of 290°. During the go-around, the Cessna 206 passengers observed the McDonnell Douglas DC-9 aircraft on its take-off run, and the front seat passenger alerted the pilot to the conflict.

The point of rotation of NWA971 was near taxiway Foxtrot 2, and, as the aircraft commenced its climb, the first officer, the pilot flying, observed the approaching Cessna 206 aircraft. He alerted the captain and took immediate evasive action to the right. A review of the recorded radar data indicated that the spacing between the aircraft was approximately 100 feet laterally and vertically over the threshold of Runway 15R.
