Transport  
Canada

TP 185E  
Issue 1/2009

# AVIATION SAFETY LETTER

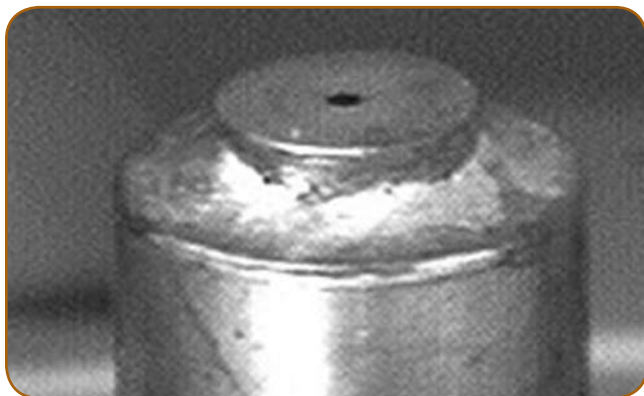
*Nozzle with a normal profile*

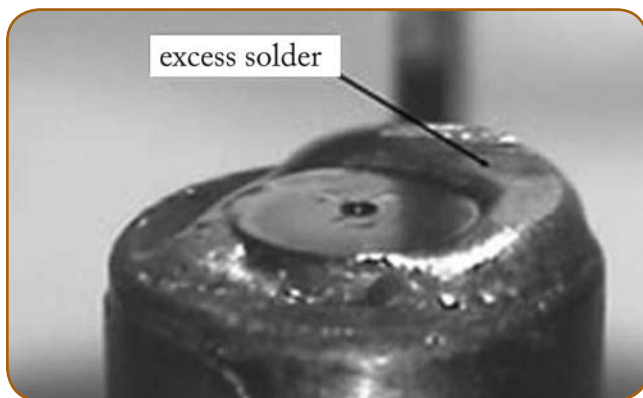
1. Excessive solder on a jet pipe nozzle in the overhauled electro-hydraulic servo valves (EHSV) reduced the clearance area so that particle contamination allowed binding, resulting in a nozzle position that commanded excessive fuel flow.
2. The manufacturer's quality assurance monitoring did not detect the excessive solder on the jet pipe nozzle, allowing the nozzle back into service.
3. Excess unburned fuel, caused by the excessive fuel flow, ignited as it exited the engine and tailpipe, resulting in severe external torching.

*Nozzle from occurrence EHSV*

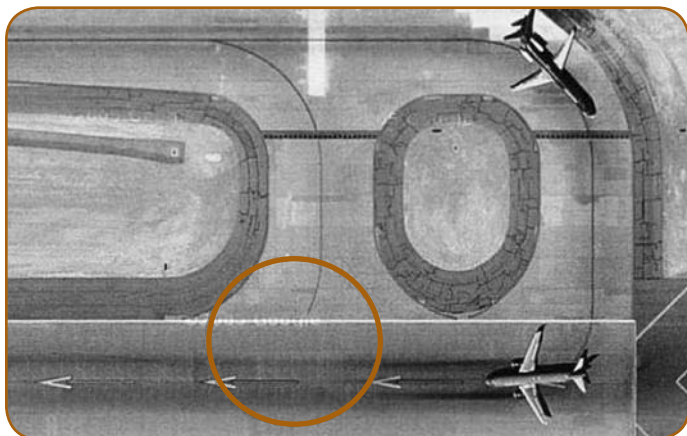
*Circle shows Taxiway B1 centreline as it curved into the runway edge line, prior to the modification*

The Las Vegas Airport Authority made modifications to the taxiway markings following the occurrence. At Taxiway B1, the radius of the taxiway centreline was extended past the runway edge line and now meets with the runway centreline in the displaced threshold arrow area. At Taxiway A2, the radius of the taxiway centreline that curves to the runway edge line was erased, and the taxiway centreline now extends to the threshold markings.

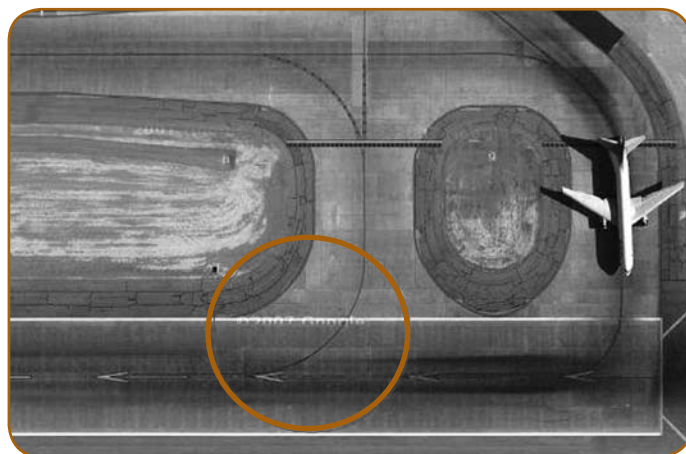
*Circle shows Taxiway B1 with the radius of the taxiway centreline extending past the runway edge line and meeting with the runway centreline in the displaced threshold arrow area, after the modification*

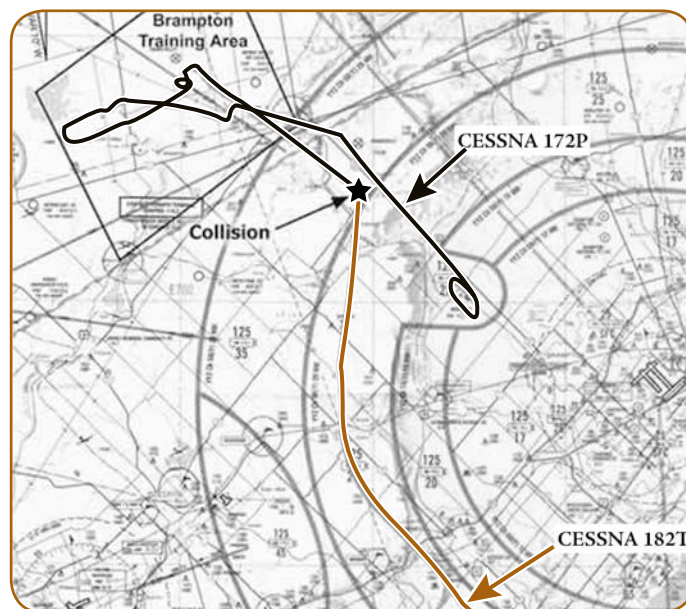
*Airplane flight paths*

1. Toronto, Ont., airspace design provides only limited vertical space beneath Class C airspace northwest of Toronto. Consequently, both airplanes were at the same altitude when their tracks intersected, and they collided.
2. There are inherent limitations and residual risk associated with the see-and-avoid principle; as a result, neither airplane saw the other in time to avert a mid-air collision.

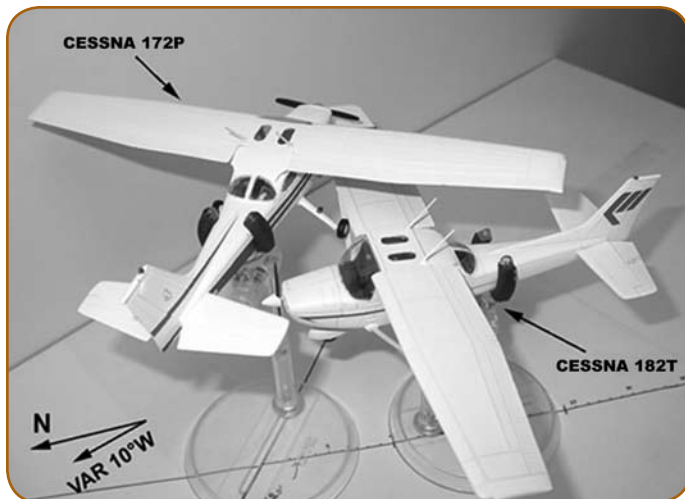
Field of view for the crew from each airplane

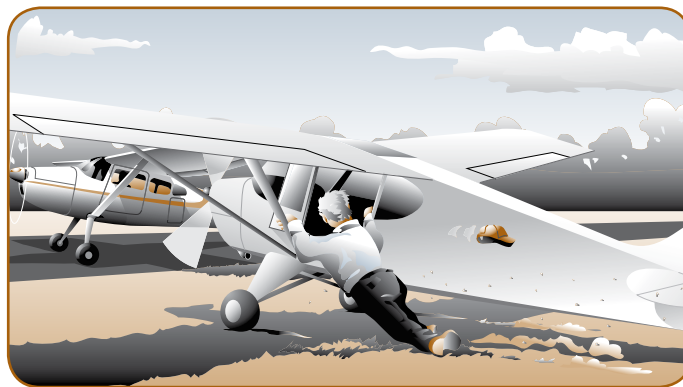
On July 6, 2008, a **Piper PA-17** was started by hand-propping at the Smith-Falls/Montague Airport, Ont. After the start, the aircraft began to move and the pilot was unable to reach the throttle or magnetos to stop it. The airplane traveled about 100 ft across the apron, dragging the pilot, before striking a parked Cessna 182. The Cessna 182's engine was running. Both airplanes sustained substantial damage. The occupants of the Cessna 182 were unhurt; the pilot of the PA-17 received minor injuries. *TSB File A08O0169.*

*Artist's impression of the runaway PA-17  
after the hand-propping went wrong*
