feed back

Canadian Aviation Service Difficulty Reports

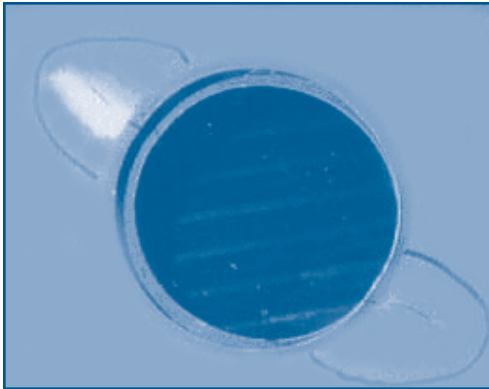
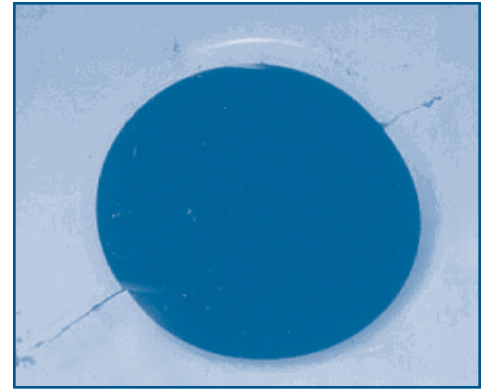
Cracks were found during a scheduled inspection of the aircraft at 8239 hrs in the area of the front spar of the stabilizer, at the lightening hole between the two nose ribs (P/N 0532001-50). The skin stabilizer center (P/N 10532001-23) was also found cracked in the same area.

**Cracks at the front spar
of the stabilizer
of a C172 aircraft**

The SDR database contains many reports of similar cracking in this area. Transport Canada reminds maintainers pay close attention when inspecting this area.

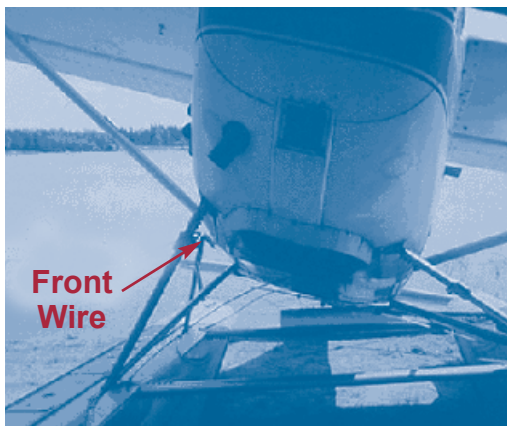
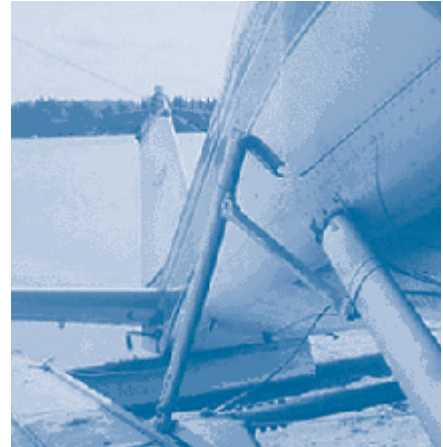
with the water. This caused the aircraft to veer left abruptly, displacing a considerable amount of water, but I managed to keep the aircraft from inverting. This caused all the fittings on the float struts to fail. The final resting position of the aircraft was engine pointing up, tail and left wing partially submerged. The aircraft was towed back to my property where it was beached. Upon inspection it was found that both cross wires were broken (left lower to right upper side)."

2. During a conversation with a very experienced local AMO, I was told that (in his opinion) this was not a particularly uncommon problem, (he had seen at least 2 others) and that it was also easy to over-torque these wires causing damage to both the wire and the aircraft structure.

Transport Canada recommends that owners and maintainers inspect these float brace wires carefully for any signs of damage in this area and be particularly careful for signs of potential overload failure in the area adjacent to the wrench flats, if a hard landing has been reported. Any suspect wires should be replaced with the updated parts from EDO.

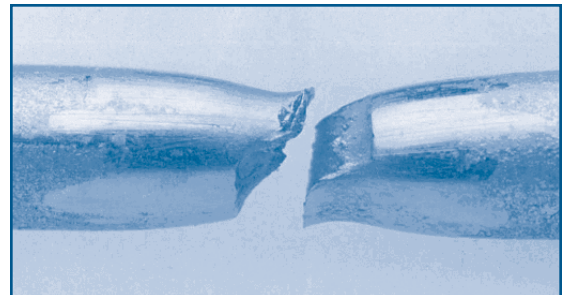
3. The broken wires in question and one additional wire from another incident were forwarded to the Transport Safety Board (TSB) lab for analysis. The report stated that the failures were "consistent with overload failure of a nominally ductile material" in the area just below the hex-shaped wrench flats below the threads.

Lab photo of one damaged wire
(Note the reduction in diameter at the area of the break)
