TP 6980E

Issue 2/2003

feed[↓]back

Canadian Aviation Service Difficulty Reports

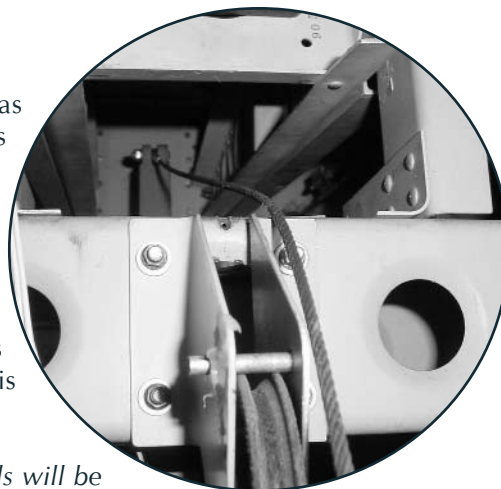
The elevator bell crank of this aircraft was replaced. This task was completed and signed by two qualified mechanics. The aircraft was returned to service and flew 84 hours with the elevator control cable incorrectly installed as indicated on the picture.

Complacency? Fatigue? Human factors certainly had a role in this incident. Mistakes can occur, however some may be avoidable. This incident could have had serious consequences.

Table to CAR 571.10 states - *Work that disturbs engine or flight controls will be inspected for correct assembly, locking and sense of operation, by a least two persons, and the technical record contains the signatures of both persons.*

CAR 571.11(6) - *If a maintenance release is signed by a person in respect of work performed by another person, the person signing the maintenance release must personally observe the work to the extent necessary to ensure that it is performed in accordance with the requirements of any applicable standards of airworthiness and, specifically, the requirements of sections 571.02 and 571.10.*

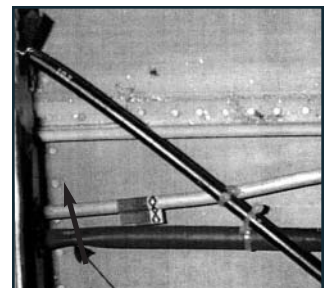
The pneumatic line, P/N 130936P8D1000, that supplies pressure to the de-icer boots was found collapsed. This pneumatic line is located under the heat register in the aft baggage compartment on that Beech C90A.

It appears the de-ice pressure line became warm and collapsed during the de-icing boot cycle. Further investigation of the heater duct revealed no sign of air leakage. Damaged area of the pneumatic line is 1 1/4 " long.

Transport Canada suggests the above be kept in mind during inspection of this area or troubleshooting the de-ice system.

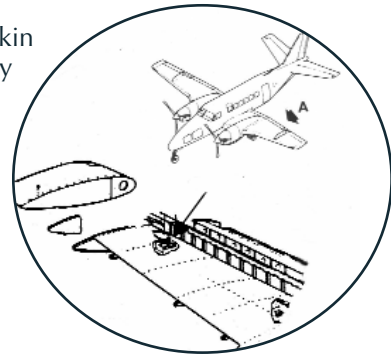
Wing Fitting Fractured

During a scheduled inspection on a Beech 99A, an AME noticed the aircraft skin forward of the wing spar and near the left wing fitting was soft and easily moved.

Further inspection revealed the leading edge pin P/N 50100002 was not engaged in the last 2 feet of the hinge on the inboard side. The hinge pin fractured where it bends to pass under the safety plate. As a result, the pin worked its way out and curled up inside the wing tip.

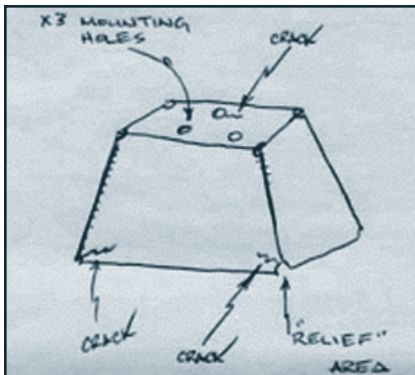
Oil Cooler Bracket Cracked

Cracking in this area is not uncommon and should be suspected when inspecting the oil cooler bracket both in service and prior to installation of a new part.

Oil cooler bracket is a welded assembly from factory.

Cracks originated from mounting holes and "relief" area.

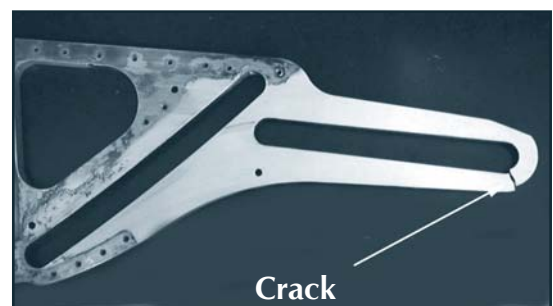
Flap Track Cracked

While performing an aircraft walk-around on a Beech A100, an AME discovered a crack in the inboard track (rear bottom) P/N 501600183 located on the right flap.

It may be difficult to detect a crack since the bottom aft portion of the track runs inside the flap. The submitter added that there are no inspection requirements to remove the flap in order to carry out an inspection of the track.

Part total time: 16,964 hours

Transport Canada reminds AMEs to remain diligent during inspection in such difficult areas and angles. You may be the one who finds the defect that is hard to find.
