feed**back**

Canadian Aviation Service Difficulty Reports

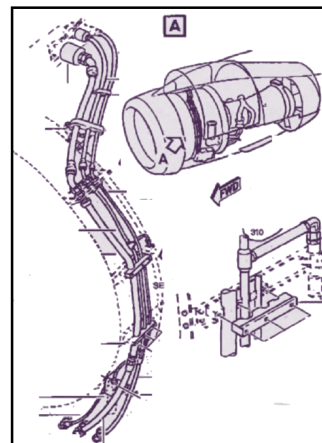
A hydraulic hose was found chafed through on Engine 1 green hydraulic system pump pressure transducer of an A320. This resulted in substantial fluid loss, emergency decent and a subsequent unscheduled landing.

The SDR program continues to receive many reports of line failure due to inadequate clearance to adjacent structure. By ensuring adequate clearance and/or protection, both at initial installation and during maintenance, the risk of this costly failure is negated.

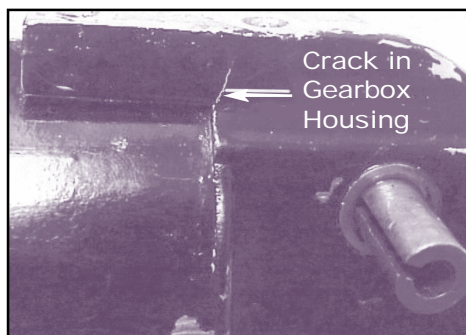
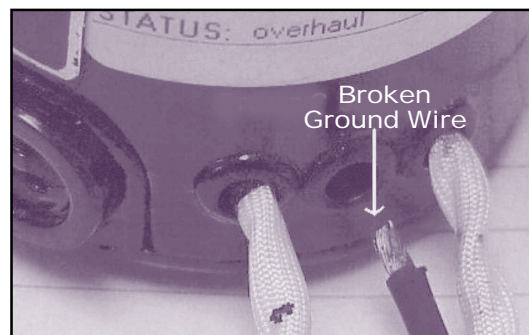
Subsequent to the installation of a newly overhauled flap motor (P/N 3536415157); the AME noticed intermittent flap indications during functional checks.

Upon removal and investigation of the suspect flap motor; the source of the problem was traced to a faulty/loose internal wire. A further inspection of the flap motor revealed an obvious crack in the gearbox housing.

Transport Canada reminds maintainers to carefully examine all aeronautical parts for defects and also for traceability before installation. The SDR data base lists many other similar reports of this nature.

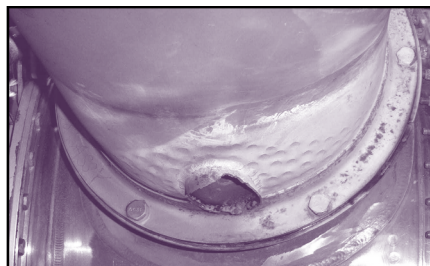
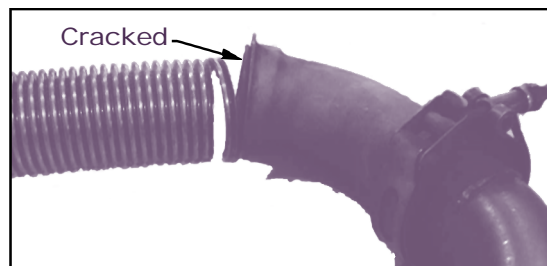
SDR # 20030115006

During a routine inspection on a Beech C90A, the anti-ice boss on the LH exhaust stack (P/N 109-950000-1) was found broken off with the anti-ice flex tube. The flex tube was also cracked around the lower elbow.

A heads up for maintainers when inspecting this area.

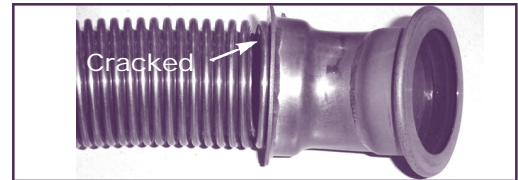
During inspection on a Beech C90A, the R/H engine cowl was removed and the anti-ice flexible tube, PN 90-910100-17 that routes exhaust air to heat the engine cowl intake was discovered cracked. The crack extended approximately 1/3 of the circumference of the tube.

Time Since New (TSN): 124.6 hrs

Manufacturer's Service Bulletin 71-3142 was issued to reduce cracking in this area. However, cracks have been reported subsequent to compliance with SB71-3142.

Transport Canada recommends increased vigilance in this area for cracks.

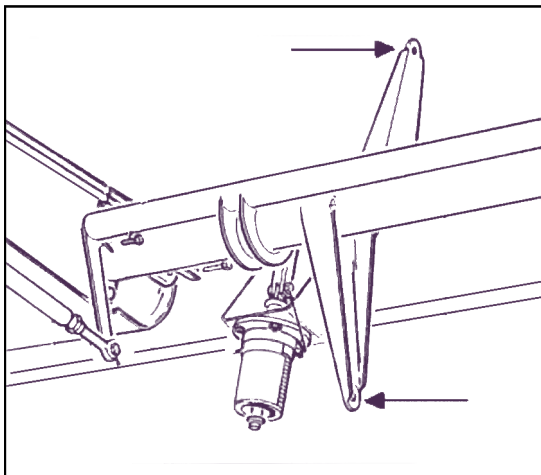
SDR # 20030318009

During inspection, the elevator torque tube, part number C2T7A, lower cable attach point was found to be elongated.

TSN: 21,878 hours.

Frequently, this sort of defect is discovered only when other maintenance requires the removal of an associated component. Diligent inspection was necessary to turn up this defect that may otherwise have gone unnoticed.

Defects occurring within a cable loop may be indicated by an unexplained change in cable tension or the inability to obtain constant cable tension readings when rigging.

To accurately inspect for this kind of defect, control cables must be loosened in order to detect any play in the attachment ends.

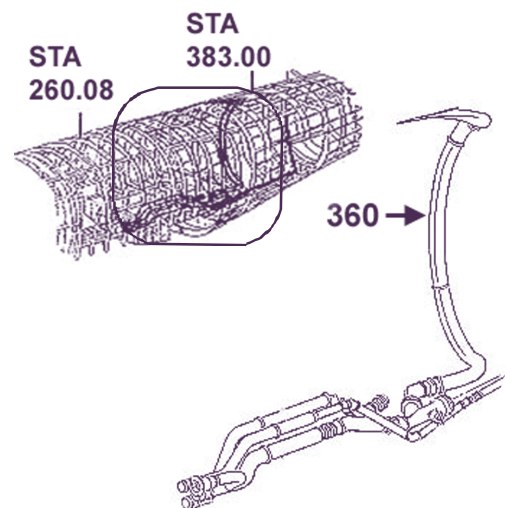
During inspection, a 10-inch circular crack was found in the duct (P/N 25W783016011) adjacent to the fuselage skin at approximately Stringer #6R (counting down from upper stringer).

The nature of this crack allowed the duct to open up when internal pressure was applied. This crack was only evident by feel, or using a flashlight and mirror.

The duct is used to clear the fuselage interior in the event of in-flight fire/smoke. Replacement of the duct was required.

Israel Aircraft Industries has introduced a new part number duct.

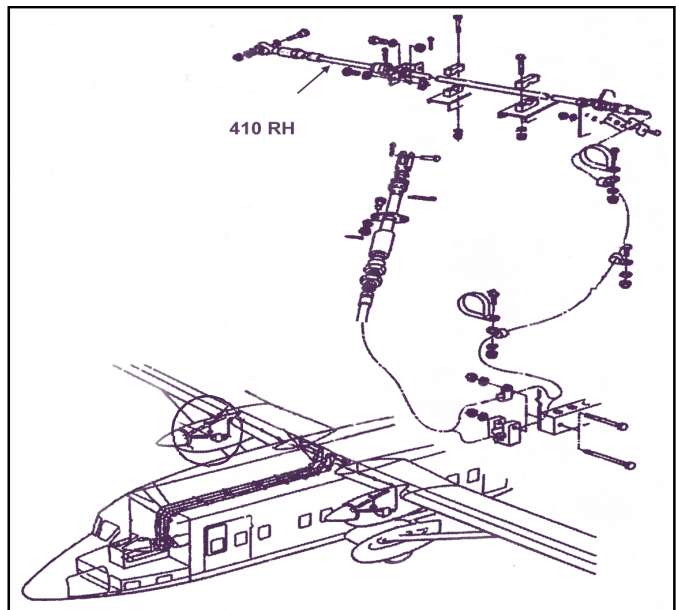
Investigation revealed that the R/H power control Teleflex cable (P/N A55 2326 Post Mod A8457) had broken inside its conduit. Location of the break was at a 180-degree bend in the cable just below the engine control cam cluster. The problem may have been compounded by the lower cowl interference with the cable conduit when the cowl was in the closed position, causing additional stress in the area of the bend. It was noted that the cowl interfering with the cable would be difficult to see with the cowl closed.

There was no significant damage to the exterior conduit so this defect would unlikely be detected in advance.

This SDR stresses the importance of proper routing and ensuring adequate clearance is obtained with the adjacent structure.

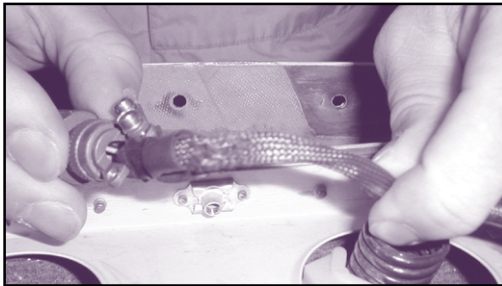
Ground wire to metal on top of vertical plate

Follow-up investigation revealed that the wire harness leading directly to the anti-collision light on the upper vertical fin had chafed through causing a direct electrical short to the Light Ancillary Control Unit (LACU). The wiring was repaired and the rotorcraft returned to service. This particular rotorcraft has been in service for

Transport Canada recommends that all EC 120 operators inspect this area for similar wire chafing pending further action from the manufacturer.

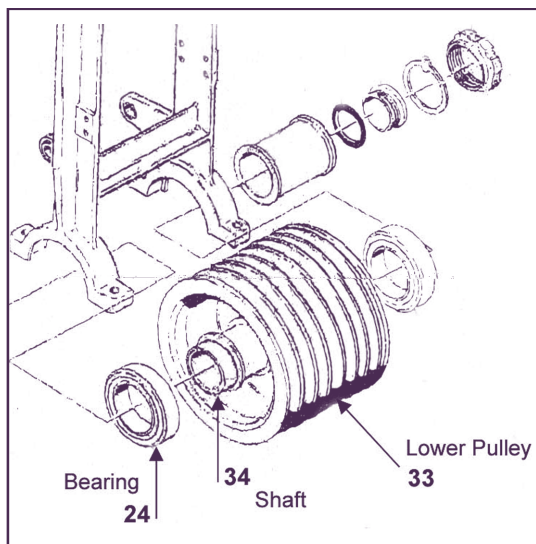
Drive Assembly and Main Rotor Transmission

While carrying out a detailed inspection of the belt drive (300-hour inspection), the engineer noted that the inner race of bearing, P/N 269A5050-85, had slipped on the shaft, P/N 269A5497-9, as indicated by the slippage marks. Upon disassembly of the "H" frame, it was noted that the bearing could be hand rotated on the shaft. The assembly was removed from service because the shaft and bearing are press fitted.

Investigation revealed that some shafts might have been manufactured incorrectly by the OEM with a very slight taper, which later resulted in the bearing becoming loose enough to rotate on the shaft. The OEM has a repair for tapered shafts, which is to grind and then nickel-plate the shaft.

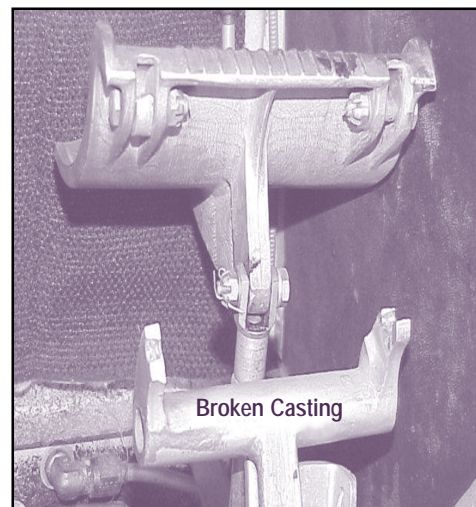
During a flight control operational check during scheduled maintenance, the L/H rudder pedal PN 505243263 fractured at its attachment point. Oblong wear was discovered in the attachment area.

The wear was not easily noticed due to design and attachment to the brake master cylinder. Therefore removal of attaching hardware securing the pedal was required to inspect for any additional wear. A subsequent inspection of the remaining company Beech 95B55 aircraft revealed similar defects.

TSN: 6189.4 hrs

This rudder pedal part number is employed in various Raytheon/Beech aircrafts; pay close attention when inspecting this area.
