Transport  
Canada

TP 6980E

*Issue 2/2004*

Canadian Aviation Service Difficulty Reports

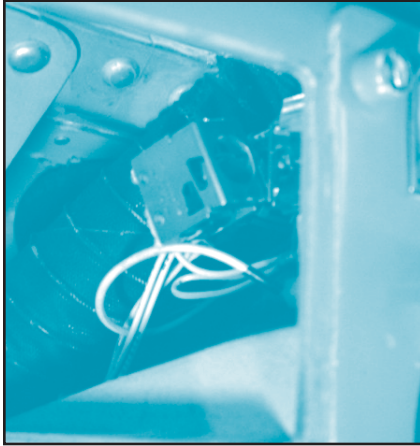
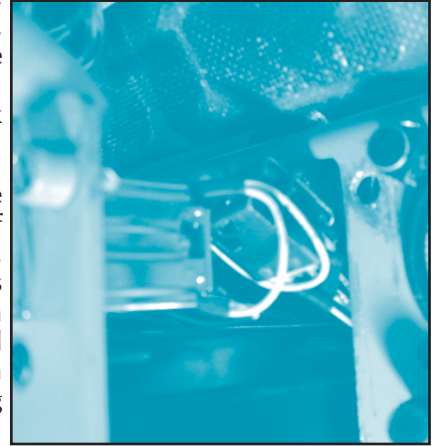
SDR # 20031008001

#### Firex Testing Failure

Upon completion of a Phase 2 inspection, the submitter discovered that the left, P/N 11991, and the right, P/N 11992, fire extinguisher activation failed to test. Further investigation revealed the back part of the switches had fallen off.

When pushed, the indicating part of the switch contacts the activation portion of the switch that normally fires the squib. The activation part of the switch is attached to the back of the indication portion with clasps. The clasps had failed allowing the activation part of the switch to fall off of the indication portion leaving the system fully disabled.

*The submitter added that Raytheon recently added the fire extinguisher activation check to the Phase 2 inspection.*

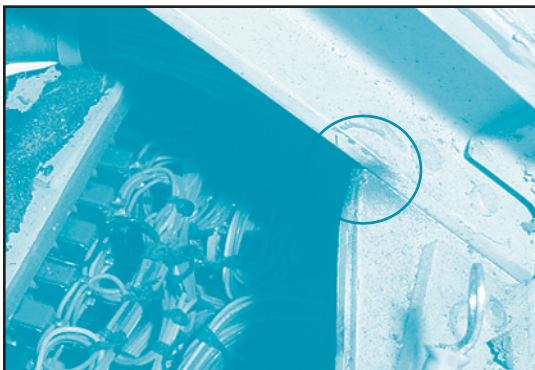
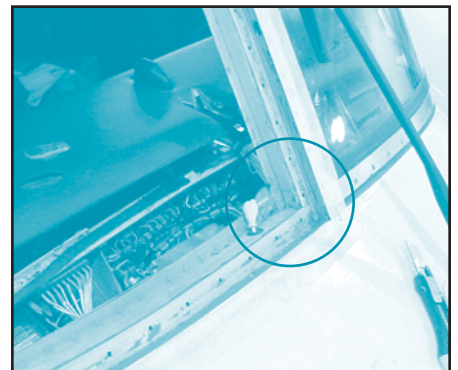
SDR # 20040303004

#### Windshield Pillar Gusset Chafed

While removing a broken co-pilot windshield, chafing was discovered on the windshield frame. The interior trim that is attached to the center pillar had become unattached and had fallen down and contacted the windshield pillar gusset.

Raytheon was contacted and a repair scheme was forwarded to the submitter, allowing the aircraft to return to service.

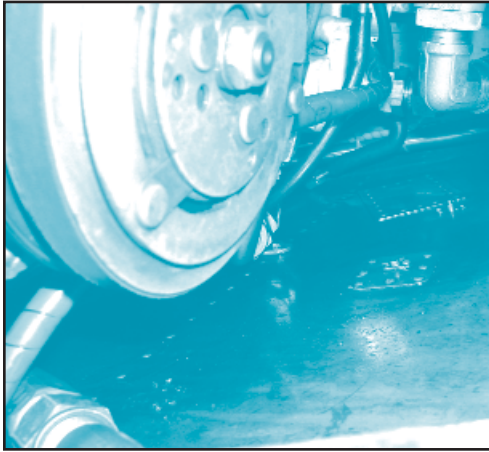
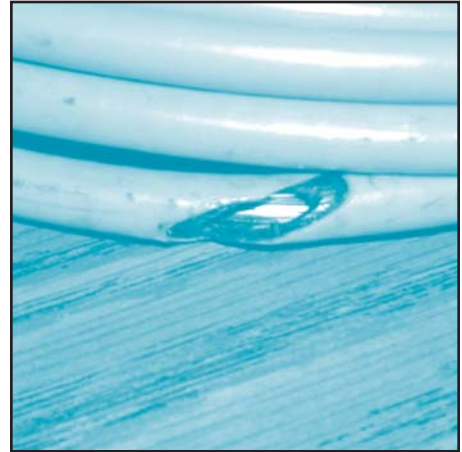
SDR # 20040309001

***Power Level Cable Severed***

After landing and subsequent taxi, the right engine spooled up and did not respond to power lever movement. The engine was shut down and the aircraft completed taxi to the terminal on the left engine.

Maintenance investigated and discovered that the pulley of the vapor cycle air conditioning system had severed the power lever cable, P/N 1143890503. The cable had been routed too close to the pulley during an engine removal and reinstallation 64 hours prior to the incident.

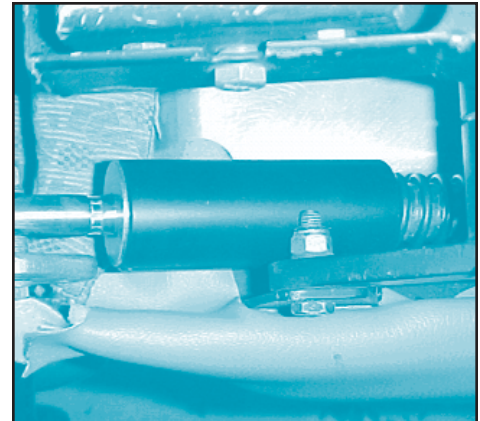
SDR # 20040216006

During the pre-flight phase, the pilot attempted to adjust the L/H seat when the seat back dropped back well beyond its normal range of adjustment. It was determined then that the seat was not in a safe condition to use and the crew made an entry in the logbook thus grounding the aircraft.

Closer examination of the seat adjusting mechanism by the maintenance personnel revealed that the aft rod attachment for the lock cylinder had sheared where the rod is secured into the end cap. The crimp remained intact whereas the shear occurred just forward of the crimp directly causing the seat adjustment mechanism to fail. A new replacement part was ordered from the manufacturer.

*Research of the SDR database has found one other record with this part number. AME's are reminded to check this particular area when performing a seat inspection.*

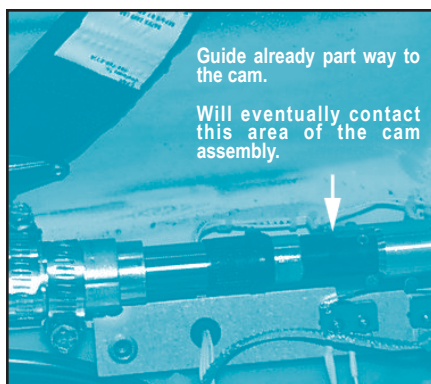
It was discovered that the splined rubber seal pushed out of position on flap actuator rod assembly, P/N 222750010. On this particular aircraft, it did not make contact with the flap position switches. The complete assembly was removed and sent to Diamond for inspection. A new assembly was installed.

Actuator in the take-off position

*This was the fourth occurrence of this nature for this operator. The submitter added that the manufacturer suggested cleaning the area with alcohol and to re-glue the seal using Loctite 409 adhesive.*

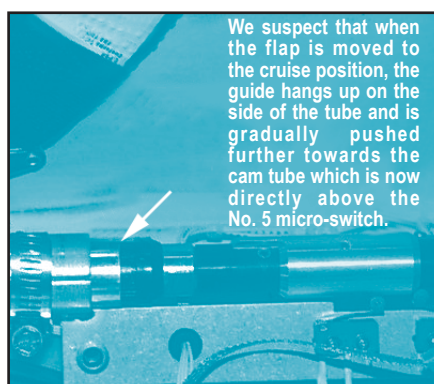
Actuator in the cruise position

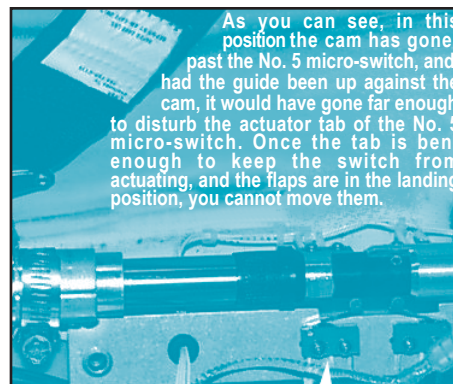
Actuator in the landing position

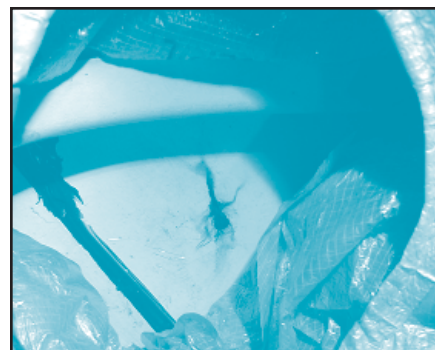
During cruise, a cockpit ceiling-mounted map light failed and the applicable circuit breaker tripped. In subsequent troubleshooting, the roof panel was removed with discovery of the lamp terminal, P/N 2527, in contact with the airframe structure.

This anomaly caused the rubber protective boot on the terminals to wear through and ground out the electrical supply. A spacer ring under the lamp collar was installed and sufficient clearance from the fuselage was obtained. The submitter carried out a fleet inspection and discovered one other aircraft with a similar discrepancy.

*The P180 Avanti completion center discovered this problem and began installing spacers on aircraft with serial number 1063 and onwards. Piaggio (Italy) was also made aware of this defect.*

*Transport Canada reminds maintainers inspecting or replacing these lamps to ensure adequate clearance with the fuselage.*

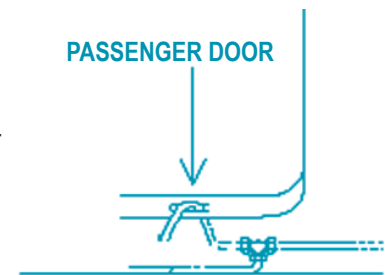
The hose that supplies the cabin door seal cracked allowing the seal to deflate. In turn, this caused the cabin to depressurize while flying at 17,000 feet.

The plastic supply hose, P/N 44P14, cracked at a kink where it passes the door hinge protective flap.

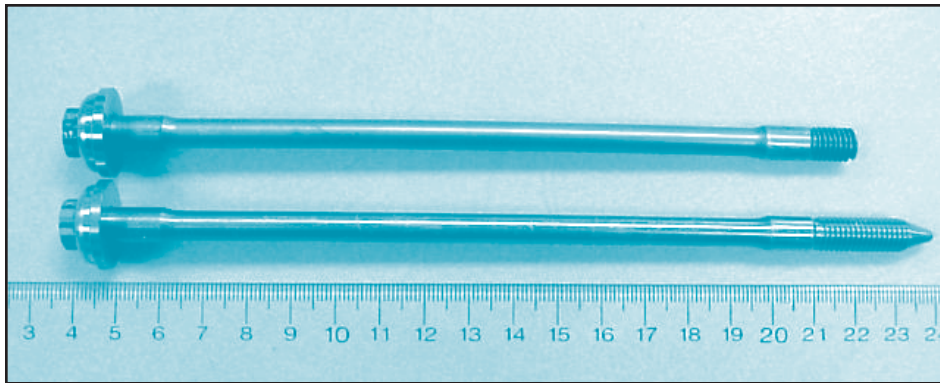
SDR # 20040202015

***Tie Bolt Sheared***

One of the three bolts, P/N 332A32323300, attaching the engine to the main gearbox was discovered sheared during a turn around check. This bolt was sheared about midway in the threaded portion of the bolt.

The engine was removed and area inspected in accordance with maintenance procedures. The cause of the bolt damage could not be determined.

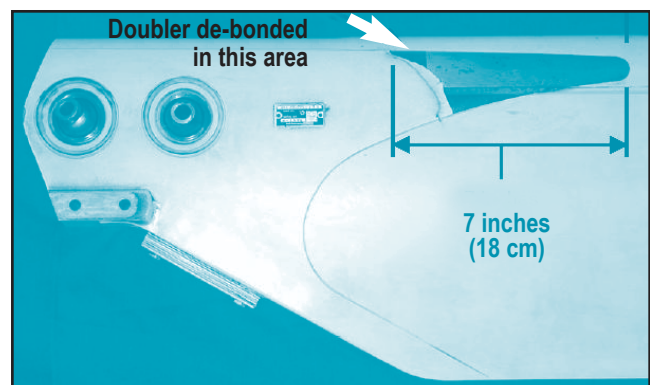
***Tail Rotor Blade Doubler Broken Off***

**View of the tail rotor blade where the doubler was missing**

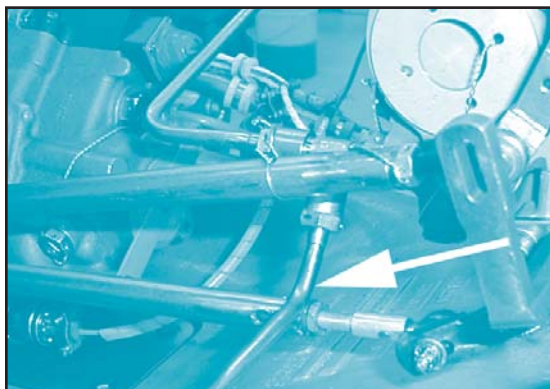
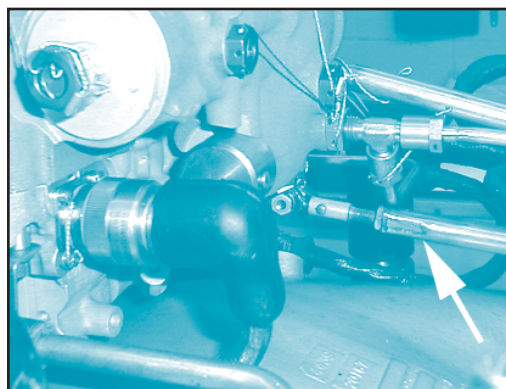
SDR # 20040304008

#### **PCU Rigging**

The shop engineer was inspecting the engine when he noticed that the PCU control rod (condition), P/N 87620097-023, was contacting the P3 air pressure sensing line, P/N 3034384, before contacting the HMU stop at max setting.

This occurs when the HMU is replaced and the "T" fitting, P/N MS 9196-04, is not positioned properly and overlooked when rigging is done.

The "T" fitting was repositioned so a gap between the sense line and the control rod was sufficient for full and normal movement of the HMU control rod.

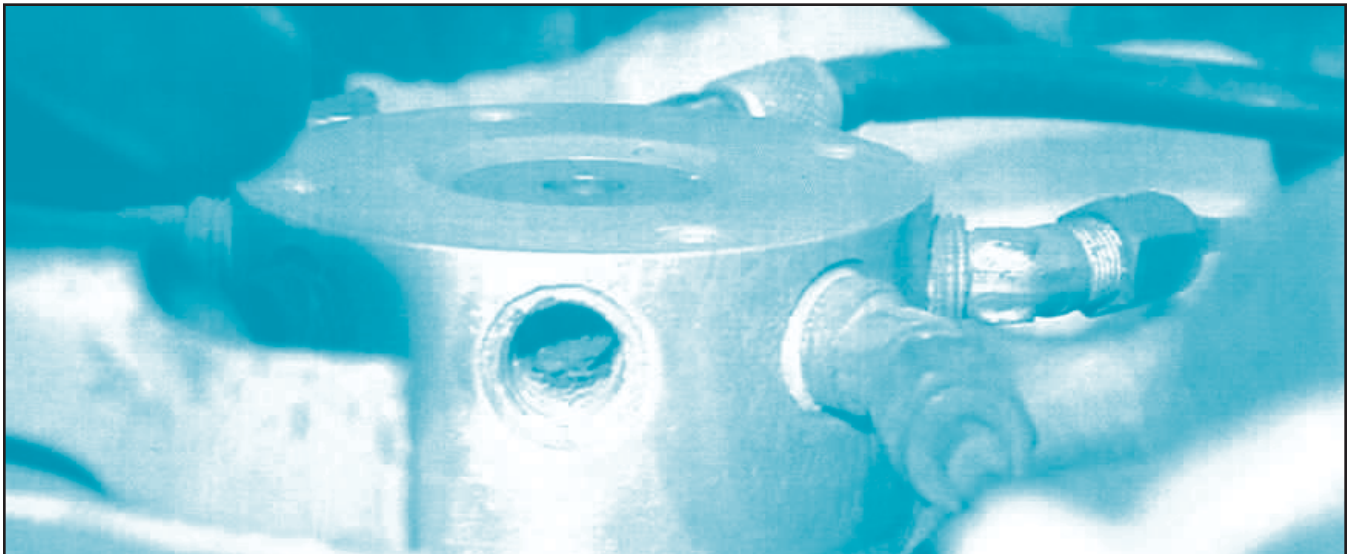
The flow divider being used has six (6) ports but only four (4) ports are needed for this particular 4-cylinder engine with the other two ports being capped off. The operator discovered the source of the problem when he uncapped the two unused ports and a large amount of scattered debris fell out. This debris was partially blocking off one or more of the four fuel injector lines causing fuel supply problems to the cylinders.

*It appears that the unused caps had deteriorated over several years of inactivity. When aircraft are in storage, rubber and other cork materials will degrade and may result in the contamination of fuel and/or oil systems.*
