Transport
Canada

TP 6980E

Issue 2/2005

Canadian Aviation Service Difficulty Reports

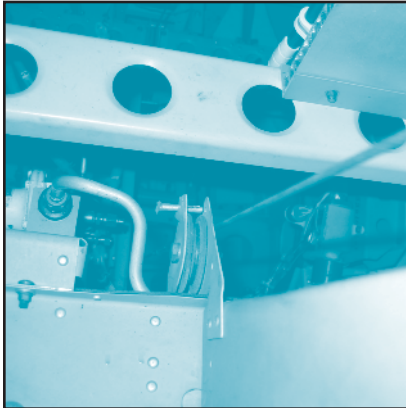
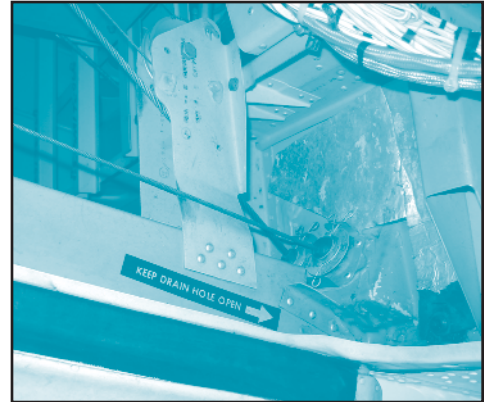
SDR # 20041123001

Pulley Spring Pin Shifted

The primary cable for the elevator control had jumped out of its respective pulley. The "spring pin", P/N NAS 427K6, that prevents this from happening was out of position, and therefore was unable to stop the cable from leaving the pulley.

This defect subsequently caused abrasion of the elevator cable on the surrounding support structure. The support structure is a short distance from where the elevator cable emerges from the pressure vessel as it travels aft to the bellcrank.

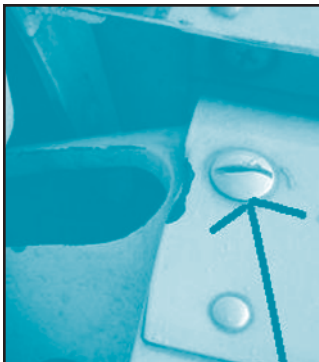
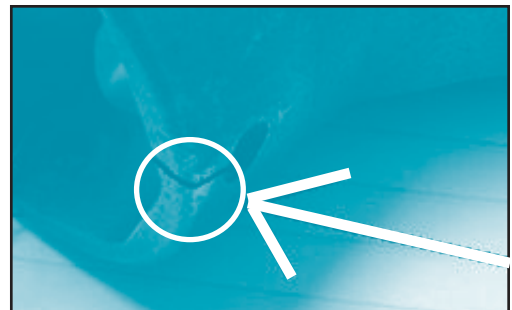
SDR # 20050127002

Elevator Horn Cracked

The operator noted that the elevator skin at the control horn attach point was cracked. Further inspection of the control horn assembly, P/N 956100054, revealed a 1-inch crack emanating from one of four elevator horn mounting bolts. The elevator control fitting was replaced.

The submitter carried out a fleet inspection using visual and eddy current inspection and no further defects were found. Transport Canada reminds maintainers to be vigilant while inspecting this area. ✂

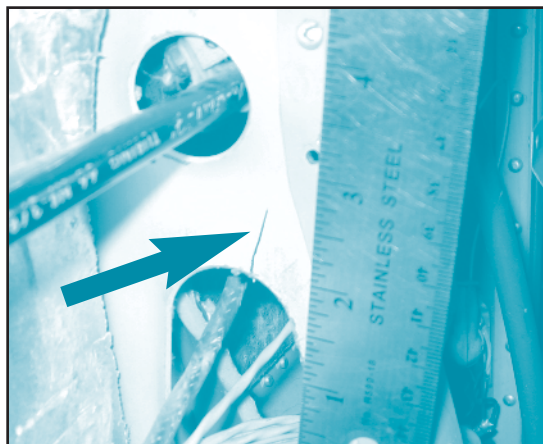
SDR # 20050117001

Frame Structure Cracked

During a routine inspection, a crack was found propagating from an oval hole in the right hand frame at station 207.125, half way between the floor and the window. The crack was approximately 1½ inches long and extended from the eleven o'clock position of the lightening hole to a rivet on the reinforcement plate.

Transport Canada reminds maintainers to keep this defect in mind while inspecting this area and other manufacturing lightening holes for cracks.

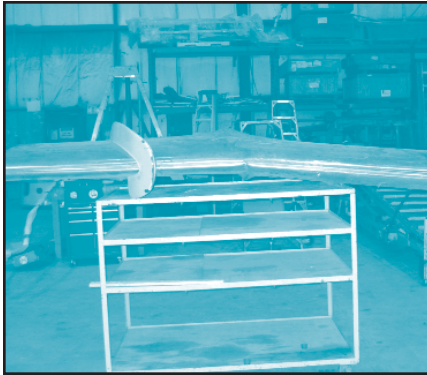
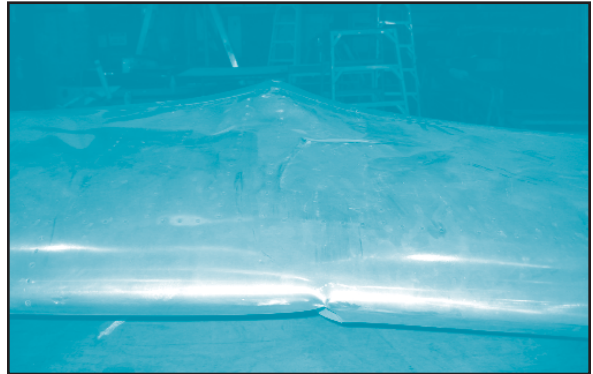
SDR # 20040913007

BOEING 727 233
Slat Actuator Failed

During departure, the crew observed a continuous slat indication problem. The aircraft returned to the airport and made an uneventful landing.

Maintenance personnel investigated and found that the #5 slat rod end bearing had separated from the piston and caused damage to the slat.

The actuator and slat assembly was replaced and the aircraft was returned to service. The submitter stated that the rod end bearing was enclosed in a shrink sleeve and this may have hidden the impending failure of the rod end.

An air operator fleet campaign inspection has been initiated on the remaining aircraft.

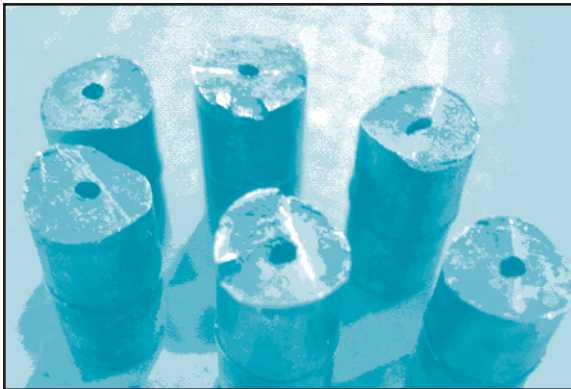
SDR # 20050228002

Wheel Dowel Pins Cracked

During a tire change, an inspection was being carried out on the wheel, P/N 215850026. Six (6) of the dowel pins, P/N 20209, used to align the rim halves were found sheared or cracked.

The cause is undetermined but this is a good reminder to complete a thorough inspection at each tire change. ✖

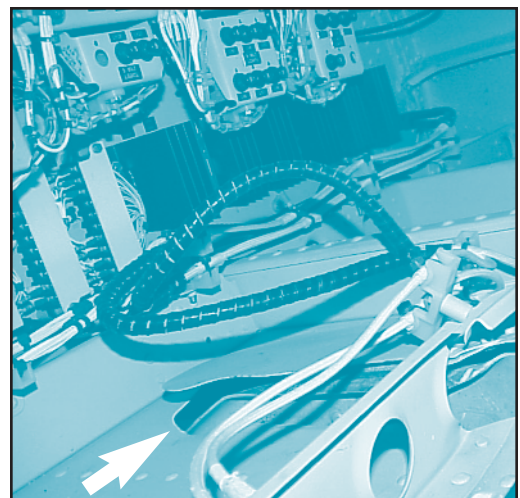
Shortly after departure and during landing gear retraction, the crew heard a loud noise under the flight deck. Following landing, an inspection of the nose landing gear area and wheel well area was carried out. It was then discovered that the nose landing gear assistor spring, P/N HC323L0001000, had failed.

Further investigation revealed that the broken assistor spring had punctured a hole, approximately 8" by 12" in size, through the floor of the flight deck.

The cause of these events appears to be a lack of lubrication and metal fatigue.

Damage caused by broken assistor spring

Transport Canada recommends that maintenance personnel pay particular attention to this area. ✖

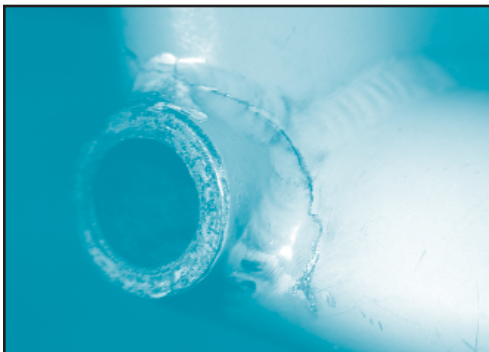
SDR # 20050201002

Engine Mount Ring Cracked

During routine maintenance, the engine mount ring (horse collar) was found cracked at two of the four attachment points. An additional task card, initiated in 1999, to check for this condition every 100 hours, was added to our maintenance schedule, and, as a result, we have discovered the condition on 12 separate collars. The collar was replaced and the aircraft released.

This problem has been around for sometime and is traced back to faulty shimmy dampers. Close inspection of the horse collar should be carried out periodically particularly when the aircraft has experienced a nose wheel shimmy problem. FAA AD 90-05-04 is available to operators at:

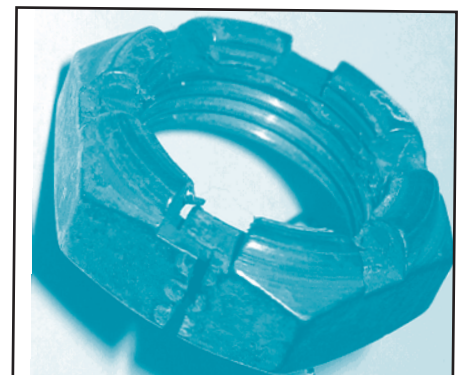
Wing Strut Attachment Bolt Cracked

During corrosion protection corrosion control (CPCP) and the supplemental inspection document (SID) inspection, the wing lower attach strut bolt and nut were removed for inspection and the nut was found fractured through.

The cotter key should hold the nut/bolt in place. The fracture was located through the manufacturer s identification stamp on the outer surface.

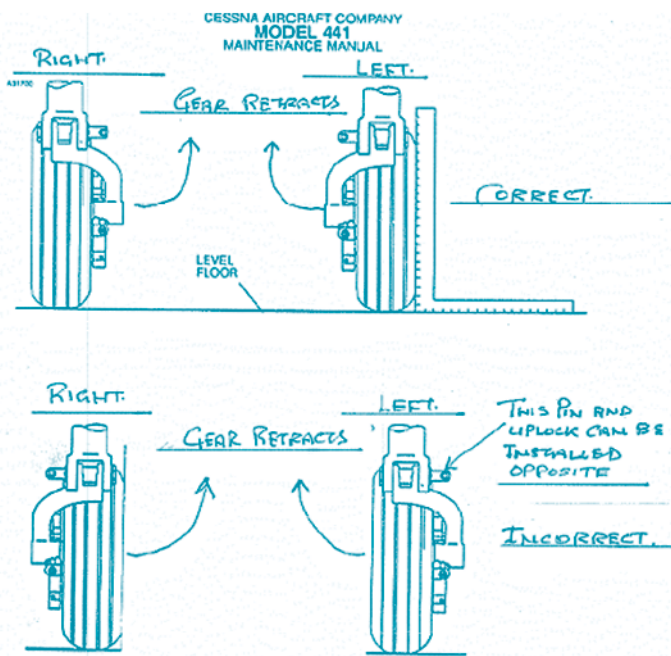
SDR #
20050201002**Installation of MLG Trailing Link Reversed**

This error was not obvious during landing gear functional retraction and extension testing. The gear retracted and locked up normally - extended and locked down normally. The aircraft flew with no loss of airspeed or any indication of airframe buffet due to the trailing links hanging below the wheel wells. Once detected, the configuration was reversed and the aircraft returned to service.

The submitter also indicated it is very easy to make this assembly error, which results in a landing gear configuration most technicians would think - "could not happen". ✖

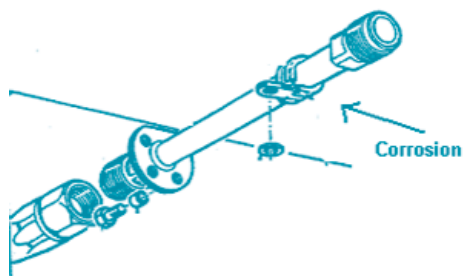
Elevator Trim Control Rod Failure

During climbout, the pilot experienced a slight "thump" through the elevator control system, and a minor vibration, which stopped when level flight was achieved. The flight continued to destination where maintenance was available. The pilot noted that more elevator trim than normal was needed to achieve level flight. After an uneventful landing, maintenance investigation revealed that the L/H elevator trim rod (P/N C2-T47A) had failed at the aft end in the steel threaded section. Close examination of the break revealed that the rod had been bent and cold straightened at some point, initiating a crack. This could have been caused by "dock handling" or a frozen trim tab. The rod was replaced and the aircraft was returned to service.

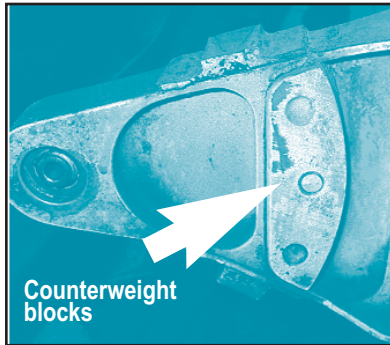
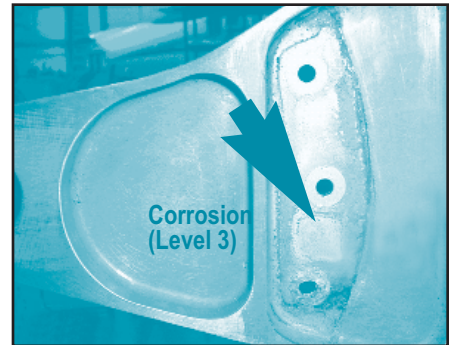
SDR # 20050224007

Counterweight Block Corrosion

While inspecting the centre hinge bracket of the horizontal stabilizer for cracks, as per Manufacturer's Service Bulletin 6/512, corrosion was found under the counterweight block, P/N C6TP1026-27, and was visible on the surface surrounding the block. When the blocks were removed for further inspection, exfoliation corrosion was found under both sides.

The operator took the initiative to investigate the visible corrosion found during his inspection of the centre hinge bracket. In doing so, he uncovered corrosion to be of significant enough nature (Level 3), which required replacement of the part. ✖

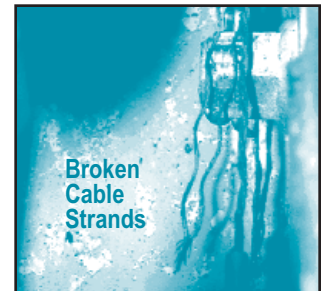
SDR # 20050317002

Main Landing Gear Emergency Release Cable Chafed

While accomplishing scheduled maintenance, of the main landing gear area, the operator noticed emergency release cable P/N 48502-3 badly chafed. The chafed cable was located in the left hand nacelle. Inspection of the cable in the right hand nacelle was completed without any findings. The operator is carrying out a fleet inspection to identify any other such occurrences.

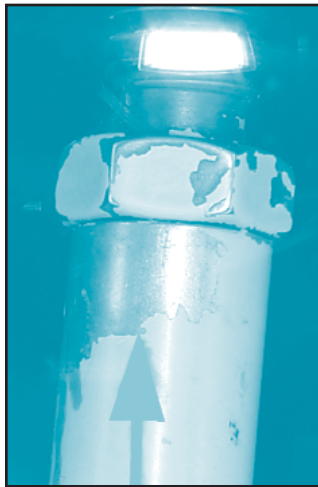
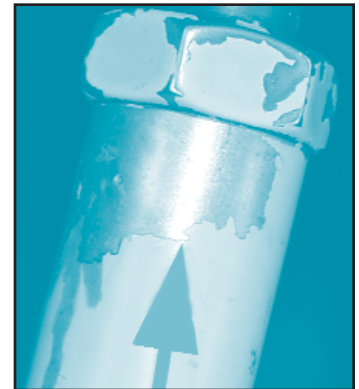
SDR # 20041223005

Pitch Link Cracks

During a scheduled 100-hour inspection, an operator discovered two (2) vertical cracks on a main rotor pitch link. The cracks discovered were approximately .180 inches in length.

Transport Canada reminds AMEs of the importance of the inspection of the pitch links and a reminder that these cracks can occur. ✖

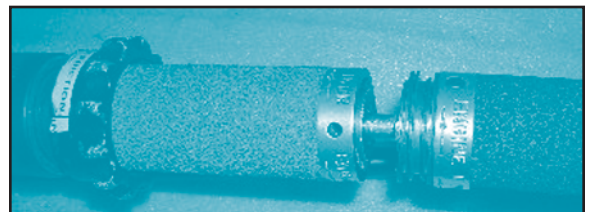
SDR # 20050125017

Collective Tube Assembly Cracked

The AME was preparing to grease the swashplate. To access some of the zerk fittings, it is easier to lift up the collective control stick. The AME was moving the collective control stick up when the ridged tube, P/N 212001181001, bent and broke in two. The breakage occurred between the two throttle grips where there is a slot in the tube for the throttle control.

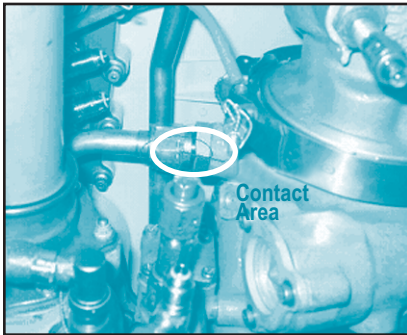
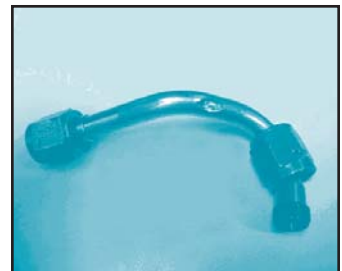
SDR # 20041119008

Primary Fuel Manifold Feed Line Damaged

During a scheduled oil pump replacement, severe wear was found on the primary fuel manifold feed line located near the fuel flow transmitter. Due to a lack of clearance, contact between the fuel flow transmitter inlet "B" nut and the feed lines caused the damage.

Most of this damage was caused by the cutting action of the "B" nut as it was tightened during installation of the fuel flow transmitter, which had been removed some time earlier for engine overhaul. Two of the three engines on this aircraft had similar damage.

It is possible that maintenance personnel caused this damage during installation. Falcon 900 maintainers should carry out a visual check in this area for chafed or damaged fuel lines. ✖

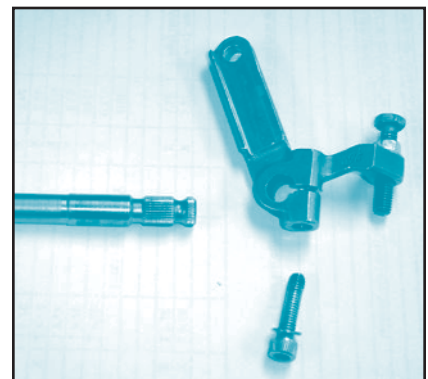
Upon inspection of the engine area, the engine control centre shaft (Christmas tree) was found disconnected from the propeller governor. It was then determined that the setscrew which secures the arm, P/N 863599-1C, located between the centre shaft and the propeller governor had "backed out". This allowed the arm to disconnect from the shaft.

Closer inspection of the setscrew revealed a flat spot on it where the shaft had been wearing into the screw, due to the fact it was loose. The linkages were re-installed and a engine run-up was carried out serviceable.

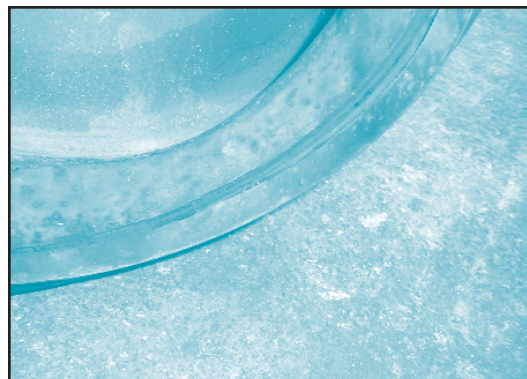
SDR # 20050309012

Turbine Exhaust Duct Flange Cracked

A turbo-Otter operator reported finding a cracked exhaust port flange. The purpose of this flange is to prevent leakage of exhaust gases between the turbine exhaust duct and the exhaust stack.

The crack was approximately 320 degrees around the circumference of the flange. The attachment flange itself was serviceable but the attached lip was the location of the defect.

The opposite exhaust flange was also found cracked to a lesser degree, approximately 120 degrees in circumference.

The submitter recommends that the exhaust stack be removed at the 100-hour inspection to facilitate a closer visual inspection of this area.

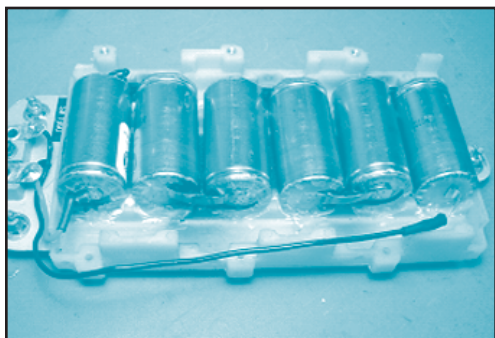
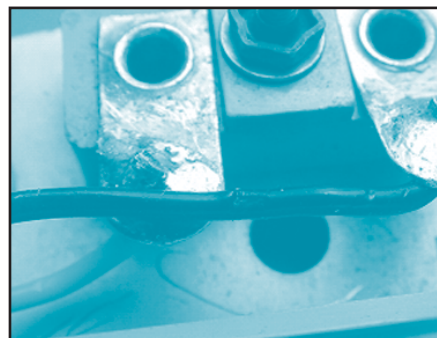
Battery Pack Assembly Failed

The emergency light battery pack, P/N 6104781, was removed due to inoperative emergency lights at the ceiling first three positions.

During overhaul of the battery pack, it was found that the pack had shorted out. It appears that during the last cell replacement, the connection leads were cut too short, which prevented the correct routing of the wires. When the pack was installed on the aircraft, the wires became pinched and the pack shorted out. The pack was installed one month prior to the failure.

This battery pack is installed in several different aircraft models and has been existence for many years. Transport Canada reminds AMO's that these battery packs need to perform when required. Proper overhaul and assembly is critical for reliability. ✖

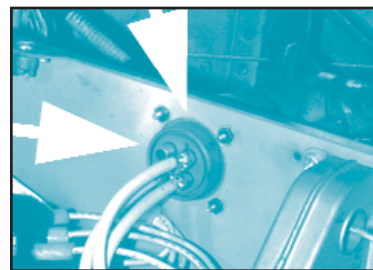
DHC 8 unprotected AC feed wires inside contactor box

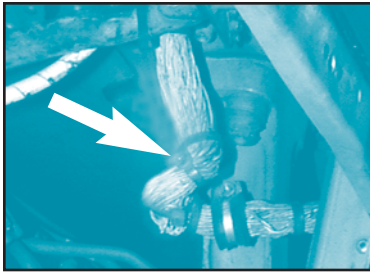
Excessive bend radius on wire bundle

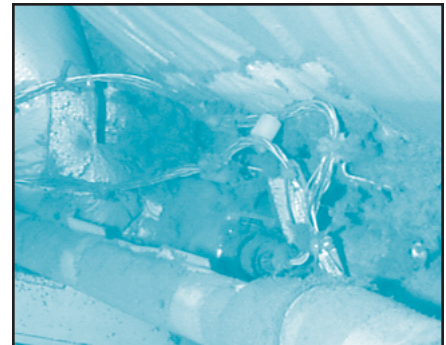
Lint Build-up
