hangar noise

A Message for Aircraft Maintenance Personnel

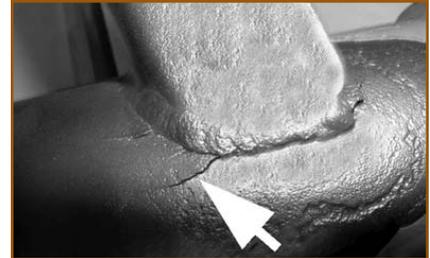
Rudder Torque Tube Cracked

While conducting a scheduled annual inspection, an operator discovered the rudder torque tube assembly, P/N 304201, cracked along the weld.

Keep this in mind. It may be difficult to determine if the weld or an actual part is cracked. Non-destructive testing may be required to confirm the suspected defect. ✖

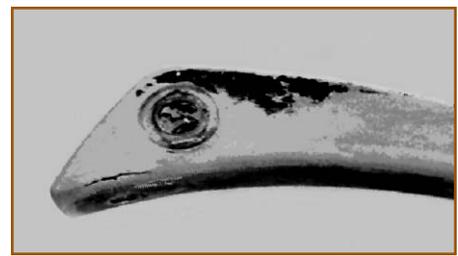
Flap Bracket Cracked

While conducting a routine inspection, a crack was noticed on the left hand inboard flap actuator attachment bracket, 50-16003-6. The bracket was removed and further inspection determined a total of four (4) cracks on the bracket surrounding the upper bolt hole. The flap was also cracked under the forward end of the bracket. The flap was repaired, the bracket replaced and the aircraft was returned to service.

The operator conducted a fleet-wide campaign inspection of this area and discovered the same defect on one other aircraft. This defect may be difficult to detect, disassembly of the flap and flap bracket may be required. ✖

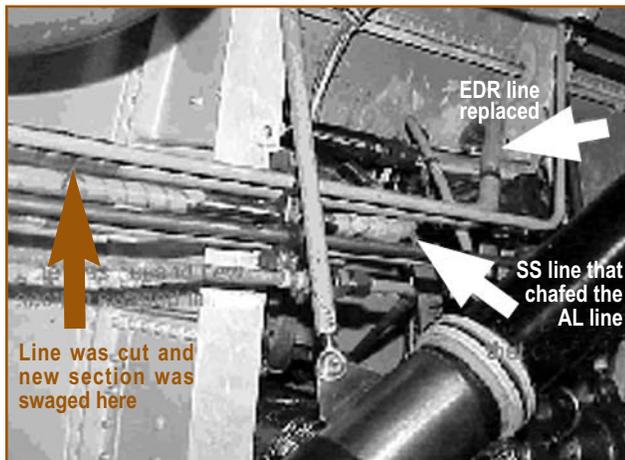
Hydraulic Lines Chafed

The flight crew reported a hydraulic problem, "HYD 1 LO PRESS" with the quantity indicating - "zero". The flight continued and the aircraft landed on the runway with no further incident. Upon inspection, maintenance personnel found the #1 system suction tube assembly chafed at a point 18" from the forward end.

The suction tube, P/N 601R75286-37, reference IPC 29-11-00, fig 4, item 120, had chafed on the #1 hydraulic system stainless steel pressure line. A segment of new suction line was perm-swaged in position, ensuring proper separation between lines.

The pressure line was inspected and found serviceable, and the #1 engine-driven pump was also replaced.

Recognizing and maintaining proper clearance between these lines could have prevented this from happening. Teflon wrap around one or both lines, in addition to maintaining the proper clearances, could have added additional protection in this close clearance area. AME s are also reminded to wear proper protection when working with Skydrol. ✂

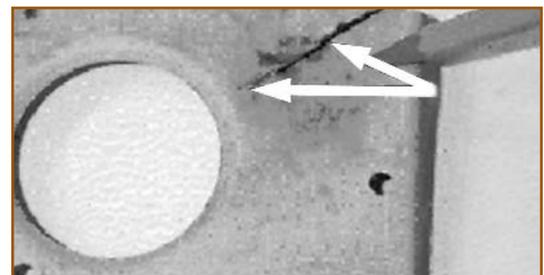
Nose Wheel Steering Bracket Cracked

The operator of a Cessna 550 had multiple nose wheel shimmy defects on his aircraft. After rectifying the defect, the area was inspected for other collateral damage associated with the nose wheel shimmy. Bracket, P/N 556561851, was found cracked. The part was replaced and the aircraft returned to service.

The submitter noted these brackets are prone to cracks and Cessna produced a heavier gauge material bracket as corrective action. The bracket found cracked was of the newer design.

If you have experienced similar defects, i.e. nose wheel shimmy, operators are encouraged to inspect this area for cracked brackets. ✂

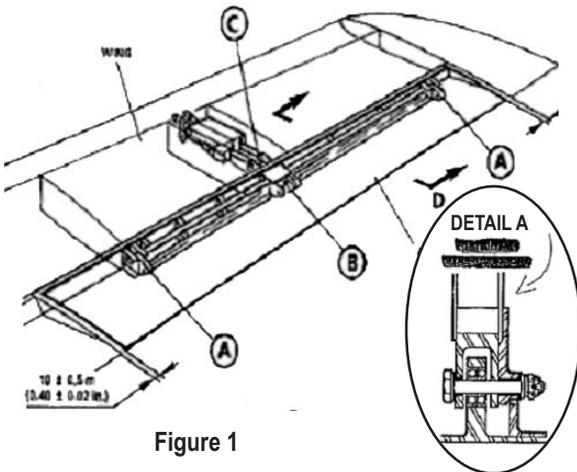
During the reinstallation of the LH aileron after maintenance, the engineer noticed that the aileron bolts, P/N 33412TX080041XA, at bearing #1 and #3 attach points, were installed incorrectly. The RH aileron bolts were checked and also found to be incorrectly installed. Both LH and RH aileron bolts were installed in the opposite direction of detail A. The bolts were removed, inspected and reinstalled IAW DA90 MM 57-511. (ref. Figure 1 detail A)

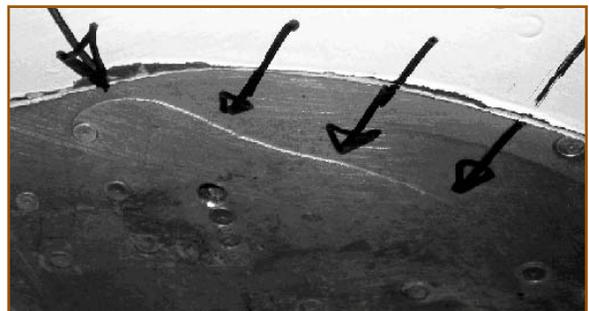
During an avionics upgrade, the forward ADF antenna was removed and the technician discovered a 3-inch crack in the fuselage skin.

The antenna had been incorrectly shimmed to the fuselage profile at a previous time. A second ADF antenna further aft on the belly was removed and the skin inspected with no damage found, although that antenna was also shimmed.

There is no scheduled requirement to inspect under the antennae, although Learjet is apparently planning to amend the inspection schedule to require structural inspection under such antennae.

The damage was removed and repaired with an external doubler, IAW the Learjet Structural Repair Manual (SRM) and specific guidance instructions from Learjet engineering.

Transport Canada recommends that a dedicated inspection task for any antenna installation be developed for structural damage or corrosion as part of the Instructions for Continuing Airworthiness. ✖

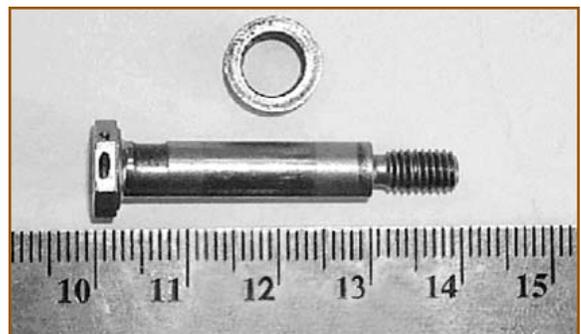
Play was discovered in the rudder upper attachment point of this aircraft. After inspecting the area, the submitter replaced; bolt P/N NAS1161-3-17, bearing P/N 940.83.28.506 and bushing, P/N 941.20.31.550 due to wear.

The aircraft had Pilatus ECE-TM-02-327 incorporated approximately 1000 hours earlier that provide a longer bolt to prevent shanking.

Pilatus is reviewing this Service Bulletin and the cause of the premature wear. ✖

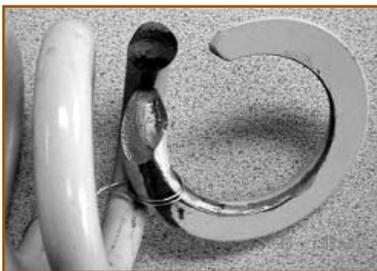
**Anti-Vibrator Spring Broken**

While conducting a daily inspection on the main rotor assembly, the engineer discovered a broken spring under the chinese hat. The affected spring was replaced with a new assembly. The remaining springs were inspected and no defects were found. The defective spring had signs of a crack, which completely fractured over time.

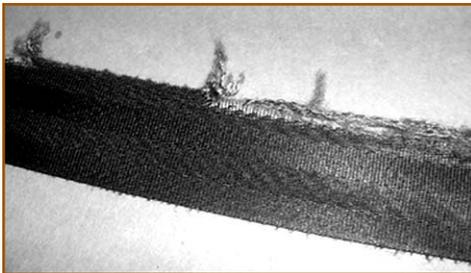
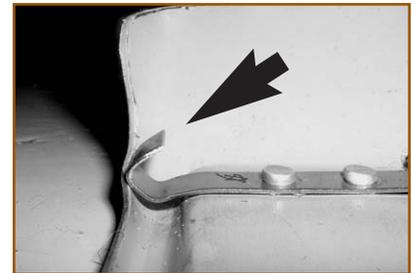
Shoulder Harness Frayed

The pilot seat belt shoulder harness, P/N 504339401, was discovered frayed. The fraying occurred between the shoulder harness and a retaining bracket for the seatback cover.

This defect was caused by the retraction and extension of the shoulder harness inertia reel over a period of two months and several flights. The bracket in question had sharp edges, and normally is not installed in this condition. The bracket also had a larger radius on one of the two brackets used for holding the pilot's seatback cover.

The submitter replaced the inertia reel assembly with a new unit and smoothed out the edges of the bracket. The submitter also added that they would be keeping a regular inspection of this area.✂

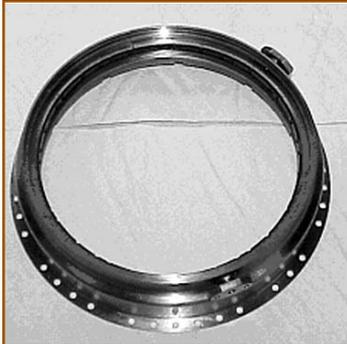
Carbon Seal

Maintenance personnel traced the problem to a severe oil leak on the No.2 engine and observed displacement of the #1 Bearing oil seal retaining spring located at the #1 oil seal retaining ring. Further investigation revealed the carbon seal, P/N STA6270B, had failed.

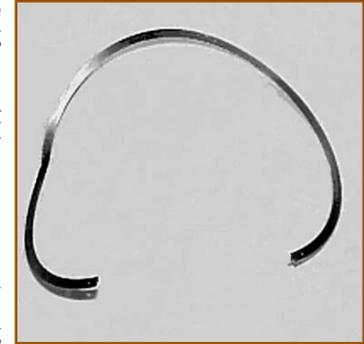
Retaining Ring

Radial carbon seals define the forward and aft limits of the three sump areas in which the main engine bearings are located. These carbon seals are pressurized by 7th stage compressor bleed air, which is greatly reduced to approximately 15 psi. The first sign of oil vapors in the cabin could be due to undesirable leakage of lubricating oil past any of the carbon seals. ✖

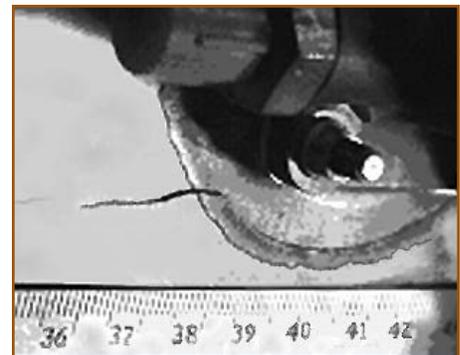
Combustion Chamber Case (Plenum) Cracked

During troubleshooting, maintenance personnel discovered that the combustion case plenum was cracked at the customer bleed air (P3) service flange.

An SDR search revealed two previous combustion case cracks on this series engine. Both these SDRs stated that a faulty 2nd stage compressor impeller had caused damaging vibrations that resulted in the fracture of the combustion case. Another SDR received from a different operator stated that overtightening the anti-ice valve during installation could overstress the weld area at the P3 service port and initiate cracking of the plenum case. ✖

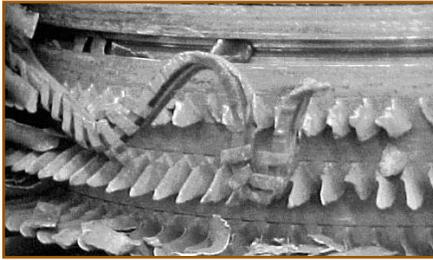
High Pressure Compressor Stage 7 - Disc

The engine manufacturer carried out an engine teardown investigation and discovered the root cause of this event was due to the complete detachment of the stage 7 disc rim of the high pressure compressor (HPC). Due to the rotation of the HPC, the detached disc rim was squeezed together and subsequently caused severe damage to all the adjacent blades on HPC stages 8, 9 & 10, which were found broken. Additionally, HPC stages 11 & 12 were found completely destroyed with only the remains of the blade platforms visible. Evidence of a titanium fire was also found

on the side of the HPC case. Heavy secondary downstream damage was also evident on the low pressure (LPT) and high pressure (HPT) turbine blades and vanes.

The engine manufacturer overhaul facility stated that the faulty disc rim is presently under investigation at the engine manufacturers facility. A teardown report to determine root cause of failure is forthcoming.

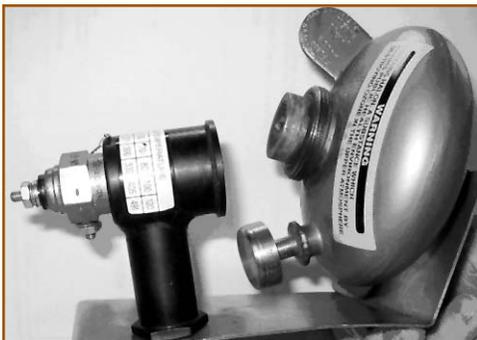
APU Fire Extinguishers Inadvertent Discharge

During a routine inspection, maintenance personnel discovered that the APU fire extinguisher bottle was reading 0 PSI.

An investigation, carried out by the operator to determine the cause of this discrepancy, revealed that, if the APU fire warning test button was double tapped or held too long; it is possible to activate and deplete the APU fire bottle. The operator has been in contact with the manufacturer with respect to this incident. Upon removal, it was found that the fire bottle had separated from the discharge nozzle.

Another operator of a Learjet 45 discovered the APU fire bottle had discharged. The fire bottle outlet valve flange nut was broken and the fire bottle support bracket was bent causing the bottle to separate from the outlet valve.

Learjet has recently issued Advisory Wire 26-002 on this subject matter of APU fire extinguishers. It appears that inadvertent discharges have occurred during APU starting procedures. Advisory Wire can be found at www.cic.bombardier.com. ✂

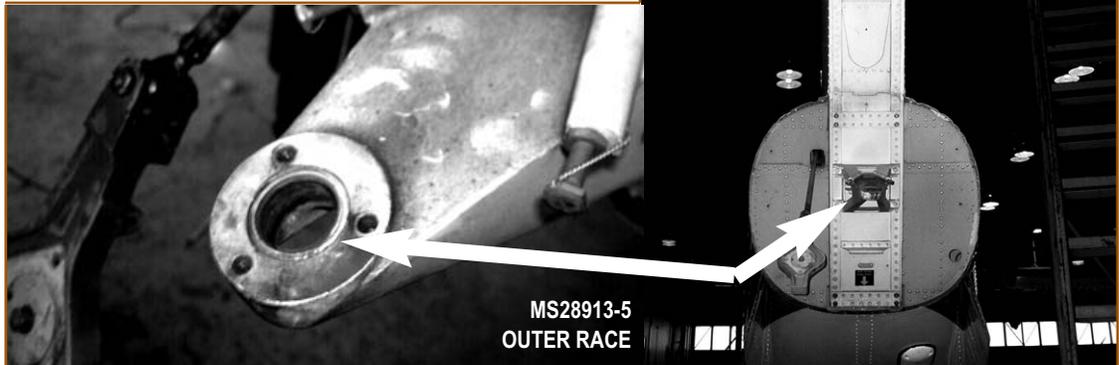
As the tail section was being inspected during a 4th phase 800-hour inspection, light rubbing and wear was noticed on the rudder hinge structure points. Also noted was that the rudder appeared to be sitting lower than normal on its hinges.

A thorough inspection of the rudder and its structure was carried out which revealed that the lower hinge point bearing, P/N MS28913-5, had completely disintegrated allowing the rudder to drop down. Parts of the bearing were found in the tail cone and the only thing remaining in the hinge was the bearing outer race. Light corrosion was evident once the bearing race was removed.

The FAA has been notified of this occurrence. The submitter noted that there is no lubrication or corrosion control required in this area as per Chapter 12 of the aircrafts maintenance manual. ✖

The hinge point damaged area was cleaned and inspected before the bearing was replaced with a serviceable unit.
