Transport
Canada

TP 6980E

Issue 4/2005

Canadian Aviation Service Difficulty Reports

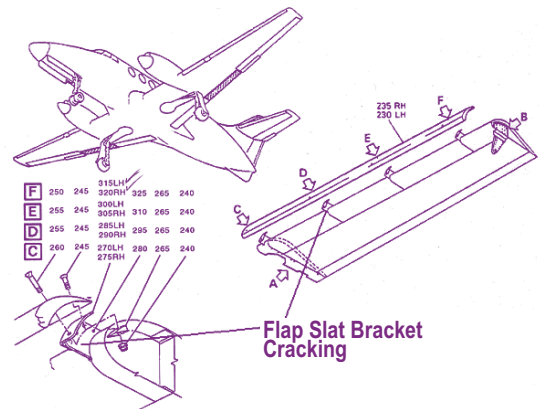
Flap Slat Bracket Cracks

The Web Service Difficulty Reporting System (WSDRS) indicates five (5) incidents of flap slat brackets being found cracked. Some cracks were approximately one-inch (1) long, located in the forward radius of the bend.

Maintenance personnel have found as many as three (3) brackets cracked during their inspection of the area. There are various part numbers for these brackets listed in the aircraft Illustrated Parts Catalogue (IPC).

Transport Canada stresses that technicians should be vigilant during inspections of this area for cracks and corrosion of the flap slat brackets. ✂

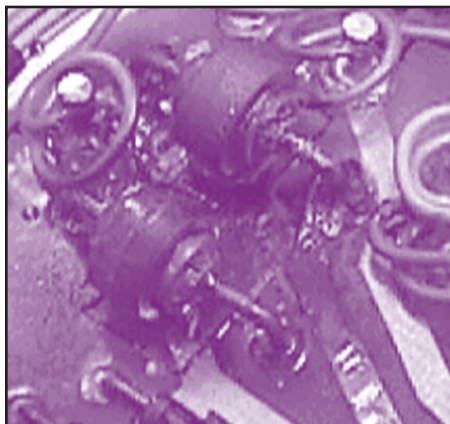
Generator Control Unit (GCU) Meltdown

After starting the #1 engine, the crew turned on aircraft power, and they immediately noticed smoke coming from the generator control unit (GCU). They turned the power off and returned to the gate for maintenance.

Maintenance personnel swapped the #1 GCU with the auxiliary power unit (APU) GCU and carried out extensive troubleshooting and function tests. The GCU was found to be at fault.

The teardown inspection of the GCU revealed that the smoke was generated from an internal short, which caused the circuit boards to melt.

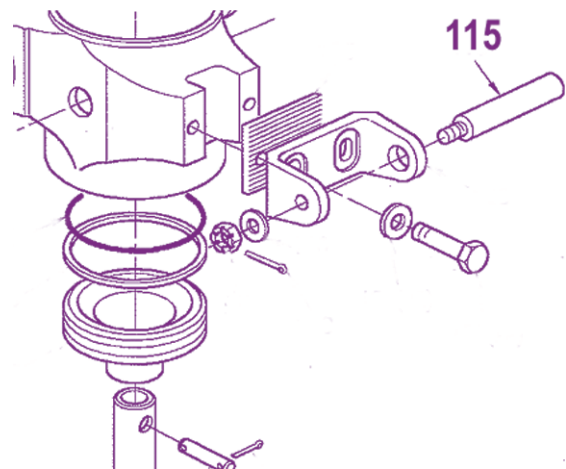
Nose Landing Gear Up-lock Pin Broken

During a walk-around, the nose landing gear (NLG) up-lock roller pin was found broken at the cotter pin hole. The submitter indicated this was the first time this type of defect has been found.

Refer to Challenger Supplemental Maintenance Data Book PSP608a, Chapter 32-20-03, Item 115.

Transport Canada recommends all Challenger operators perform a general visual inspection (GVI) of this area, specifically the up-lock roller pin. ✂

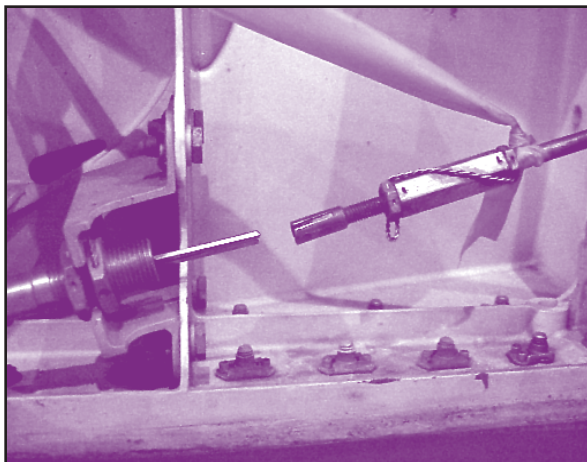
Auto-throttle Cable Severed

When both engines were removed for inspection access during a heavy maintenance visit, the left engine auto-throttle retard cable was found severed. (Canadair IPC, Chapter 76-10-00, Figure 2, Item 220).

The cable was cleanly severed between the drilled jam nut (Item 125), and nut (Item 165), just aft of the bellcrank (Item 85).

In this case, an astute technician found this defective cable. The OEM is currently investigating the cause of the cable breakage.

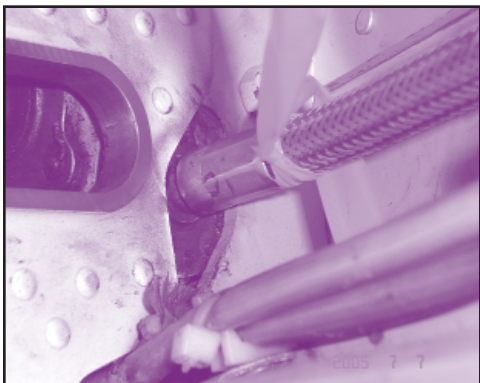
**Retainer Missing**

Flap Flex Shaft Retainer Missing

While performing a visual inspection, the right flap flex shaft retainer was discovered to be missing and possibly broken off.

These retainers are sometimes difficult to inspect as they are often covered with dirt or grease.

AMEs are reminded to take the time to inspect for these devices that are installed on many different aircraft. ✖

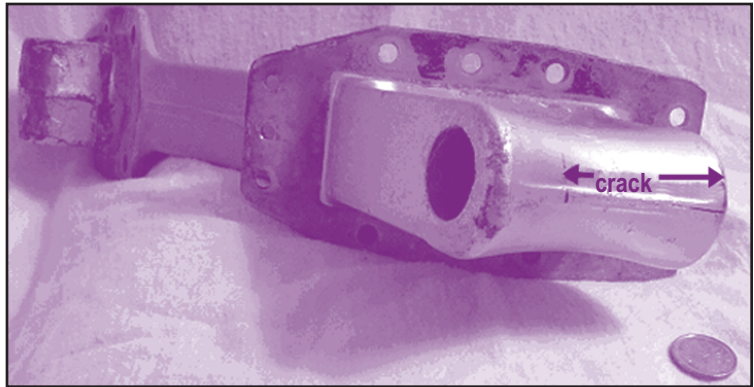
Float Strut Attachment Fitting Cracked

Upon removal of the spreader bar from the float, a crack was noted along the casting seam of the right front float strut fitting. The only time this area is exposed is during heavy maintenance, when the aircraft is removed from floats and the floats are dismantled.

While sourcing replacement parts for the repair, an overhaul facility stated that they have come across six (6) castings within the last couple of years with similar cracking along the casting seam at the taper pin attaching point.

In this particular incident, the float assembly was an EDO 679-4930 float made under licence by Bristol aircraft. The cracked fittings in question are not being inspected at scheduled intervals because it requires removal and disassembly of the float. Age seems to have been a major factor in the cracking of the fittings found so far. The associated image shows that the crack had progressed to approximately 75% of the fitting and failure was inevitable. ✖

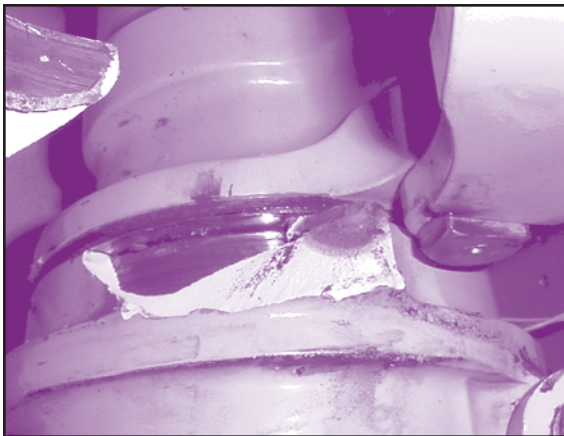
Nose Wheel Steering Collar Fractured

Following aircraft arrival, the crew reported steering problems. Investigation by maintenance personnel revealed that the nose wheel steering collar had completely fractured. Fortunately, no secondary damage was caused by this event.

The responsible overhaul facility stated that fractures of this nature are caused by repetitive and excessive turning inputs. The aluminum collar, especially at the pivot point, is not designed to withstand the severe stresses imposed during sharp turns.

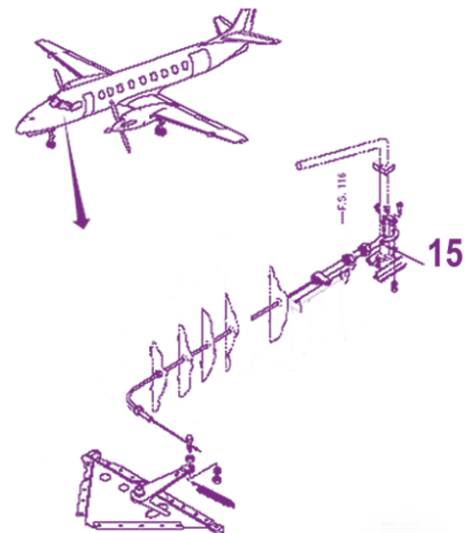
Emergency Extension Release Cable/Bellcrank

When complying with an unrelated inspection under the cockpit floor, maintenance discovered the nose landing gear emergency release cable was sheared at the clevis where it attaches to the handle bell crank. The cable failed at the point where it attaches to IPC 32-30-00, Fig 4, Item 15.

This aircraft had recently (within 50 hours) undergone a phase 5 inspection where the system was inspected and tested, and no defects were found. The cable was replaced with a serviceable unit, gear swings were conducted and no further faults found.

This is the first failure of this type experienced by this operator. ✖

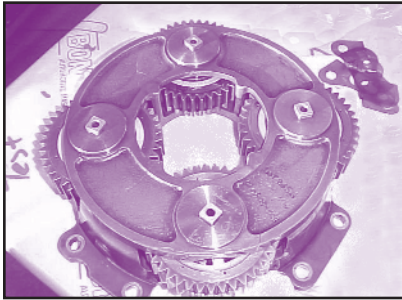
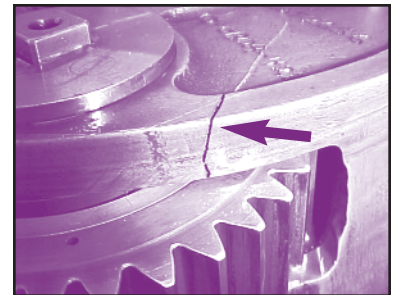
Planetary Gear Carrier Cracked

The flight crew observed the engine oil pressure trend to be steadily declining over a short period of time. As an experienced operator of this engine, it was thought that this indicated a cracking problem with the planetary gear carrier in the engine gearbox. The engine was removed and, as suspected, the planetary gear carrier assembly had multiple cracks and was near complete failure.

In a more recent SDR from the same operator that reported similar oil pressure problems resulting in another premature engine removal, the planetary gear carrier had fractured with pieces of the oil distribution galleries missing. Excessive wear was also evident on the planetary gears. During the last overhaul at only 381 hours ago, the LPI inspection revealed no cracks of this planetary gear carrier.

In addition, another SDR reported declining oil pressure that would drop even further on application of a higher power setting. Maintenance personnel changed various oil pressure regulating components in an unsuccessful attempt to rectify this snag. Eventually, the reduction gear case was disassembled and it was noted that the planetary gear carrier was completely cracked around its circumference. The oil galleries were affected by these cracks and caused the low oil pressure condition. The operator stated that an inadvertent or unreported over-torque event of the engine may have led to this problem. Complete failure would have caused severe damage to the engine and possibly caused a severe engine overspeed.

A service history review has revealed several other SDRs reporting declining oil pressure and cracked planetary gear carriers, P/N 8679225.

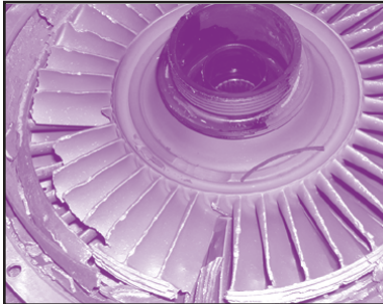
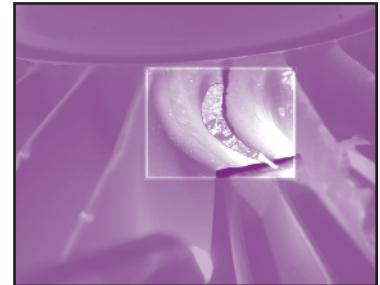
Turbine Wheel Liberated

During a scheduled landing with the weight of the rotorcraft on its wheels, the pilot heard a loud bang, followed by N2 deceleration of the right engine. An engine chip light indication was also noted at this time. Preliminary investigation revealed failure of the 3rd stage turbine wheel.

A domestic engine AMO investigation concluded that the 3rd stage turbine wheel was the primary failed item. It appears that cracks developed at the trailing edges of the blade root end, eventually resulting with the blade separating from the disc.

A review of the SDR data base revealed two other recent SDRs on this part number turbine wheel. One of these events occurred during flight resulting in a crash. The turbine wheels had only 1144 and 2852 hours since new (TSN), respectively.

Rolls Royce has issued CEB A-72-3068 requiring fluorescent penetrant inspection of all 3rd stage wheels at the next shop visit. No cracks are allowed in the hub or root end area of the blades.

It is therefore recommended that all operators comply with CEB A-72-3068. ✖

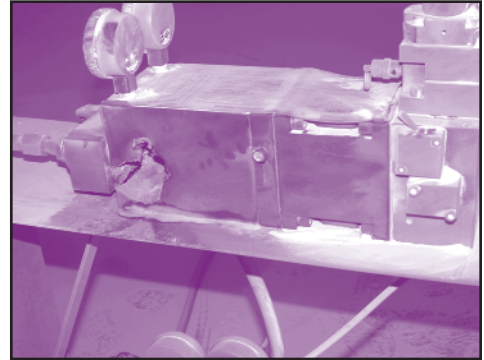
Fortunately, the ground operator of the subject oxygen booster unit escaped with minor burns. Quick action on the part of the nearby crew was instrumental in limiting any further damage.

Shop-powered hangar air (80 psi) is used to power this OB-30 portable oxygen booster unit to produce 2200 psi oxygen pressure.

The manufacturer did not positively identify the cause of this explosion, however, it is possible that contaminated shop air may have somehow seeped past the twin rod seals of the booster unit and caused this explosion. ✖

The operator stated that another filter has now been installed in the hangar shop air line even though the OB-30 unit does have a integral filtration device.

Following this event, the manufacturer of this equipment has made several upgrade improvements including a blast shield. The manufacturer's Installation, Operating and Maintenance Manuals do list a number of safety features and warnings/cautions to persons operating this equipment. In particular, that all personnel receive proper training and that components used in the oxygen system or shop air system shall be clean, dry and free of all contamination.

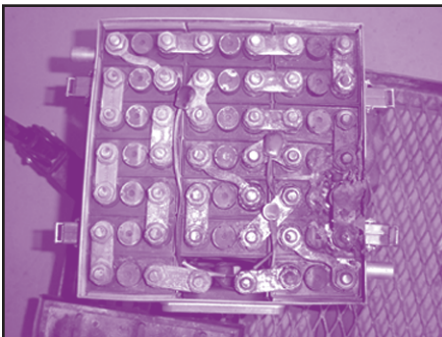
Ni-Cad Battery Damaged

During a scheduled check, the ni-cad battery was observed to have a 1-inch diameter hole in the top of the case. Erosion was also evident on the side of the battery case. Three cells in the area of this hole exhibited evidence of overheating and thermal damage.

This battery has (six) 6 months time in service since new and 226 hours since its last service.

It has not been determined what caused this damage, however thermal runaway is a possibility. Thermal runaway is a condition where the battery chemicals overheat to such a degree that the battery can be destroyed or even explode.

The nickel-cadmium battery requires specific maintenance procedures; always follow the manufacturer's recommendations. ✖

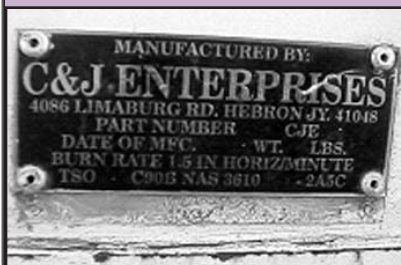
Figure 1. Falsified Data Tag

The falsified data tags identified the ULDs as manufactured by C&J Enterprises, 4086 Limaburg Road, Hebron, JY (rather than KY) 41048 and identified the part number as CJE (rather than CJE-90). Some tags also lacked the date of manufacture and burn rate information that TSO-C90 and NAS 3610 require to be displayed. (See Figures 1 and 2 for falsified and authentic data tags.)

Regulations require that type-certificated products conform to their type design. Aircraft owners, operators, maintenance organizations, and parts distributors should inspect their aircraft, aircraft records, and/or part inventories for fiberglass ULDs that have been sold by IDF, S.A. or distributed by Apparel Transportation, Inc. Referenced ULDs installed on aircraft should be inspected for conformity to type design. If any are found in existing stock, it is recommended that the ULD be quarantined to prevent installation until a determination can be made regarding each ULD's eligibility for installation.
