Transport  
Canada

TP 6980E

# feedback

Canadian Aviation Service Difficulty Reports

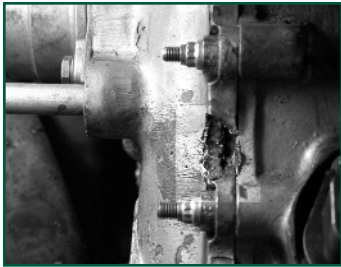
SDR # 20050427005

Shortly after aircraft departure, the No.2 AC generator went off-line. The aircraft returned to its point of departure for verification by maintenance personnel. Technicians replaced the generator control unit (GCU), which did not rectify the problem. Further investigation revealed that arcing had occurred between the AC electrical harnesses at the "D" flange location of the engine case.

*The arcing caused a noticeable portion of the engine case at the D flange location to be damaged. Short circuits in electrical systems constitute a serious fire hazard and also may cause the destruction of electrical wiring and damage to units of electrical equipment. Visual inspection of proper routing and clearances for electrical wiring harnesses are not always given the same attention as other system installations. This service difficulty is an example of the significance of wiring harness routing and clearance. ✖*

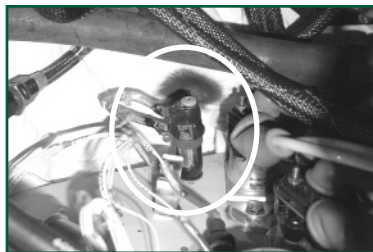
An overheated resistor, R145, was discovered at the top of the forward bulkhead behind the instrument panel during a routine inspection. The fluorescent light resistor, P/N 2K40D10, was scorched and had slightly burned the insulation located behind the glare shield.

A company fleet-wide campaign produced three (3) similar defects.

*Transport Canada (TC) recommends maintainers to carry out a detailed inspection of this area to ensure that adequate clearance between the secured resistor assembly and aircraft insulation is maintained.*

*The operator noted that resistor, P/N D25K10R, has been superseded by P/N 2K40D10. ✖*

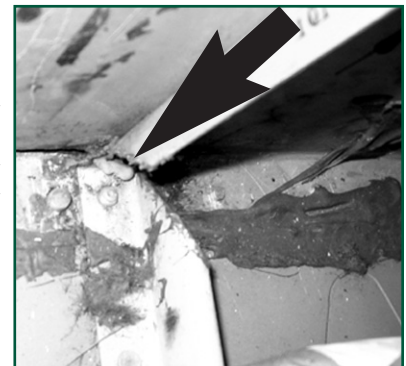
While troubleshooting a pressurization snag on the aircraft undergoing maintenance at an operator's facility, maintenance discovered a 3.5" long crack in a section of the bulkhead lower flange attached at the rear spar at FS 227. The crack was causing a major pressurization leak that could be felt outside of the aft spar box on the exterior of the aircraft. No specific repair instructions are provided in the maintenance manual for this damage.

*This defect underlines the importance of careful visual inspection when the aircraft is undergoing maintenance. ✖*

Upon completion of repairs a pressurization test was completed and the aircraft returned to service.

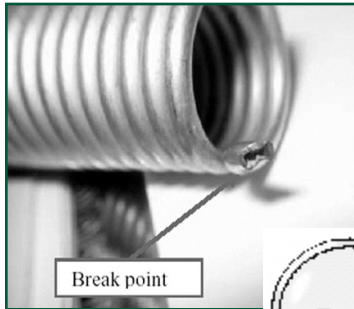
SDR # 20051129002

While taxiing the aircraft, the flight crew noticed a full left bias deflection in the aileron system. Maintenance discovered that one of the aileron/rudder interconnect springs had fractured near the end ring that provides connection to the bridle. This defect may have been induced during phase inspection requirements in removal of the springs during tensioning procedures. The tool marks from a set of pliers or other mechanical means during the removal process may have scored the spring, providing areas for stress risers to develop.

*The operator issued a supplemental inspection into their process control to avoid future occurrences of this defect. Maintainers should remain vigilant when inspecting this area and judiciously use the correct tool to prevent damage to aircraft hardware. ✖*

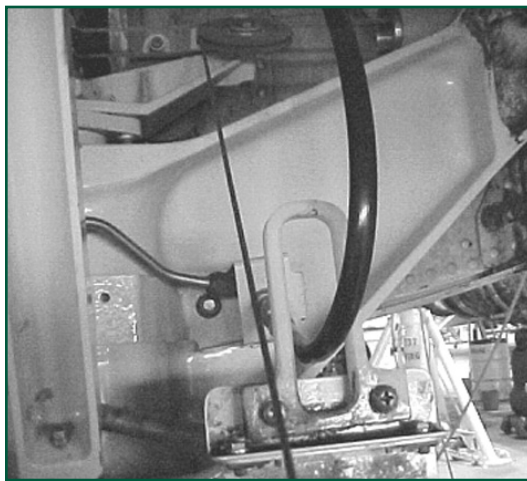
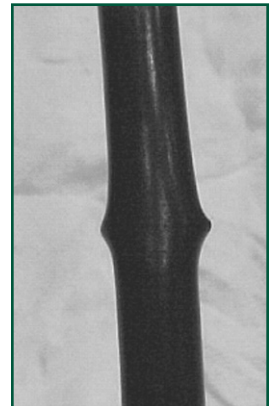
SDR # 20051128009

The subject aircraft had intermittent history associated with nose gear extension/retraction anomalies. The Pilot reported that the gear lever had to be cycled twice to get the nose gear to extend. A visual inspection was carried out with no obvious faults. The aircraft was ferried back to base with the nose gear selected down.

During a recent heavy check this issue was further investigated. Flex line, P/N BACH8A04NM0274T, is a Teflon flex line supplying hydraulic fluid to the nose gear ski actuator. This line was found kinked. It is believed that this finding also contributed to the extension/retraction anomalies by restricting the flow to the nose gear ski actuator.

Upon arrival the transfer cylinder and lock actuator were replaced, along with the nose ski actuator, without successful rectification of the anomaly. The selector valve was then replaced and a test flight conducted, which verified positive operation. Selector valve, P/N 10-61213-1, appeared to have cured the snag. During troubleshooting it also appeared that greasing the points of the nose gear made a difference.

*During troubleshooting the operator noted that nose gear grease fittings were missing and has established an inspection of Main and Nose Landing Gear grease fitting throughout the fleet. It should be noted that some defects can be rectified with part replacement but further investigation and inspection is a prudent approach. Those hidden anomalies can lay dormant and eventually fail causing more down time and possible safety hazards. ✖*

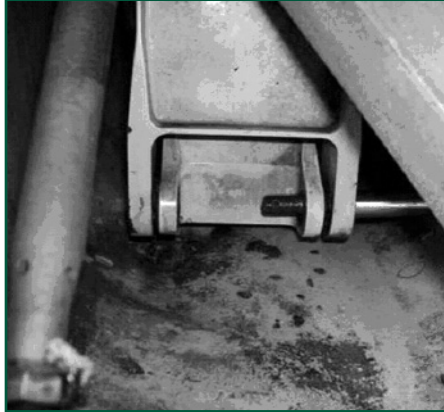
During ground inspection it was discovered that the AFT attachment bolt of the No. 3 flap fairing had migrated inboard and punctured a hole through the composite fairing. The aircraft was removed from service for repairs.

Upon further investigation, three (3) of the fairing AFT attachment bolts were found without cotter pins installed, two nuts had backed off and the third had separated completely allowing the bolt to migrate. This aircraft had recently had a base visit during which the fairing was removed for access. An investigation is underway with the facility that performed the work.

*Human Factors concerns are still prevalent throughout the aviation community. Try to stay out of those elements that cause Human Factors issues to infuse themselves while carrying out your professional duties as an aviation technician. ✖*

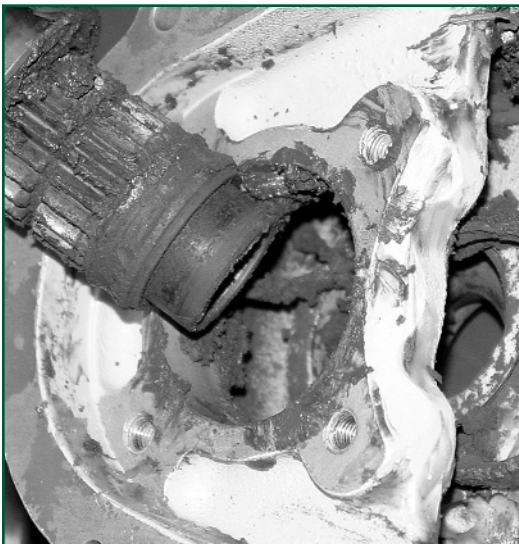
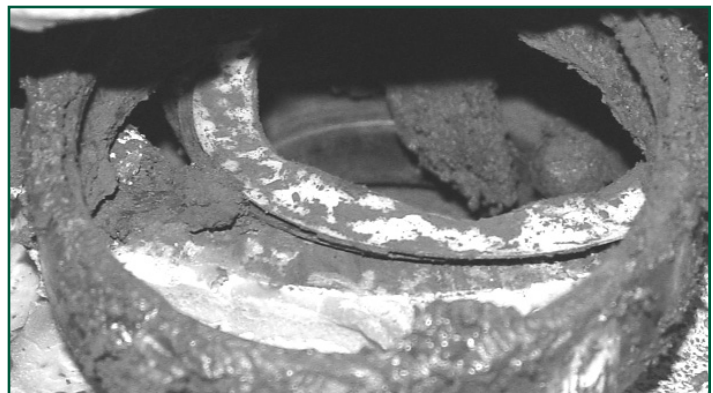
SDR # 20040920001

The horizontal stabilizer actuator assembly, P/N 251T4310-1, was removed from the airplane after maintenance personnel observed rusty grease on the ball screw. Following examination both bearings, P/N 105KS, (Ref: CMM 27-41-01, Item 95) and pinion (Item 100) were found heavily corroded inside the housing assembly, P/N 251T4324-1. The bearings were so corroded that they broke apart upon removal.

The SDR submitter also stated that water ingress is suspected to have occurred (water accumulation) in the housing assembly P/N 251T4324-1. Additionally, the web service difficulty reporting (WSDR) database contains a number of other past and more recent SDRs reporting similar corrosion problems on the horizontal stabilizer actuator.

*Transport Canada Civil Aviation (TCCA) reported this SDR to the FAA expressing our concerns about severe corrosion of the stabilizer trim actuator, and the possibility of reduced controllability of the aircraft. The FAA requested that Boeing make a Safety Determination on the effects of severe corrosion and the effect of the stabilizer trim actuator jamming and reduced controllability of the aircraft. ✖*

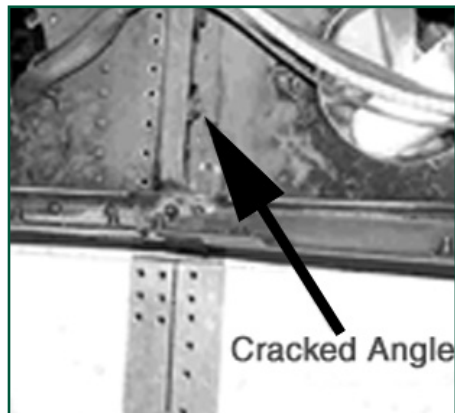
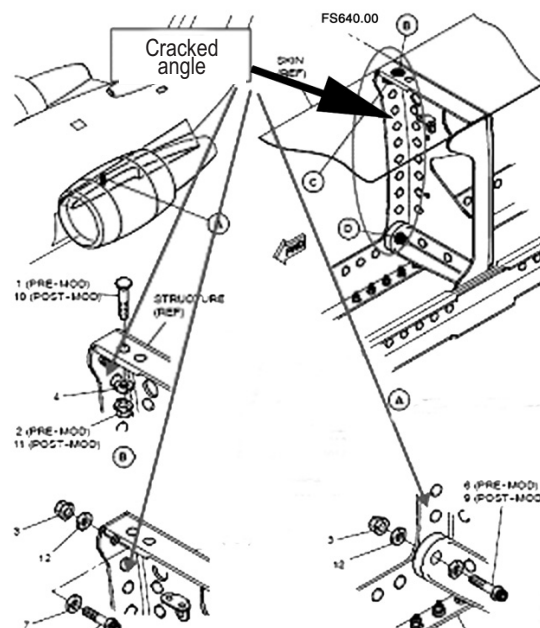
SDR # 20051208010

While replacing the engine pylon bolts as per Service Bulletin (SB) 601R-54-005, the AME working in the area noticed that both the left and right side formed angles inside the engine pylon at FS640, Stringer 10, were cracked. Both the left side angle, P/N 601-37003-81, and the right side angle, P/N 601-37003-82, were removed and replaced.

*As in this case, an astute technician also found another defect in the immediate area. Good work! ✂*

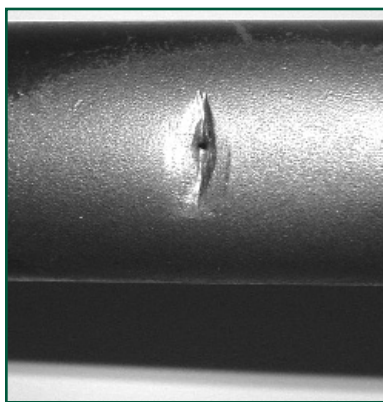
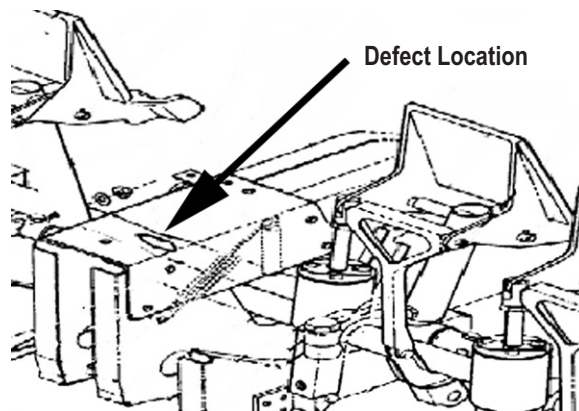
SDR #20051211002

During a 100-hour inspection of a Cessna 152, the rear rudder bar was found to have a hole worn through it on the co-pilot side.

The plastic centre console is attached to the rudder pedal covers with screws. If the screws are too long, they will wear into the rudder bar over time. This could eventually cause the rudder bar to fail causing the loss of rudder control.

This was the second identical finding on a similar airplane.

*Always ensure that correct parts are installed! ✂*

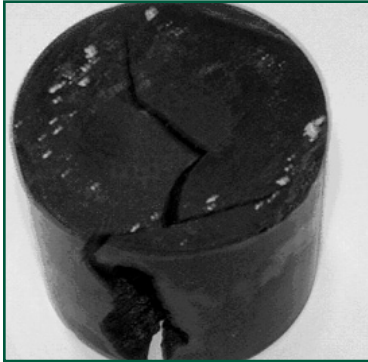
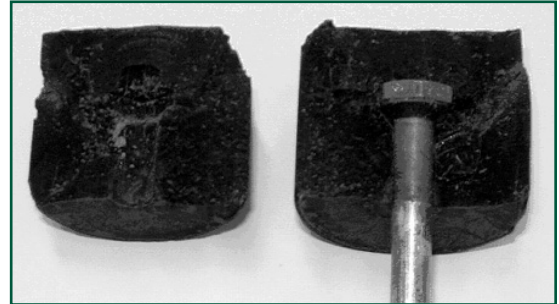
SDR # 20050602005

An abnormal amount of elevator travel was observed during flight control range of travel checks. Maintenance discovered one upper elevator stop bumper assembly was missing and the other upper elevator stop bumper assembly split. No damage was noted to the surrounding structure.

Canadian Airworthiness Directive CF-2001-08R1 indicated that a DHC-8 aircraft experienced an elevator trim problem in flight, due to a broken or missing elevator stop bumper. Investigation revealed that failure of the elevator stop bumper could lead to an elevator over-travel and damage to the elevator trailing edge if it impacts the top portion of the rudder. The damaged elevator can then jam the spring tab, which could result in reduced controllability of the aircraft. A life limit was therefore introduced for the elevator stop bumpers and revised when in-service experience indicated that the elevator stop bumpers were deteriorating prior to the original life limit.

Transport Canada has received four (4) reports of deteriorating or missing elevator stop bumpers since the issuance of this Airworthiness Directive.

Bumpers had been replaced 215 cycles earlier, and the elevator stop bumper assemblies were replaced in accordance with the Aircraft Maintenance Manual, AWL TR 2-20 and CF-2001-08.

Stay vigilant during inspection of this area for deteriorating or missing elevator stop bumpers and report any reportable Service Difficulties as per CAR 591. ✖

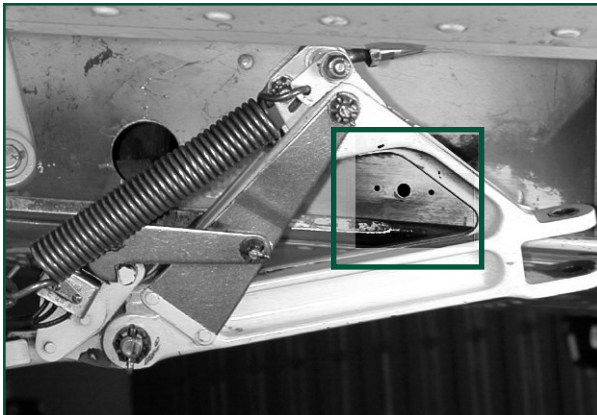
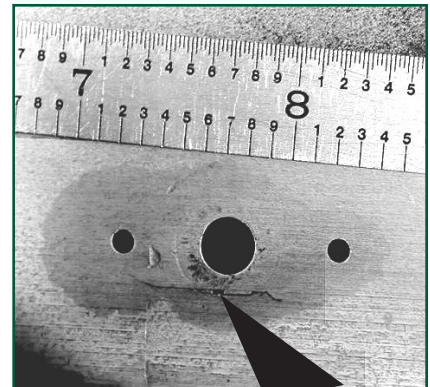
SDR # 2005123004

During scheduled maintenance, a wing main spar extrusion crack was discovered near the main landing gear sidestay support brackets on the left and right sides. The spar cracks run spanwise in the fillet radius and extend through the full thickness of the spar web. The longest crack is about 1.25" long.

These defects were initially detected through an inspection hole looking at forward side of spar web and later confirmed by removal of sidestay supports and inspection from aft side.

Maintainers should keep this in mind while inspecting this area; the sidestay brackets are the subject of Airworthiness Directive 97-01-01R1. The wing spar is a principal spanwise member in the structure of a wing and is subjected to even greater stresses during flight and landing. Cracks are thus more probable to occur at landing gear attachments on the rear spar. ✖

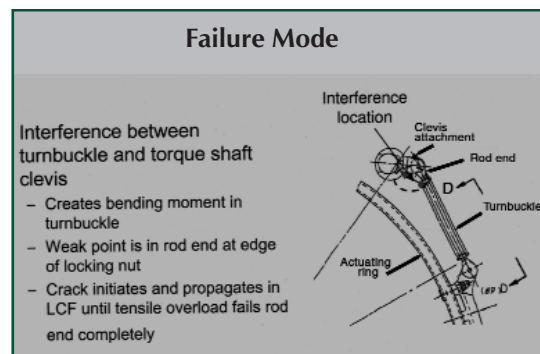
A CAR 573-accepted, European Aviation Safety Agency (EASA) 145 maintenance organization, performing maintenance on Canadian-operated engines has reported failures of three Stage 2 VG turnbuckles, affecting two engines operating in regular revenue service. The subject engines were last inspected by this AMO. The details of the failure were a separation of the VG shaft side turnbuckle rod end, with failure occurring in the threaded portion where it meets the jam nut on the turnbuckle assembly. The failure mode has been confirmed to be low cycle fatigue (LCF), resulting from a side (bending) load induced by interference of the turnbuckle assembly with the torque shaft clevis.

One of the two engines found with the broken turnbuckle condition experienced an in-flight shutdown (IFSD). The IFSD occurred because failure of both turnbuckles did not allow the HPC Stage 2 vanes to track properly.

The other engine was found with only one broken turnbuckle and thus did not result in an operational event. The VG system can work properly for some time on one turnbuckle, however if both turnbuckles fail, an IFSD can occur.

*The EASA-145 AMO (SDR submitter) has instituted specific shop procedures pending corrective action by the original equipment manufacturer (OEM). The first procedure is to inspect the Stage 2 VG turnbuckles for correct installation and replace any incorrectly installed VG turnbuckles that failed the inspection to ensure that interference will not occur.*

*Pending corrective action by the TCH, Transport Canada Civil Aviation (TCCA) recommends that operators inspect, at the first opportunity, the VG turnbuckle rigging, the safety wire methods employed and a non-interference fit between the VG turnbuckle and the torque shaft clevis. ✖*

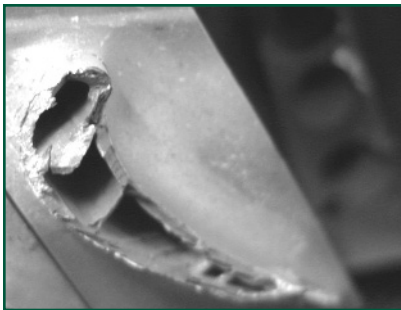
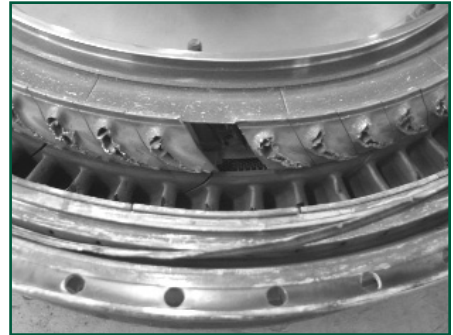
SDR # 20051125004

During flight, the crew reported an engine internal turbine temperature (ITT) over-temperature event of 1045 degrees Celsius for 36 seconds. This overheat condition resulted in an uncommanded in-flight shutdown (IFSD).

Engine disassembly at Rolls Royce revealed a number 1 (HPT) high pressure turbine blade failures, at the blade roots.

**Total Time Since New (TSN): 8 408 hrs**

Although technicians and flight crews take every precaution to prevent over-temperature of the engine, such events do occur. Often the cause of turbine over-temp is a malfunction of engine fuel control or a malfunction in the engine itself.

An SDR service history review revealed numerous reports on damaged turbines caused by exceeding the temperature limitations of the respective engines, especially during engine start-up. ✖
