TP 6980E  
(04/2007)

Issue 1/2007

Canadian Aviation Service Difficulty Reports

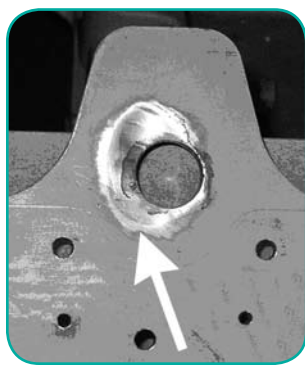
Upon visual inspection and cleaning of attachment lug area of a vertical fin to horizontal stabilizer, the technician noticed material flaking off of one bolthole area. Further inspection revealed exfoliation corrosion. Since this type of corrosion is difficult to detect visually it was only when the technician was cleaning the area that he noticed the damage.

Upon consultation with the manufacturer (Raytheon), the corrosion was removed to determine the extent of penetration and coverage (photo illustration). The penetration and coverage was determined to be out-of-tolerance and required replacement of the reinforcement plate. This was the first time the manufacturer had come across this type of discrepancy.

Especially significant was the fact that it was exfoliation corrosion and not any type of surface corrosion. The task to replace the part was extensive, requiring specialized jigs, tools and machining along with rigging checks. The job was successfully completed by a qualified service center.

Corroded (exfoliation) area blended out – Out-of-Tolerance

*Transport Canada recommends that operators and maintenance organization be cognizant of the manufacturer's Corrosion Prevention and Control Program (CPCP) and aging aircraft initiatives. ✖*

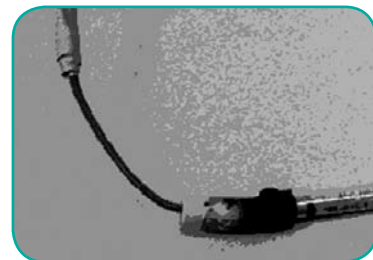
While performing the post flight inspection, an electrical burning odor was detected in the aft area of the cabin. Further inspection of the lavatory mirror vanity lights was carried out and one lamp was found to be defective. When the lamp was removed for replacement, it was noticed that one end of the lamp assembly had started to melt. With the defective lamp assembly removed it was also noted that the defective part number was incorrect. The lamp found installed was AL-845-T-279 however, lamp assembly AL-845-T-279-F should have been installed as per the Falcon 2000 IPC.

After the defective lamp assembly was removed and tested, the electrical burning smell in the cabin was no longer present.

*Extreme care must be used when installing interior or exterior lamps. The smallest deviation in part number could heat things up. ✖*

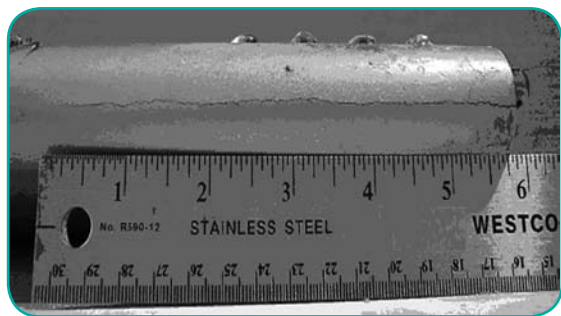
During 100-hour inspection of a DHC 2 (Beaver), six (6) inch stress cracks were found to have originated at the top forward side of the struts on the right and left rear float struts.

Time-in-service is unknown and total aircraft time is over 22,000 hours. The aircraft is operated exclusively on floats in a corrosive environment and generally adverse landing conditions.

*Most of these legacy aircraft have seen many hours of operation in a corrosive environment and rough water landings are common. The deterioration of aircraft structural elements can be greatly accelerated by the environment and undesirable landing conditions. Special attention to these legacy aircraft will keep them structurally sound and safely flying for many more years. ✖*

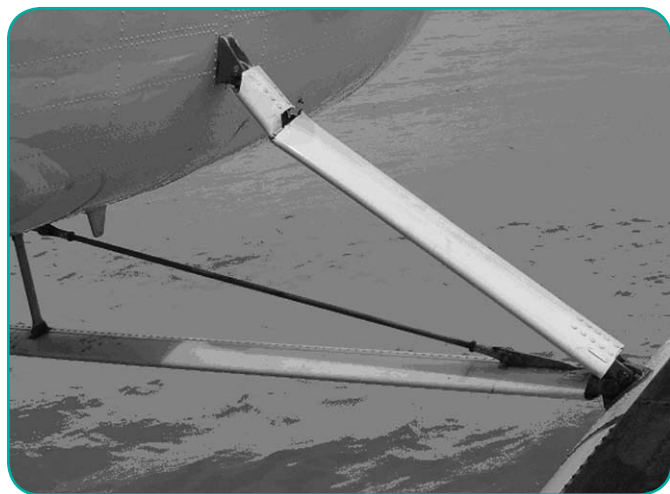
A foreign operator of a DHC-6 Twin Otter reported to the aircraft manufacturer that he landed in high waves and broke both front float struts. The aircraft taxied to the dock without incident.

A maintenance technician inspected the aircraft for other damage caused by landing in such rough water. No other damage was evident. Both front float struts were replaced and the aircraft returned to service.

*Transport Canada recommends following the manufacturers' recommended operational procedures and inspection criteria.*

*When operations require you to utilize the aircraft in extreme conditions, preventive maintenance and additional inspections may have to be considered. ✖*

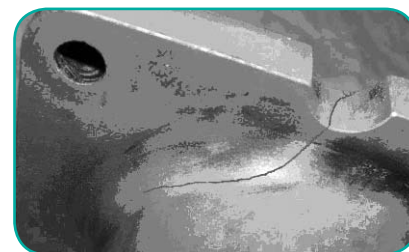
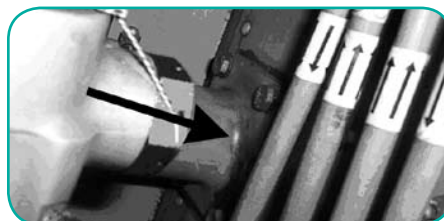
During a C-check inspection, a crack was discovered on the rudder actuator-mounting adaptor (upper) to the vertical stab spar. The crack is approximately 2.5 inches around the circumference of the adaptor tube.

*Although there is no probable cause mentioned, it is likely stress induced fatigue cracking. A thorough visual inspection*

*by the technician detected this crack and prevented subsequent failure of the mount. ✖*

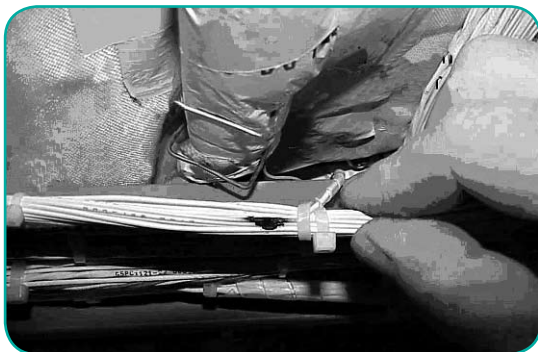
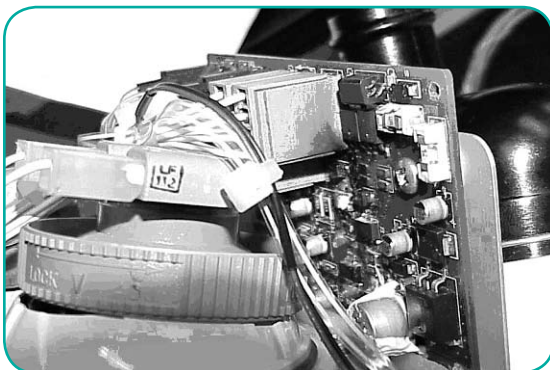
Upon arrival at the main base for overnight maintenance, flight attendants alerted maintenance personnel that a number of the passenger call button lights could not be reset. During the course of the maintenance check, it was discovered that all of the passenger service unit (PSU) control circuit boards had heat damage.

Investigation into the cause of the circuit board damage revealed that the wire on the outlet side of all of the PSU control circuit boards had chafed through the outer insulation resulting in a short circuit to ground at STN X312.35. This short circuit resulted in the outlet transistor to burn out on all PSU control circuit boards.

It is to be noted that since the aircraft was brought into service, the area of the wire chafe had not been inspected nor was it a requirement. The damaged wire was able to contact a trim support clip because the wiring bundle was incorrectly placed outside of the cable trough.

*The aircraft manufacturer has indicated that an investigation into this incident was conducted. It has been determined that the wiring bundle should have been in the wire trough provided. Also, as per the drawings, no insulation clip is located in this area.*

STN X312.35 - Wire 3322AP  
- Cable trough - Insulation retainer Clip

All aircraft cabin PSU's were replaced and the aircraft returned to operational service.

*The manufacturer is considering the addition of a fuse to prevent damage to the PSU if an electrical short in the wiring installation were to occur. ✖*

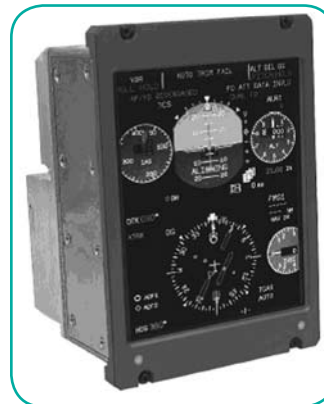
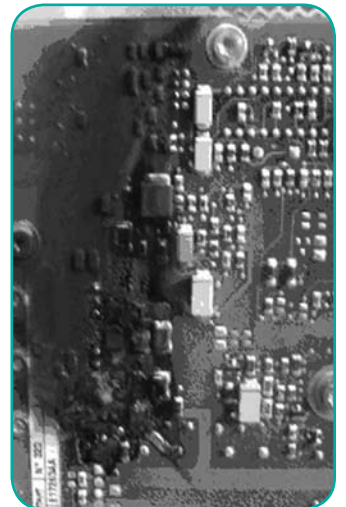
Following this incident a burning odor with no visible smoke or flames was detected. The odor was carried throughout the cabin by the re-circulation fan and detected by the flight attendants. Mechanics found evidence of soot around the cooling holes of the removed PFD.

The part was returned to the PFD manufacturer for investigation. The manufacturer reported a strong burnt smell before disassembly. When the power was turned on to the PFD unit there was high smoke emission. The root cause analysis was the short circuit on C43. This type of ceramic capacitor (C43) is no longer used on power supply module (PSM) boards.

*This SB is applicable to the Thales Avionics SMART MULTI-FUNCTION DISPLAY 6X8 (SMD68) PNR C19190AB04. The SB indicates that for each display with Serial Number below 892 equipped with PSM board Serial Number below 1531, it is recommend to exchange the PSM board by a new one with a Serial Number above 1531 (1531 included). ✖*

*Thales Avionics (manufacturer) issued a service bulletin (SB) C19190A-31-014 to inform operators of the introduction of a new technology of capacitors in the PSM board in order to prevent capacitors from breaking and causing short circuits.*

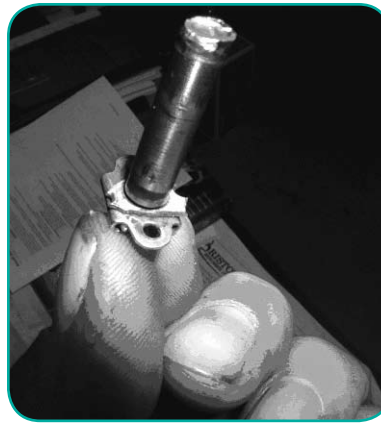
While performing an aircraft walk around, there was excessive play found at the rudder upper attachment bolt.

Further investigation discovered the upper attachment bolt had elongated the hole and also damaged the nose rib. When trying to remove the bolt, the nut plate broke away and a piece of the nose rib that was already cracked actually broke away with the nut plate. The bolt head had to be cut off to remove the rudder and the upper bearing was found damaged. The damaged rudder is now awaiting parts to facilitate a repair.

*Maintainers are reminded that movement of flight controls while performing daily checks can detect latent failures. Had this defect gone undetected, serious rudder control restrictions could have been experienced. ✖*

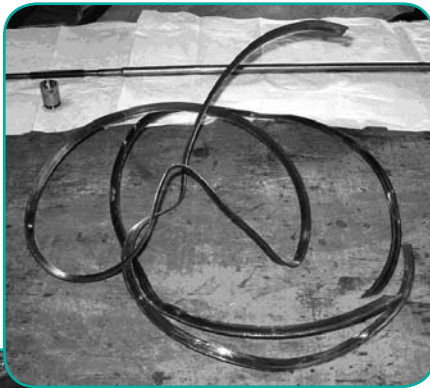
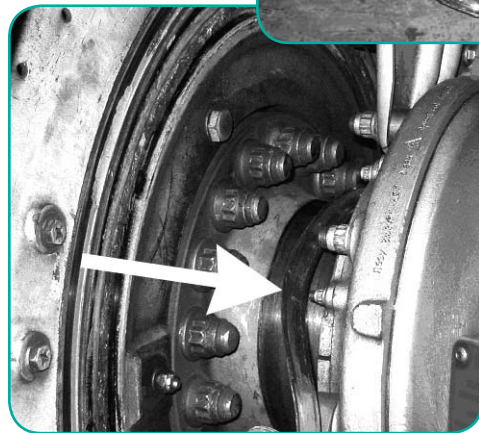
Slip Rings

Upon further investigation, maintenance personnel found that all three of the propeller brush block slip rings had separated from the propeller bulkhead and then wrapped around the propeller shaft.

The surrounding area of the engine compartment was inspected but no damage was found.

*The propeller bulkhead has been sent out for repair and a strip report. ✖*

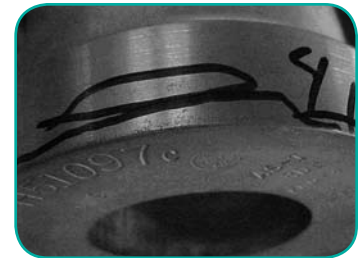
& Harland SD3-60 aircraft. Even after rework to the specified minimum dimensions, the corrosion damage was still present. It was noted that the blade width and thickness was well above minimum dimensions.

*Environmental factors may have contributed to the excessive corrosion found on the blade retention shanks. ✖*

A visual inspection revealed corrosion on the blade shanks of all the five blades that were removed from Shorts

All five propeller blades were removed from service.

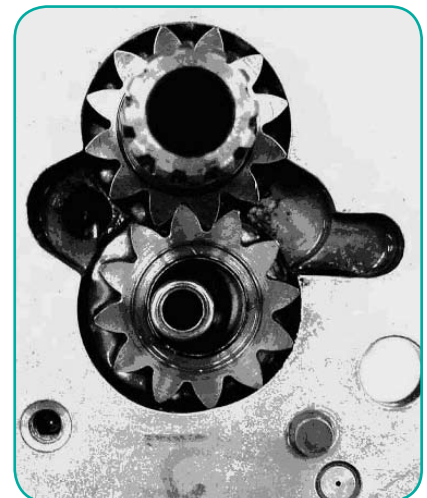
The engine was submitted for its scheduled first time overhaul. When the propeller governor 1584 hours time since new (TSN) was dismantled for cleaning before overall inspection, it was discovered that the idler gear bushing, P/N 5337050, was severely worn. The excessive bushing wear resulted in an elliptical rotation of the idler gear, which caused the gear pocket to wear in an oval manner on the pressure side.

A normal idler gear bushing measures approximately 0.100", however this worn idler gear bushing measured 0.0175". It is not known what caused this excessive bushing wear.

The periodic oil analysis did not detect any metal contamination. After discovering this condition, the maintainers were unable to rotate the

gears manually and found that the gears would stick and bind. This raised concerns that if this occurred in service, then seizure and complete loss of propeller governor oil pressure (loss of thrust) was possible.

The governor manufacturer stated that they seen a similar wear condition before on a TPE 331 engine which had a propeller governor of similar design. ✖

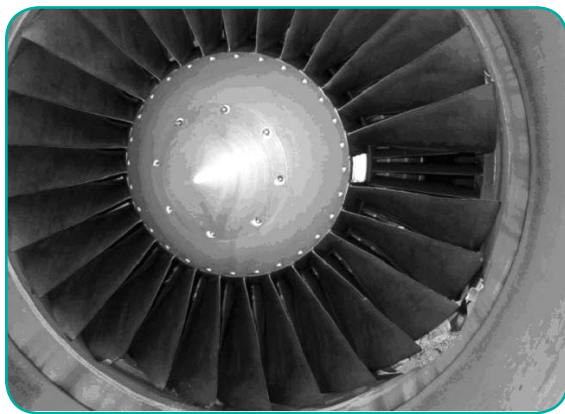
Maintenance personnel reported that one of the fan blades was missing and that the jet pipe appeared burnt and cracked.

The General Electric field service representative observed that one fan blade and the outboard fan cowlings was missing. Two (2) small punctures were noted in the fan containment case as well as damage to the bolts that connect the LP Turbine and HP Turbine flanges. Fire damage to the exhaust nozzle was evident.

*Shortly after this event, the engine manufacturer issued an All Operator's Wire CF34-06-07 related to this event. Investigation is ongoing at this time to determine the cause of failure of the #11 fan blade. ✖*

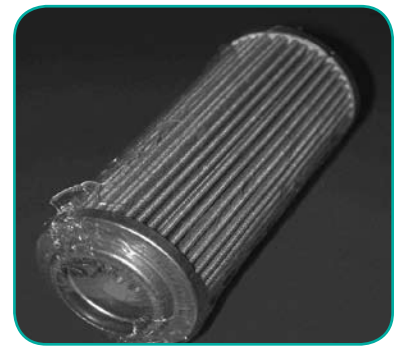
The engine-driven fuel pump filter was replaced with a new PMA filter which was pre-packaged in plastic wrap. This particular PMA filter has an opening at one end and is sealed at the other end. The installer used his finger to remove the plastic wrapping, however a piece of plastic inadvertently got pushed up inside the fuel filter.

The SDR submitter stated that the Purolator airframe fuel filters are also wrapped in this fashion. The main difference is that the airframe fuel filter is open at both ends allowing pieces of plastic to fall through it. Maintainers must be aware of this problem and ensure that filters are free of contaminants prior to installation.

*Transport Canada Civil Aviation concurs with the SDR submitter's recommendation that maintainers ensure that filters are clear of contaminants. Always double-check before installing parts. ✖*

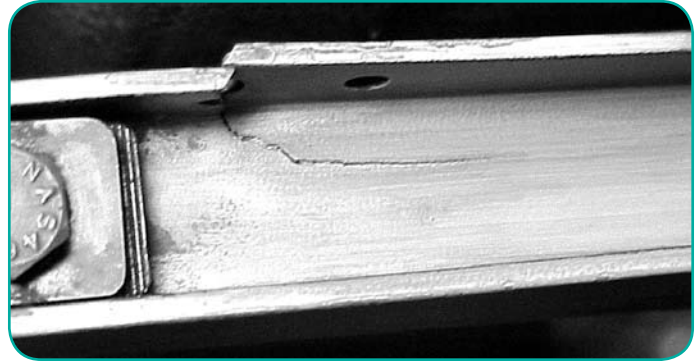
While carrying out an inspection on the engine thrust reverser system, the AME visually detected a significant crack on the LH lower thrust reverser track.

*The cause of the thrust reverser crack is likely due to time in service. ✖*
