Transport
Canada

TP 6980E
(12/2007)

Issue 2/2007

Canadian Aviation Service Difficulty Reports

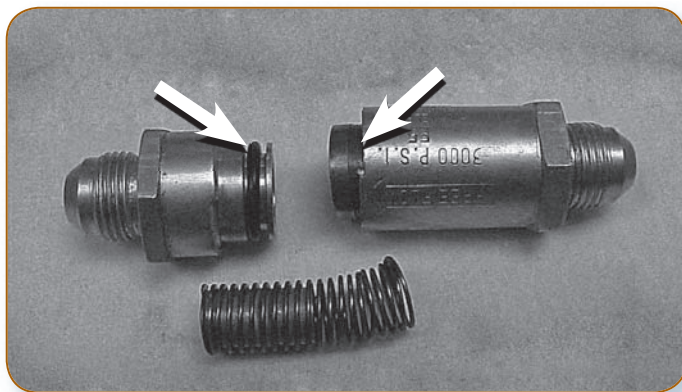
After troubleshooting the system, the one-way check valve in the main pressure line at wing station 54, on the right wing leading edge was found defective. This check valve prevents hydraulic fluid pressure from flowing back to the engine driven pump when using the ground test equipment or the auxiliary hydraulic pump.

The check valve housing is constructed of aluminum. After receiving reports of failure of this check valve, Bombardier (Canadair) produced service bulletin (SB) 215-0466 (stainless steel check valves) to rectify this problem.

Failure of Valve in this location

Transport Canada highly recommends operators incorporate SB 215-0466 at the earliest convenience. There are two check valves per aircraft.

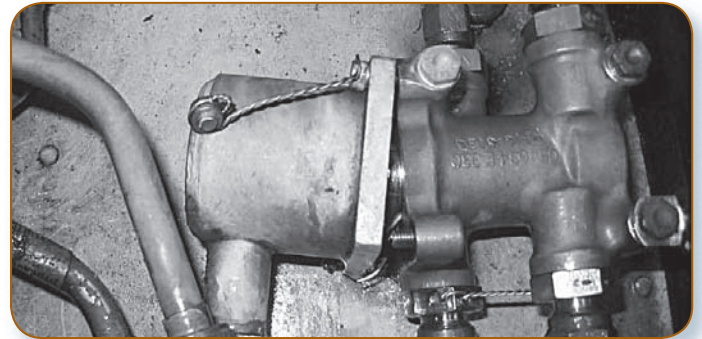
Upon retraction of the landing gear the crew heard a strange noise followed by hydraulic fluid quantity loss in the No. 2 system. The crew carried out the applicable procedures to extend the landing gear but was not able to get the nose landing gear to extend. The crew flew the aircraft for several hours to burn off fuel while trying to extend the nose gear. Their efforts were unsuccessful and the crew completed a nose gear retracted landing on a snow packed

runway. The aircraft was subsequently damaged in the nose landing gear door and radome areas.

Upon initial investigation by maintenance it was found that the left hand main landing gear door sequencing solenoid valve was ruptured causing the loss of the No.2 hydraulic system fluid. It is not known at this time why the nose gear would not extend in the alternate extension mode. An investigation to determine the cause is on going.

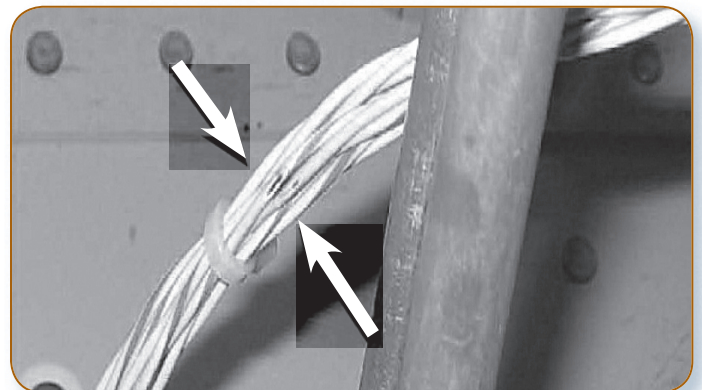
Left (L/H) fuel quantity caution light illuminated during descent. Fault code indicated that probe No. 3 Part Number 66082813 was defective. Further investigation revealed that the wiring in L/H tank had chafed in two (2) places (WS 116.0), on top of fuel pilot valve line. The harness assembly was not secured properly.

No chafing was found in R/H fuel tank, but the wire bundle was also found unsecured.

Checking the wires inside the tank for chafing prevented the AME from re-opening the tank after the aircraft was refueled.

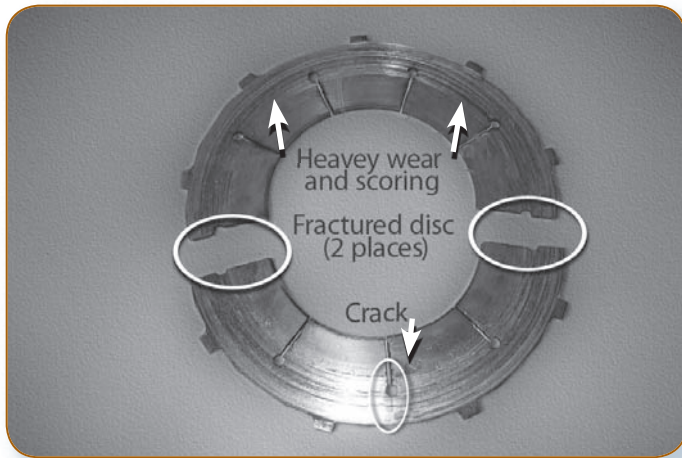
During a maintenance check (B4), the No. 1 tire was removed to service the wheel bearings when a piece of the brake disc fell from the brake unit. The brake unit was removed and a serviceable one was installed.

Upon investigation of the unit it has been determined that a brake adjuster had seized resulting in the brake disc sitting at an angle instead of at 90 degrees to the axle line. This resulting force caused stress to be placed on the disc causing it to fracture. This also caused the brake pucks to score and damage disc face.

Continue with reporting any discrepancies as per CAR 591 to assist Transport Canada in identifying any specific trends.

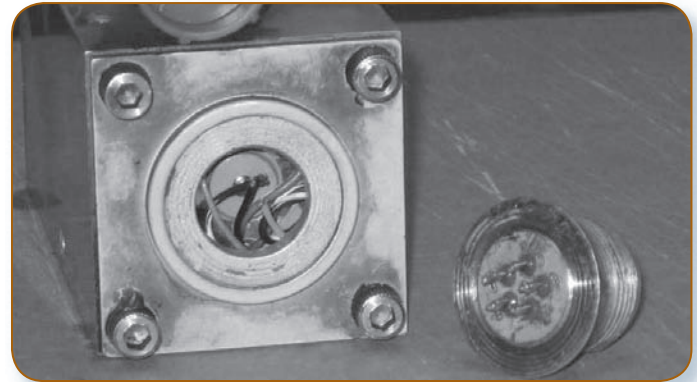
aircrew reported that the snag was still present. Maintenance began investigating deeper and found the No.1 fuel flow transmitter canon plug boss separated from the main body. This allowed the wires to contact the housing during flight due to normal vibrations, shorting out the transmitter. This component has been installed on the aircraft since 2001. A new transmitter was installed and aircraft released serviceable.

The fuel flow transmitter canon plug may have been previously over tightened, which may have contributed to the failure of the unit.

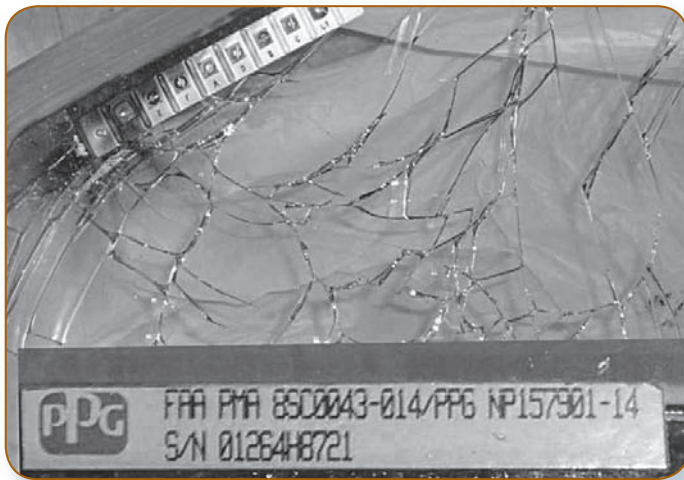
During flight, smoke and flames starting coming from the top of First Officer's windscreen. Seconds later windscreen showed several cracks. Technicians replaced terminal end L2, which was found burned, and replaced the affected windshield.

Investigation by PPG Aerospace and Bombardier Aerospace indicates that the most probable cause for these events is poor connections between the aircraft wiring and the windshield heater terminal block.

To prevent further occurrences, changes are in the process of being introduced to the Aircraft Maintenance Manual to provide torque limits for the windshield heater terminal block screws. A special note will be added to highlight the importance of this torque limitation. If the L1 and L2 power wires are not secured and torqued correctly, arcing of the heating element can occur and may result in a windshield crack. In addition, Zonal Inspection Task 211 is being revised to include a note advising technicians to pay particular attention to the windshield heater terminal blocks for signs of overheating. The terminal cover should be removed to inspect the wiring going to terminals, and it should be ensured that they are secure and not showing any visible signs of overheating/discoloration.

As a precautionary action, operators may wish to inspect the windshield heater terminal block connections for security and condition. The MS51957-26 screws at sensor terminals CB, DA or FE should be torqued to 15 to 20 lb-in. (1.69 to 2.26 Nm). The MS51958-59 screws at the power and return terminals L1 and L2 should be torqued to 20 to 25 lb-in. (2.26 to 2.83 Nm). After torquing, the screws should be witness-marked or identified clearly (ref. AMM 20-14-01, Torque Procedure and Identification of Fasteners - Maintenance Practices).

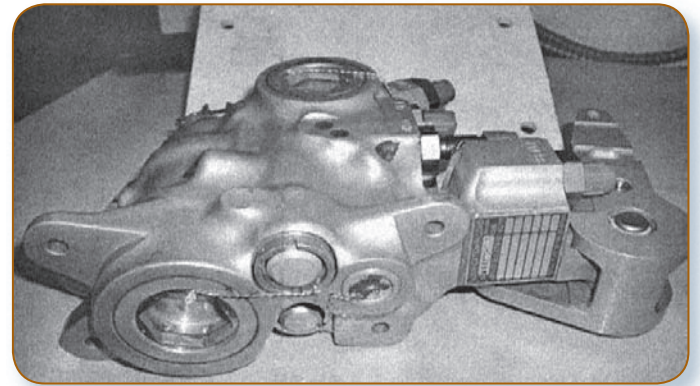
While doing a pre-flight walk around the pilot noticed hydraulic fluid dripping from the right hand flap track No. 3 fairing. The leak was found to be coming from the outboard roll spoiler actuator. Upon removal of the actuator it was found that the housing had cracked in the area surrounding one of the plugs causing the plug to dislodge. The crack extended around the entire circumference of the threaded portion of the actuator body where the plug is threaded in. The actuator was replaced and the aircraft returned to service.

The crack in the actuator body extended around the entire circumference of the plug causing it to dislodge. Only the safety wire was holding the plug.

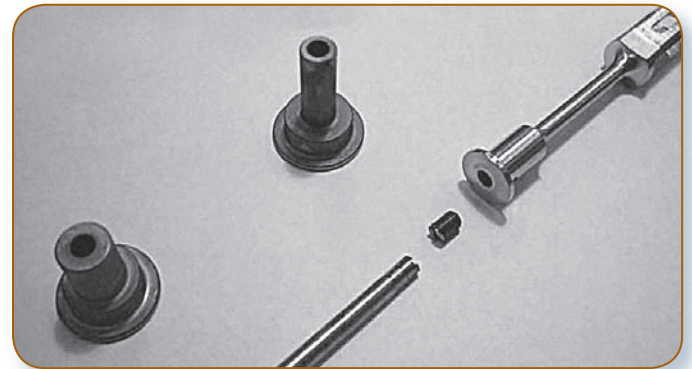
Following disassembly in the overhaul shop, the shaft was found broken at the shaft rivet hole area (P/N MS204170AD3). It appears that the size of the rivet hole leaves minimum material around the shaft and therefore weakens the shaft.

The Type Certificate Holder (TCH) conducted an investigation and determined that the spring strut shaft fractured in 2 places due to low load, high cycle fatigue. One fracture occurred at a rivet hole and the other at the thread base.

In spite of the low fracture rate of the spring strut shaft; the TCH will proceed with product improvement modification to change the shaft to a more fatigue resistant material. The rivet hole size will be reduced and the shaft fork end dimension will be increased.

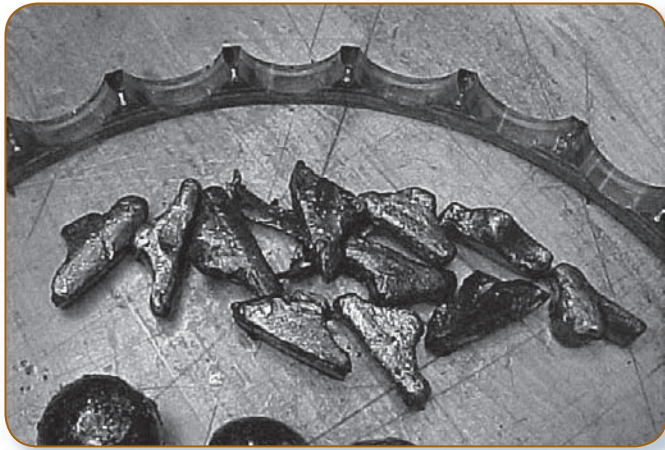
Engine teardown investigation revealed that No. 4 ball bearing failed. This bearing is the thrust bearing for the N2 rotor and supports the compressor to the turbine shaft.

Ball bearings are commonly used for thrust bearings on gas turbine engines. Bearings designed to resist thrust in a particular direction will have a heavier race design on the side that takes the thrust. When installing this type of bearing always ensure that the correct side is towards the thrust load.

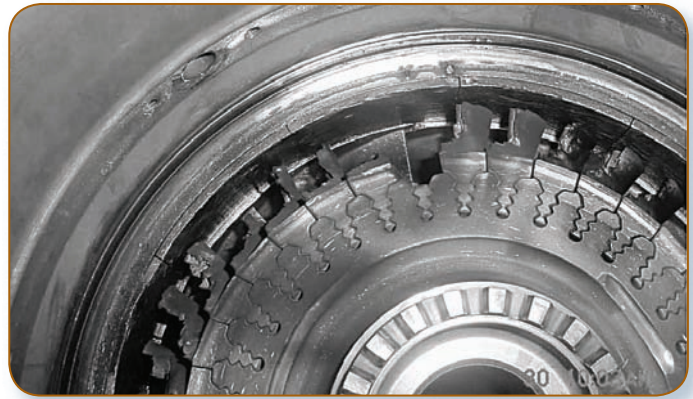
Engine teardown investigation revealed that a 1st stage turbine wheel blade had fractured at the blade root. The time on the blades is 350 hours / 478 cycles since installation at the previous inspection by the engine OEM.

The engine OEM is still investigating the root cause of the fractured turbine blade.

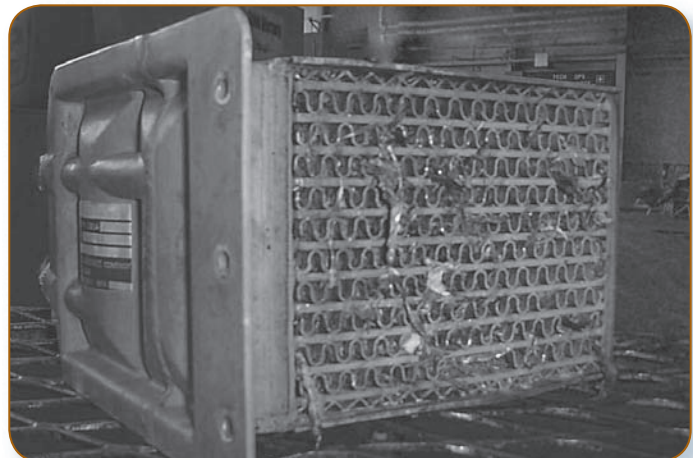
The aircraft returned to originating departure airport and carried out an uneventful landing. Maintenance personnel observed that several of the No. 1 engine fan blades were damaged and bird remains were found on the oil cooler.

Bird strikes especially on takeoff during high power engine demands are always dangerous.

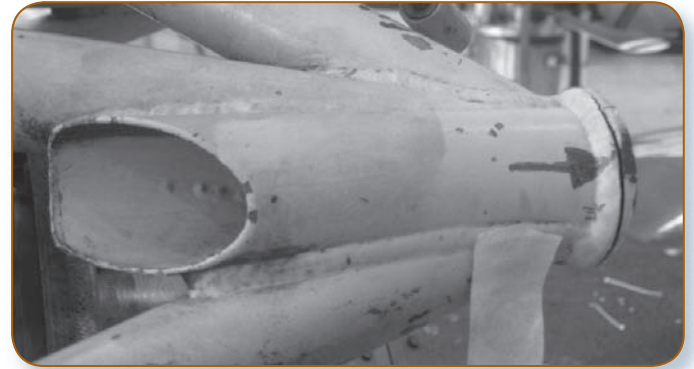
Further investigation revealed that the lower spar cap had a splice repair from a previous operator that was not in accordance with the Structural Repair Manual (SRM). Additionally, not all the requirements of manufacturer's Service Bulletin (SB) 409 (Flap Panel Rivet Spacing)

had been fully complied with. In particular, the flap panel replacement material was found to be 2024 and not 7075 material that is specified in the SRM. It appears that the flap panel section had separated at the unapproved splice repair.
