Transport
Canada

TP 6980E
(02/2009)

Issue 1/2009

Canadian Aviation Service Difficulty Reports

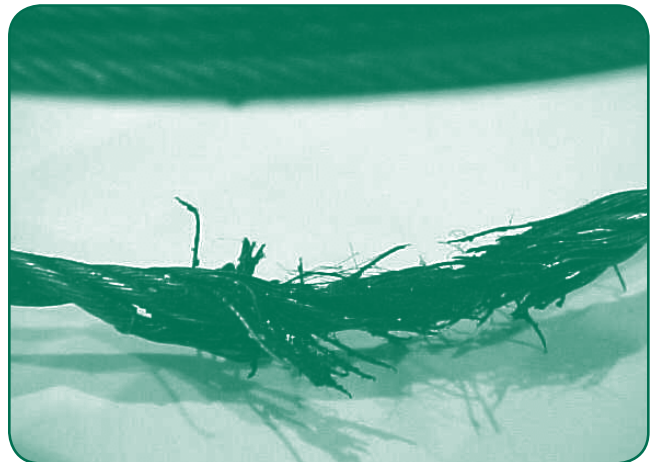
Following flight, a DHC 8 100 operator reported that the aileron controls were stiff (outside air temperature of -20 Celsius). Inspection of the aileron control system revealed a significantly frayed cable at WS 189. Closer examination revealed that 47 strands of cable were broken at a position where the cable crosses a roller fairlead, which was also found to have a seized (sealed) bearing. Both the L/H and R/H aileron quadrants were found to be very stiff and subsequently replaced, along with the defective roller fairlead bearing. The aileron control system is inspected every second C Check or 10,000 hours, which was carried out 7618 hours ago.

Another recent SDR, submitted by a DHC 8 300 operator, who reported that both the L/H and R/H aileron cables were found severely chafed with numerous cable strands completely severed at wing station (WS) 171. The aileron cables are carbon steel and Type 19 X 7 (7 strands with 19 wires on each strand). The L/H cable had approximately 40% of the cable strands frayed. This aircraft had logged some 16000 airframe hours since new. The Type Certificate Holder (TCH) investigated further and noted that cold weather can cause drag on all bearings and pulleys. It was also concluded that these broken cable strands were caused by wear as evidenced by a pointed sharp edge at the strand break location. The cables were found correctly tensioned to 52 pounds; however, an increase of 20% cable tension is recommended for these cold weather operators. An increase in cable tension would provide more positive contact against the aileron pulleys and fairleads and provide more responsive movement from the flight controls.

The principal function of flight control fairleads is to dampen vibration, maintain cable alignment and seal the openings in bulkheads. Deflection of flight control cables in excess of 3 degrees is undesirable. Ideally, a properly rigged airplane will fly straight and level "hands off" at its normal cruising speed. If air currents disturb the stable flight attitude, the aircraft should correct itself, and resume straight and level flight.

During a cable inspection, a cloth or rag should be used to clean accumulated debris from the cable and to catch any frayed cable strands. ✖

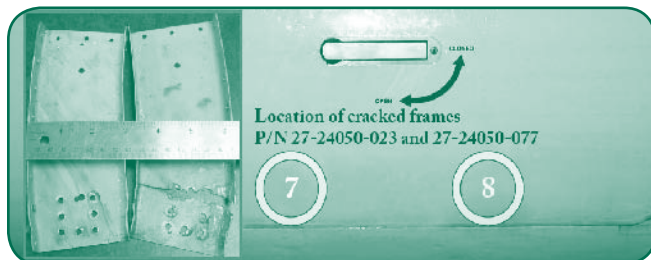
Aging Aircraft, a Great Reason to Look for Cracks

During an aging aircraft inspection, a crack was detected, visually extending from the lower aft latch (position 8). When the door was removed for repair, further cracks were discovered on the attaching structure for both lower latches (positions 7 and 8).

This failure is believed to be the result of fatigue and if undetected could eventually result in failure of the cargo door. It should also be noted that FAA airworthiness directive (AD) 98-06-25 requires an inspection of the latching system.

Loss of a cargo door could be catastrophic. Ensure your inspections are thorough. ✖

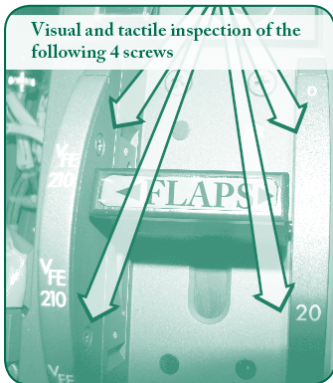
Make Sure your Screws aren't Loose

After takeoff, the crew reported they were unable to retract the flaps from the 10 degree position to the 0 degree position. The preliminary report states that a loose screw was found inside the flap lever guard. The forward right screw located inside the guard was found to be protruding sufficiently to prevent the lever from moving from the 10 degree position to the 0 degree position. All three remaining screws were found to be secure.

A visual and tactile inspection should be performed to ensure that all four (4) screws located inside the flap lever guard are slightly countersunk and do not show any signs of being loose. ✖

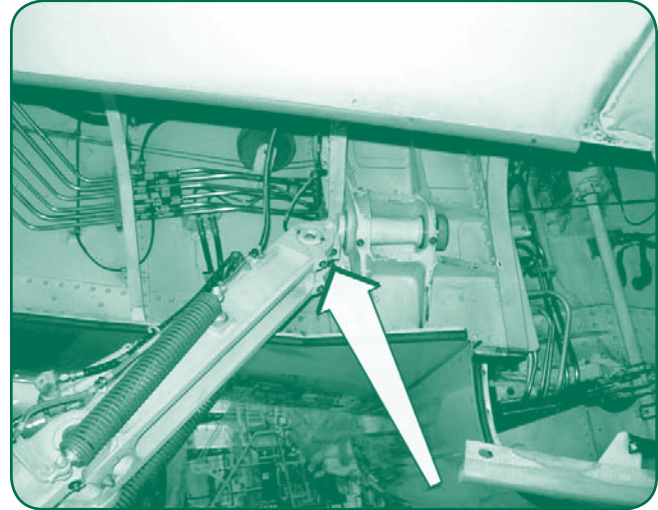
On visual inspection during a C2 check, maintenance found a crank bolt assy bushing on the L/H main gear to have signs of rotation. Both bushings were replaced.

This may be a difficult area to inspect. Be vigilant in areas where grease may hide defects. ✖

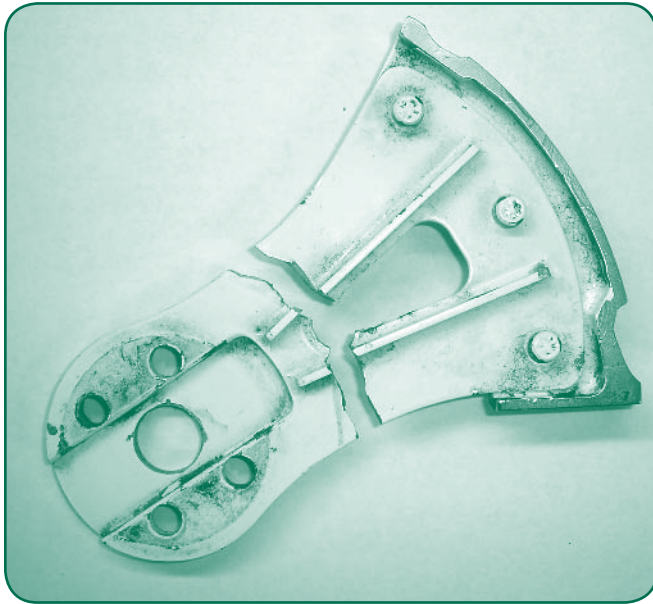
Pilot reported that the service door message was displayed. Maintenance personnel were called to investigate the problem. The engineer could not open the door and started removing the door liner. Once removed, they found that the service door up-lock mechanism had broken completely. By looking at the material inside the crack it was noticed there were signs of dirt accumulation in different areas indicating that the crack was not recent.

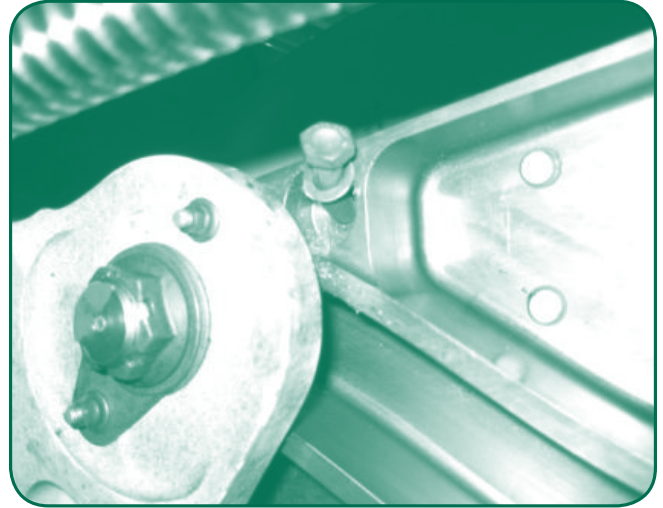
L/H Inboard Flap Main 1 Carriage Assy

L/H inboard flap main 1 carriage assy (Part Number (P/N) 190-92001-405) was found grooved on the inside by a loose bolt from the track assy. Embraer advised that the root cause of the damage was caused by a loose bolt in the flap track mechanism.

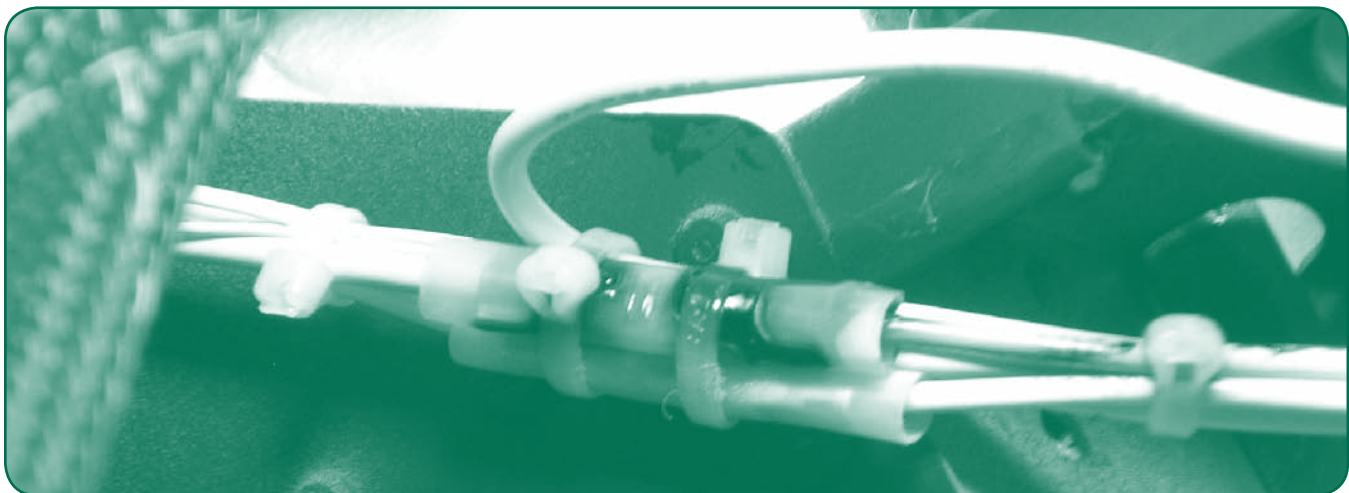
During an unrelated installation of a sat phone system, an amp type splice in the existing aircraft wiring was discovered burnt and discolored. Further inspection indicated that the wiring was for the windshield heat system. Wire No. 1H81A12 was also discolored and burnt; there were no indications of burning in the surrounding area. The burnt splice was found poorly crimped to the wire. When the wire was untied for

repair it fell out of the splice. The adjacent splice was damaged and required replacement. A further inspection found all four splices were improperly crimped. The remainder of the windshield heat wiring inspection was completed and no faults found.

This was a new delivery aircraft with 19 airframe hours. Undetected, this eventually would have become a defect for the windshield heat system resulting in expensive downtime. ✖

The wires 1H83A12, 1H85A12, 1H80B12, 1H81A12 and splices were all replaced and a function test of the windshield heat system completed.

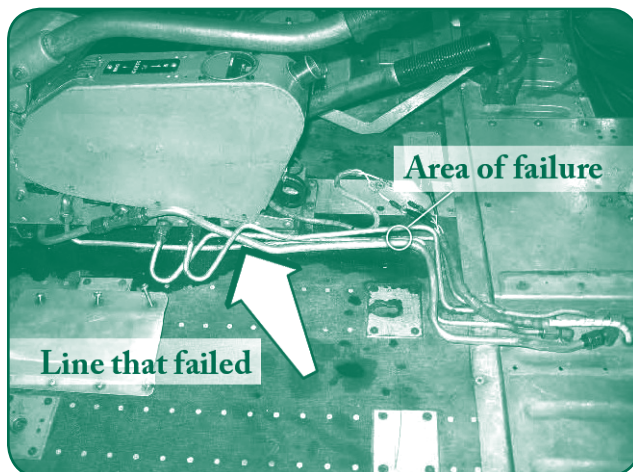
Flash Fire in Cockpit

A turbo beaver was conducting pre-taxi checks in preparation for takeoff when suddenly the hydraulic pump supply line located in the cockpit centre console area developed a pin-hole leak and sprayed atomized hydraulic fluid into the pilot's seat area.

The electrical power wire for the hydraulic pump had arced against the tubing and ignited the atomized hydraulic mist starting a flash fire. Fortunately, the fireball was unable to sustain itself and did not ignite the whole aircraft. The pilot's upper body suffered 1st and 2nd degree burns to his face and right hand. A crewmember who was sitting in the L/H seat did not receive any injuries, thus he was able to extinguish the fire, possibly saving the pilot's life. There was the potential for a more serious event as the aircraft was carrying two drums of fuel at the time of this event.

The SDR submitter stated that the hydraulic system configuration has been in the aircraft since the date of manufacture, but does not match routing shown in the IPC. After a thorough records search (since manufacture) the SDR submitter was unable to find any mention of the lines being replaced or installed. The operator has been in possession of the aircraft since the early 1900's and has never modified or changed the set-up it arrived with.

Subsequently, the operator replaced the affected hydraulic lines in the cabin and installed a fire sleeve to help prevent a reoccurrence. The electrical wire connections were inspected and protected as required.

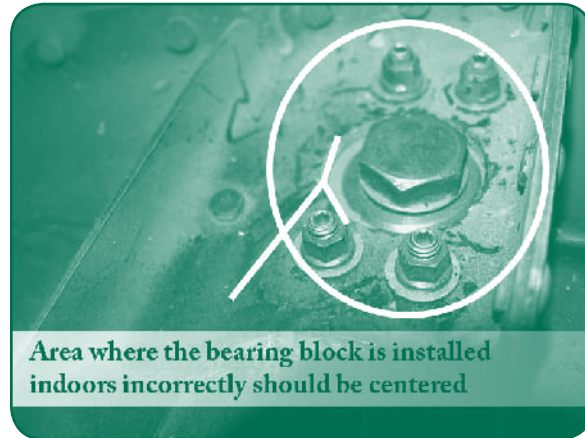
During an inspection on this aircraft, it was discovered that the L/H inboard chord-wise flap rod was rubbing against the span-wise rod. Once the assembly was removed from the aircraft, it was noted that the span-wise rod had a groove worn in it from the other rod. At this time, it was noted that the bellcrank support structure was possibly not situated correctly leading to a lack of clearance between the 2 rods. The defective flap rod was replaced.

Both the “re-lifed wing” assemblies were sent back to the supplier. It was then discovered that the bearing blocks for the bellcrank were not installed correctly thereby causing the chordwise rod to move up slightly when the flaps were deployed.

The bearing blocks were replaced and the aircraft was returned to service.

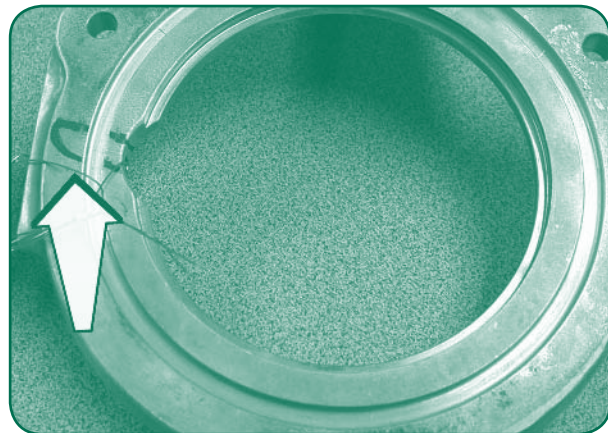
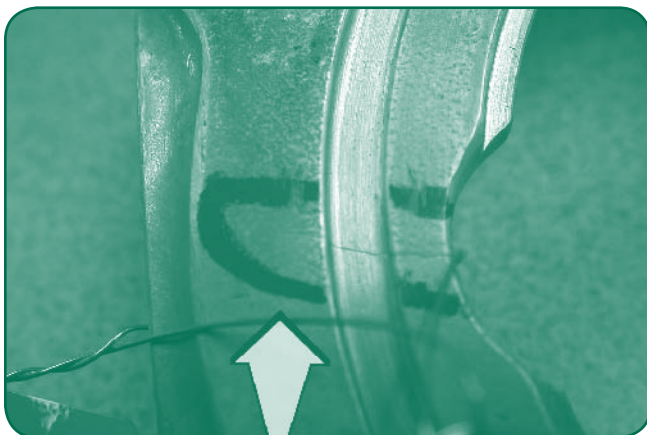
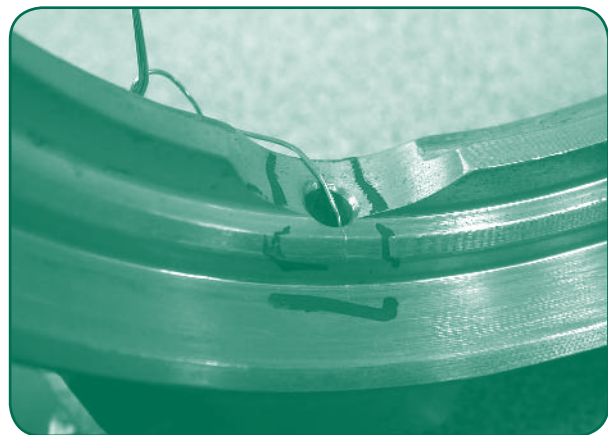
Cracked Pitch Horn Grip

A crack can be seen on the inside of the pitch horn leading from the seal-seating surface to the grip-mating surface. On the inner side where the hole for the relief valve is, the crack is about 1/8 of an inch above the corner where the seal seats all the way through.

The crack can be seen on the inside of the relief valve hole also.

Although this defect was discovered during overhaul, it should be kept in mind while inspecting the hubs in service. ✖

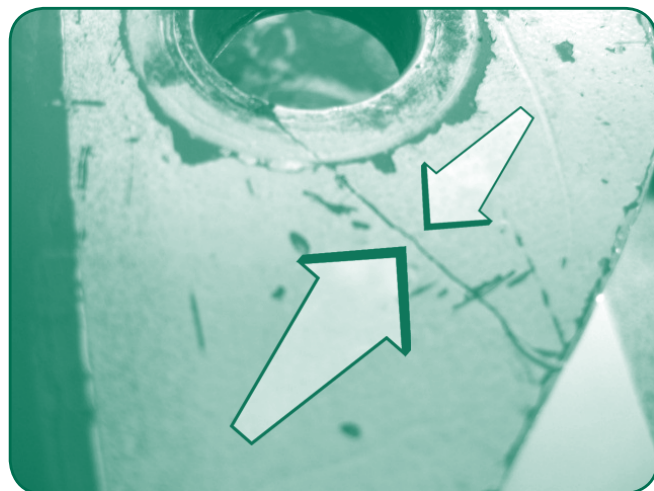
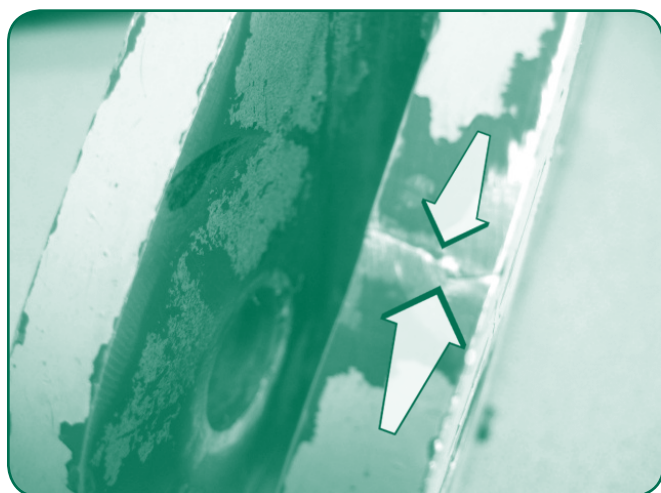
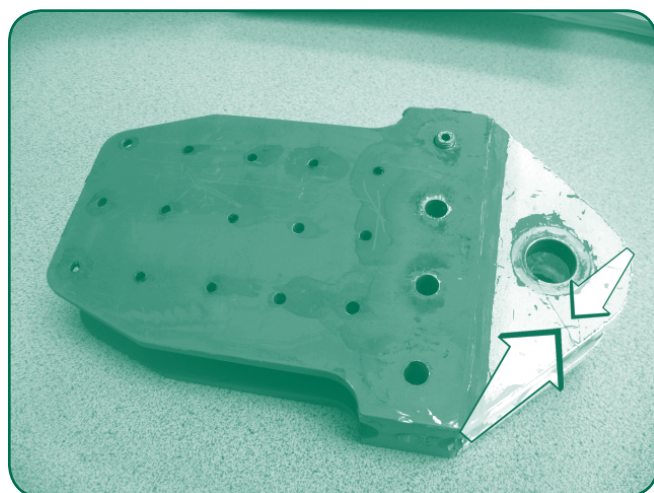
While conducting a 25-hour inspection, a crack was noted on the lift link beam lug. The part was removed and total time of the beam is unknown at this time. The crack was found on the aft ear of the lug on the R/H side.

The SDR database revealed numerous SDRs reporting this defect. Due to the location of the lift link, extra attention is required during inspection. ✖

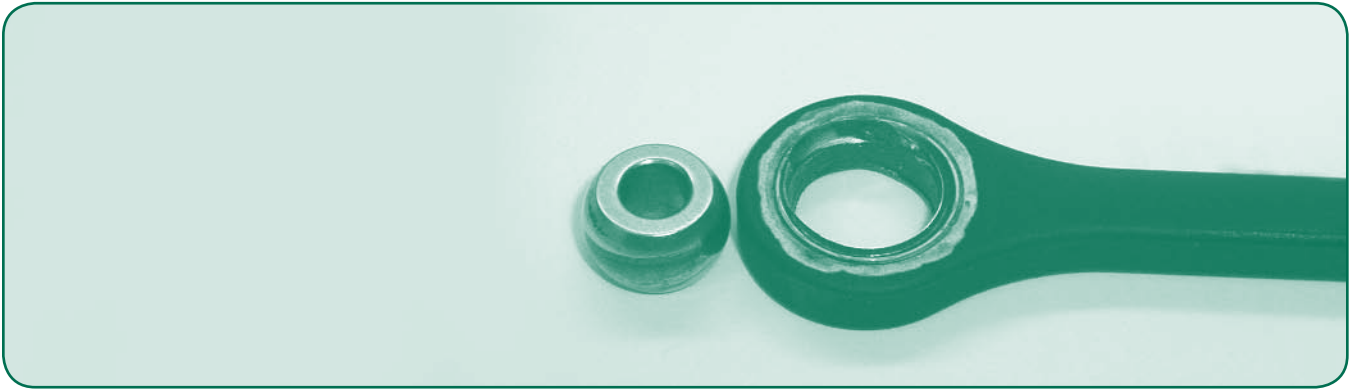
Tail Rotor Pitch

The pitch change rod end-bearing ball was found separated from the pitch link. The pilot reported that the tail rotor felt different upon landing, the pilot conducting a post flight inspection discovered the defect. An AME was dispatched to attend to the problem. Both pitch change rods were replaced and the helicopter was returned to service.

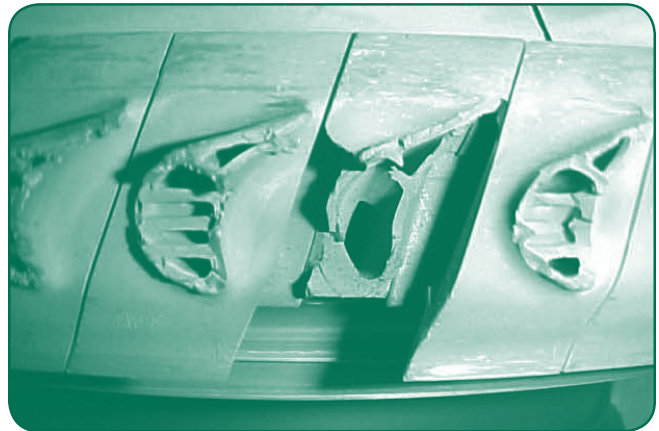
There have been recent SDRs reporting the release of HPT Stage 1 blade(s). The blade(s) fractured beneath the inner blade platform. In several cases, replacement HPT blades were installed during the last shop visit in accordance with manufacturers Service Bulletin (SB) 72-101467 to upgrade to the latest turbine blade (BR700-715 series).

Rolls Royce is pro-actively addressing the engines at risk for the replacement of the HP1 turbine blades and is currently investigating all SDR reports to establish root cause of these blade fractures. Recently, Rolls Royce issued Worldwide Communication WW/20199/4/20 December 2007, addressed to All BR 715 operators.

Pending identification of root cause by the manufacturer, Transport Canada recommends that operators comply with the most recent Rolls Royce Service Bulletins. ✕

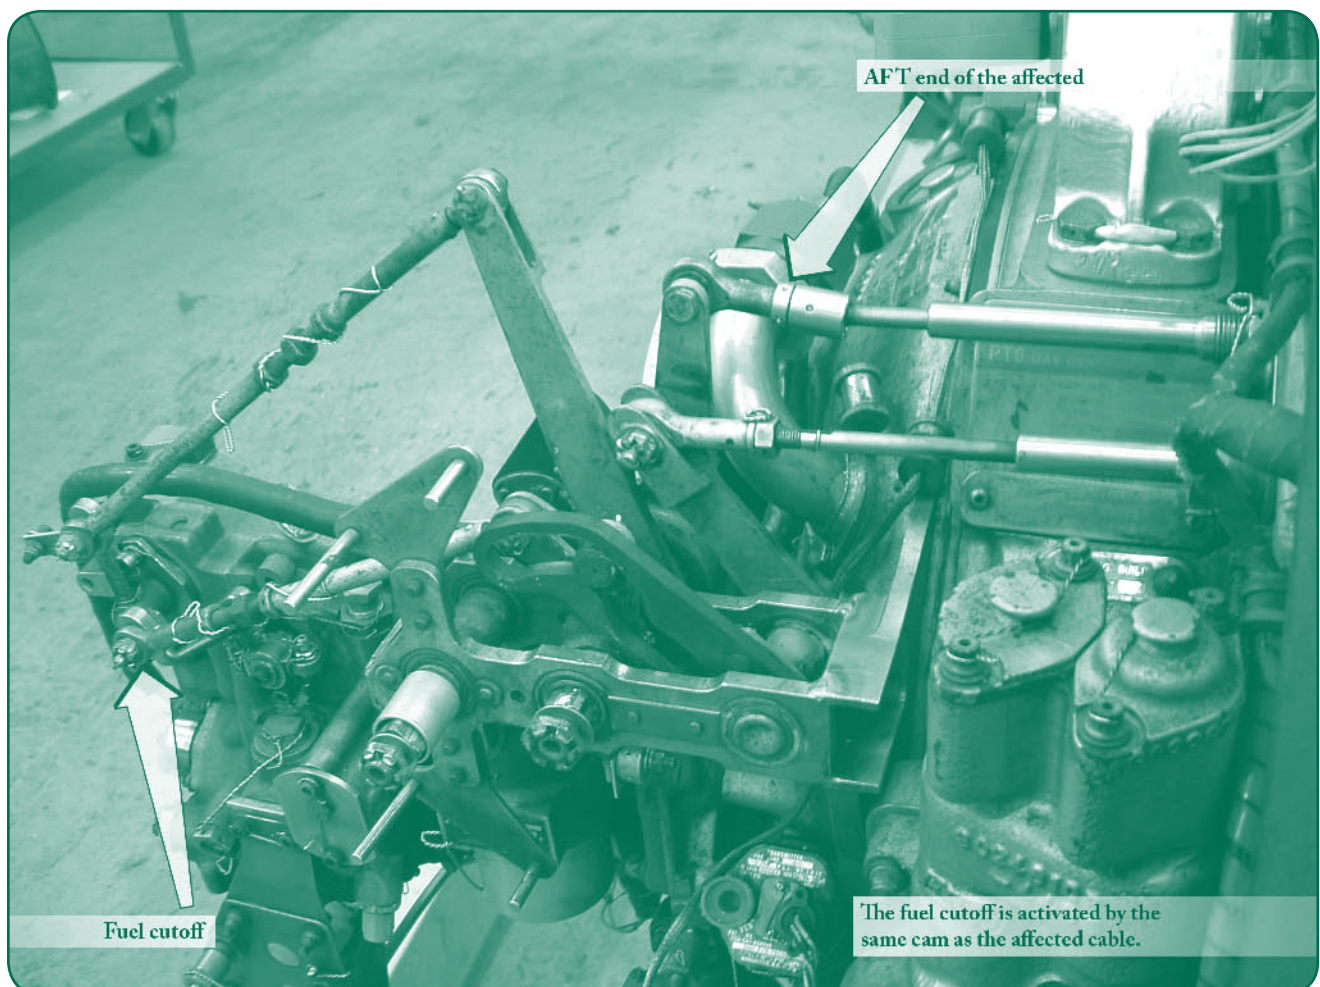
While carrying out a post flight shutdown, the No. 2 Condition Lever would not feather the propeller or shut off the fuel supply (via a cam mechanism) to the subject engine. As a result, the emergency shutdown “T” handle had to be used. Further investigation revealed the No. 2 Teleflex cable had become unscrewed near the bearing. The operator was unaware that the cable could become unscrewed at this location, as there is no visual indication (lockwire or witness paint). Another aircraft in the operator’s fleet was also found to have a partially unscrewed Teleflex cable.

The Teleflex cable controls the positions of the propeller governor and the engine fuel cutoff. The propeller governor is initiated first, and then through a cam mechanism before the fuel cutoff is initiated.

Unfortunately, human factors were the primary cause of this event. ✖

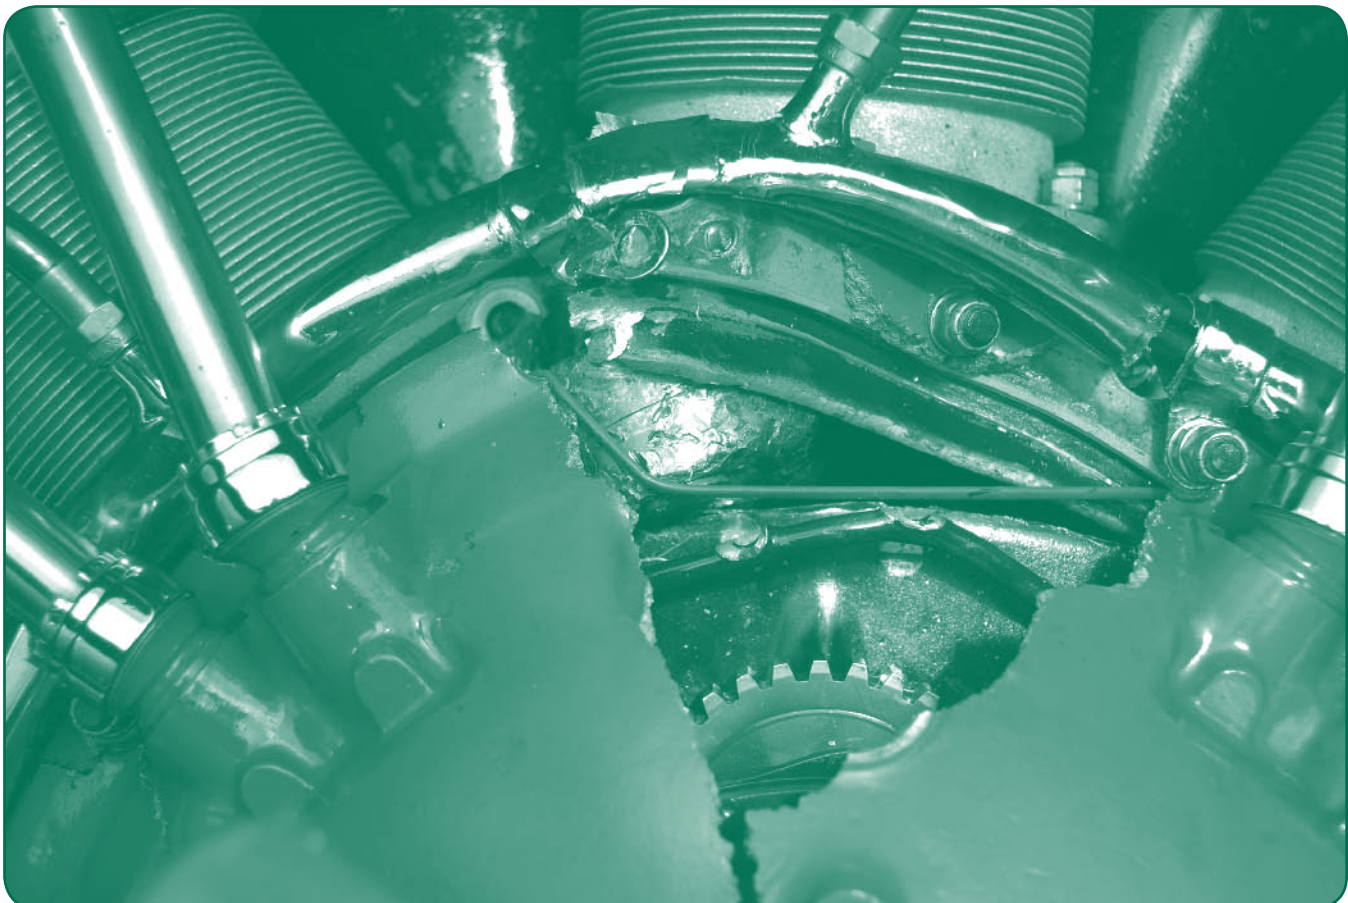
Crankshaft Counterweight Engine Failure

In the process of dismantling the failed engine, the AME discovered a large portion of the crankshaft forward counterweight had broken free and was lying in the cavity of No. 1 cylinder. It appeared that the failed counterweight then took out both No. 1 & 2 cylinders causing the abrupt engine stoppage and severe internal engine damage.

The engine was sent to the Transportation Safety Board of Canada (TSB) to determine the root cause of the failure. Because of severe internal damage, the engine had to be sawed into several sections before investigation was possible. Initial visual examination revealed that the forward counterweight assembly had separated from its crankcheek. The liberated counterweight caused severe and extensive damage to the cylinder skirts, connecting rods, pistons and crankcase. The No. 1 cylinder assembly had completely separated from the crankcase. Pounding damage from interaction between the rotating crankshaft and the separated counterweight had so deformed the front section of the crankcase that the screw heads from the rocker oil manifold were imprinted onto the crankcase.

Further investigation of the failed crankcheek revealed that it had fractured as a result of fatigue cracking, beginning at a drilled rivet hole that retains the counterweight to the crankcheek. It was determined that this fatigue crack (low stress/high cycle) was in existence for an extensive

period of time; long before the last time between overhauls TBO (250 hours ago). Evidence revealed that the rivet hole had been drilled with a dull drill bit during the initial manufacturing process. The rough edges had eventually created a stress riser leading to a fracture, which did not occur until many years later.

The design of this crankshaft makes crack detection on the specific crankshaft cheek rivet bore extremely difficult. Magnetic Particle Inspection (MPI) will almost certainly not detect cracks in this case, because the origin area in question is hidden by the inner and outer pieces of counterweight material. Ultrasonic inspection may be an option if an approved procedure were developed that would reliably detect cracks in the subject area. Alternatively, disassembly of the front counterweight assembly would be necessary to reliably inspect for cracks initiating from the rivet bore in crankshaft cheek, but may not be practical or may introduce new issues upon reassembly. It is now clear that it would be impossible to properly carry out an MPI inspection in this area. ✖
