## AVIATION INVESTIGATION REPORT

A09Q0065

### COLLISION WITH CABLE - SINKING IN WATER

AIR RICHELIEU 1990  
CESSNA 150L C-GJAE  
SAINT-LOUIS, QUEBEC  
04 MAY 2009

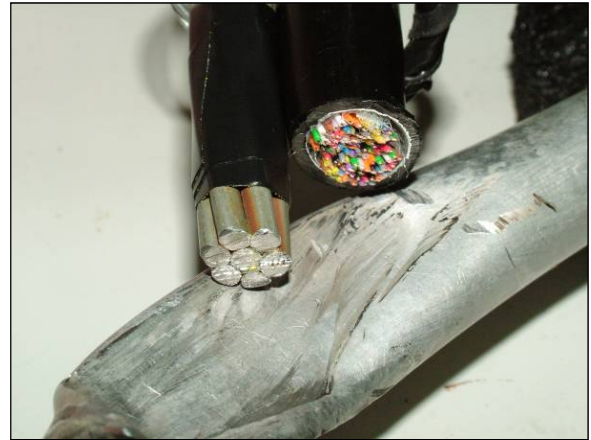
Impact marks and material transfer from the telephone cable were noted on the engine crankcase vent line. The impact marks on the vent line had the same spacing and width as the wires of the steel cable that support the telephone cable (see Photo 2). Neither the propeller nor the main nose wheel tire exhibited indications of damage from possible contact with the cable. However, the right steering arm rod end failed in overload, probably as a result of the impact with the cable, but any material transfer from the cable was probably masked by the engine cowling.

**Photo 2.** Cable markings on crankcase vent tube
