RAILWAY INVESTIGATION REPORT
R09H0010

LOCOMOTIVE ENGINE FIRE

VIA RAIL CANADA INC.
PASSENGER TRAIN 46
MILE 14.26, SMITHS FALLS SUBDIVISION
RICHMOND, ONTARIO
16 AUGUST 2009

Report Number R09H0010

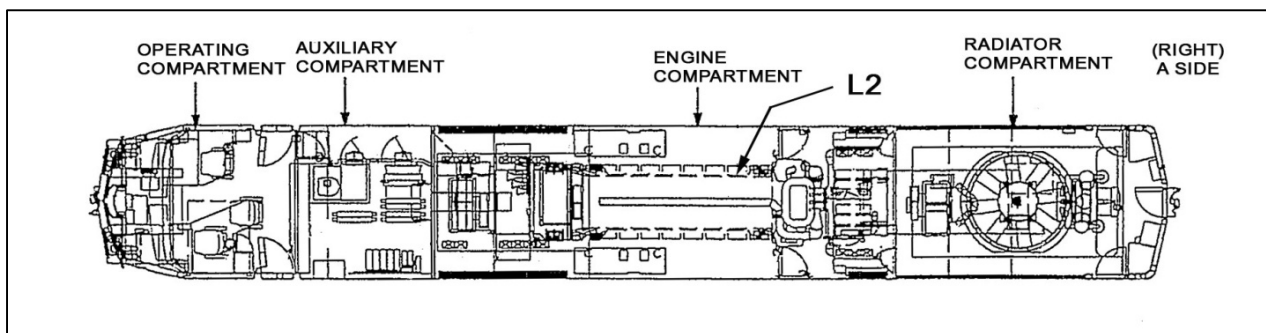
VIA 902 was a Genesis P42 locomotive manufactured by General Electric (GE). It entered into service in 2001. Post-occurrence examination of the locomotive determined that the fire started at the top of the L2 power assembly of the V-16 diesel engine (see Figure 3).

Figure 3. Genesis P42 locomotive showing location of L2 power assembly

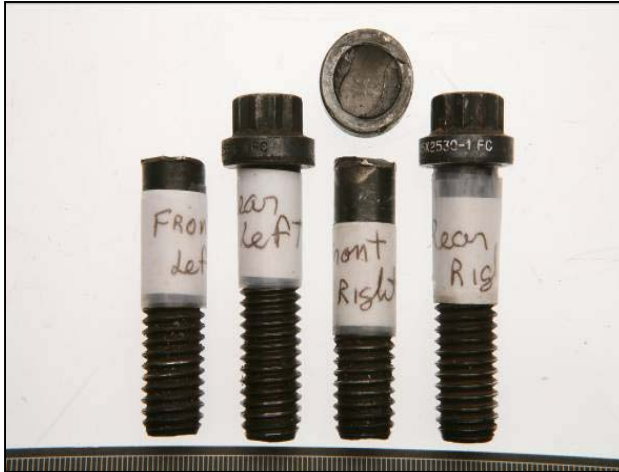
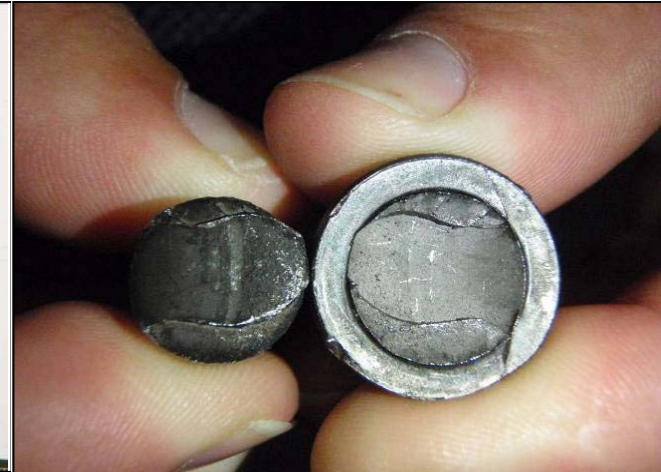
Fuel Pump Mounting Bolts (see photos 1 and 2)

- The mounting bolts used to fasten the L2 fuel injector pump to the cylinder were the original bolts that had been installed during factory assembly.
- The fuel injector pump front mounting bolts (left and right) failed due to progressive (high-cycle fatigue) cracking.
- The fatigue cracks advanced in different intersecting directions, which was most obvious in the case of the front right mounting bolt (see Photo 2).
- No discrepancies were found when compared with the mounting bolt specifications (that is, dimensions and material).

Photo 1. Fuel injector pump mounting bolts

Photo 2. Front right mounting bolt for fuel injector pump

excessive vibration of the pump, leading to progressive, high-cycle fatigue cracking and failure of two of the four mounting bolts that secure the pump to its seat. Once the fuel injector pump was loose, continued vibrations led to fatigue cracks and the eventual failure of the high-pressure fuel injection line.

Examination of the bolts revealed that fatigue cracks had advanced in different intersecting directions. This suggests a change in the direction of the applied stresses. The most probable explanation for such a change is rotation of the bolts. The bolts could have turned on their own if they became loose during operation, or they could have been installed at a different turn position during removal and re-installation of the fuel injector pump. The re-use of fuel injector pump mounting bolts during scheduled maintenance increases the risk that bolts will fail in service due to undetected fatigue cracking, leading to locomotive engine fires.

- To better identify on board personnel during train evacuations, each VIA car is equipped with reflectorized vests for employees to wear.
- VIA updated the training program for on board train personnel to include on site (hands on) evacuation procedures.
- VIA is updating its passenger handling safety plan (to be released September 2010).
- VIA's training program entitled "Emergency Response Procedures Refresher Course for On-Train Employees" was revised to provide consistent training for bilingual emergency announcements and to improve communications between the in-charge locomotive engineer and the service manager during emergencies.
- VIA's maintenance documentation was revised to indicate that old mounting bolts on fuel injector pumps are to be discarded and replaced with new ones. A new pump replacement checklist was created to reflect this change.

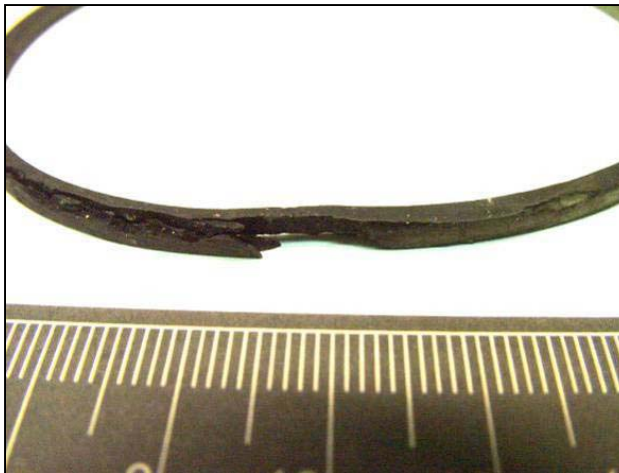
O-Ring Gasket (see Photo 3)

- A portion of the rubber O-ring gasket had jammed between the pump base plate and the cylinder seat. There were scrapes and small cuts along half of the outside surface of the gasket, including a 15 mm longitudinal tear and a 10 mm missing portion.

Photo 3. Damaged O-ring gasket

Laboratory analysis determined that the O-ring gasket, which is intended to ensure proper fit of the fuel injector pump, had been pinched between the fuel injector pump base plate and its cylinder seat. During normal train operation, this misaligned fuel injector pump created

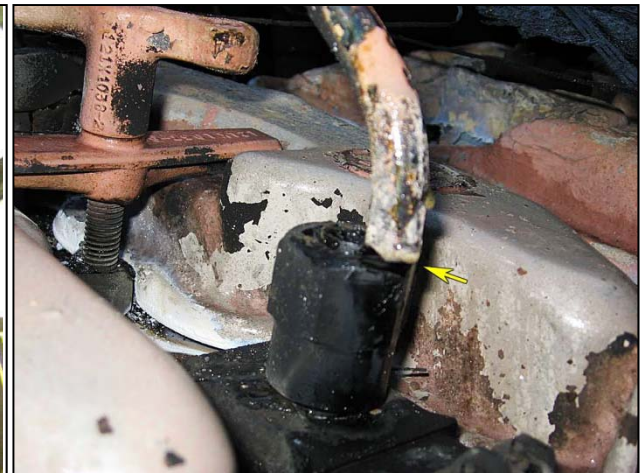
High-Pressure Fuel Injection Line (see Photo 4)

- Subsequent to the bolt failure, the fuel pump-to-cylinder joint became loose, leading to the development of fatigue cracks in the high-pressure fuel injection pipe.
- The fuel injection line broke in overstress mode due to the reduction of its load-bearing cross-section.

Photo 4. Broken fuel injection line

The accident occurred when the diesel engine on VIA 902 caught fire. A broken high-pressure fuel injection line led to the release of fuel. The fuel contacted the hot surface of the engine exhaust manifold and ignited.

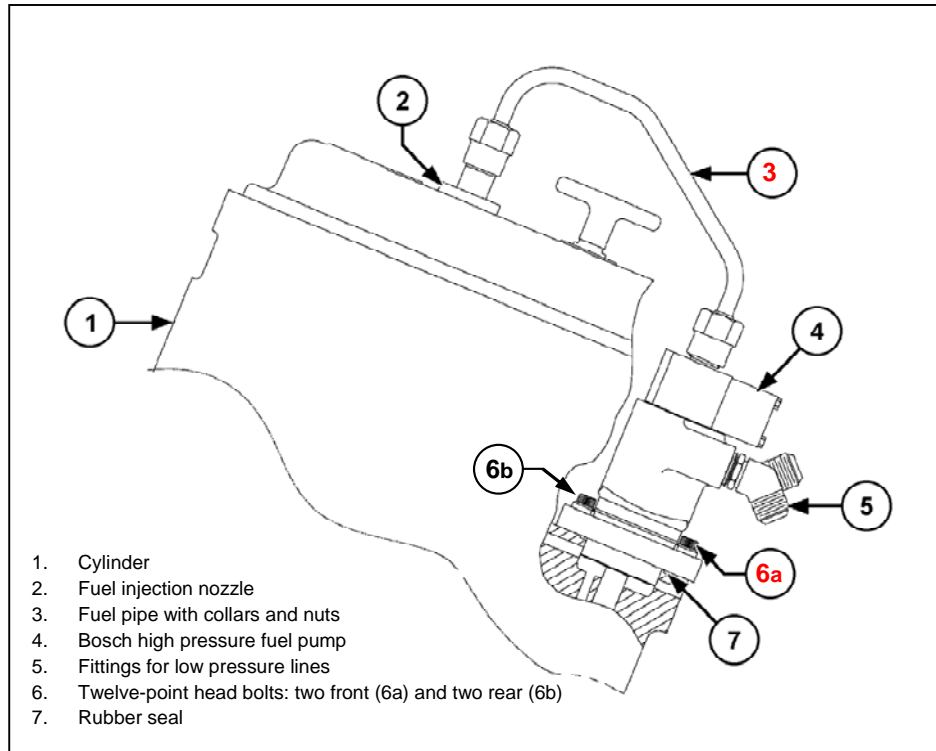
Figure 4. Schematics of the fuel pump-to-cylinder attachment (adapted from GE Parts Catalog PBE-93342-006D). Items 3, 6a and 7 were the failed components.
