**MARINE INVESTIGATION REPORT**  
**M07L0158**

**STRIKING**

**PASSENGER VESSEL *NORDIK EXPRESS***  
**ENTRÉE ISLAND, HARRINGTON HARBOUR, QUEBEC**  
**16 AUGUST 2007**

Report Number M07L0158

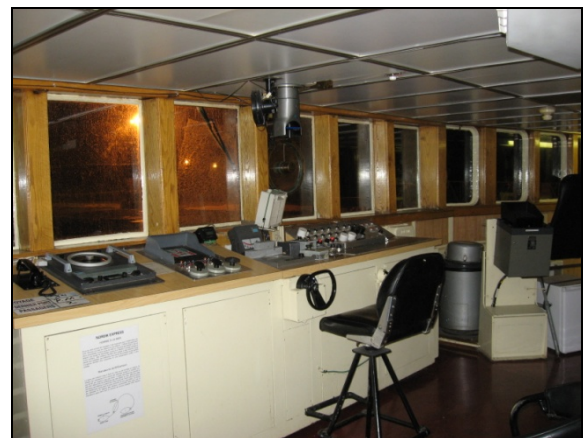
Neither the radars nor the ECS could be monitored without leaving the helm.

**Photo 2.** Bridge centre console showing the starboard radar. The other radars and ECS are out of view to the left (port).

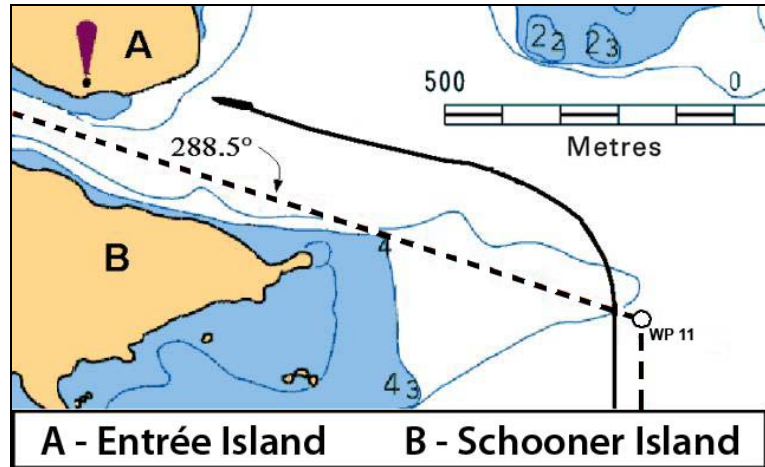
At about 2303, or approximately two minutes after leaving, the helmsman returned to the bridge. The vessel, back on its heading of 288°, was still full ahead and making way at 11.7 knots;<sup>10</sup> its actual track, however, was offset to the northeast, parallel to the intended track (see Figure 1).

**Figure 1.** Screen capture of the vessel's ECS at 2303:13, showing the vessel's actual track and position (solid line) compared with the intended track (dashed line).

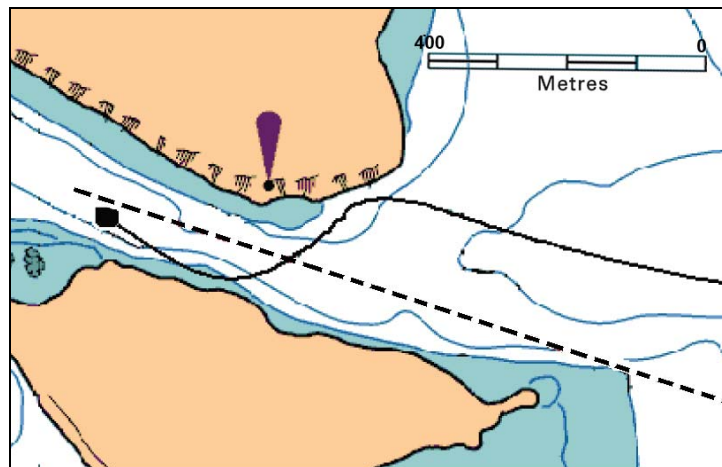
After striking Entrée Island, the vessel crossed the narrow passage, almost grounding on Schooner Island. The helmsman then saw the harbour's leading lights ahead and began to steer the vessel into the middle of the passage (see Figure 2).

**Figure 2.** Track showing vessel striking Entrée Island and rebounding toward Schooner Island (solid line).

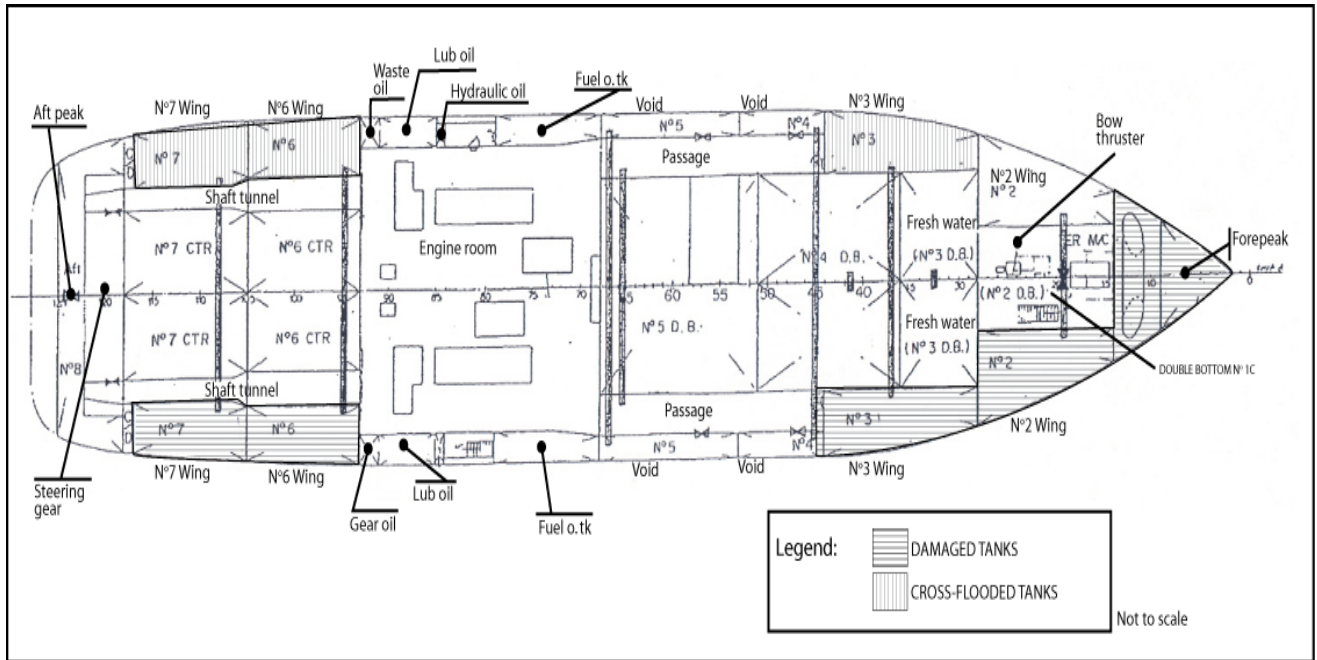
# Appendix F – Tank Plan of Vessel

The vessel sustained heavy damage on the starboard side near the bow, quarter, and starboard propeller. The forepeak tank, double-bottom tank No. 1C, as well as starboard tank Nos. 2, 3, 6, and 7, were breached and took on water (see Appendix F). This flooded the Nos. 3, 6, and 7 tanks on the port side by means of the cross-flooding pipes.
