National  
Defence

1016-22-1 (DFS)  
25 June 2010

# 2009 Annual Report on Flight Safety

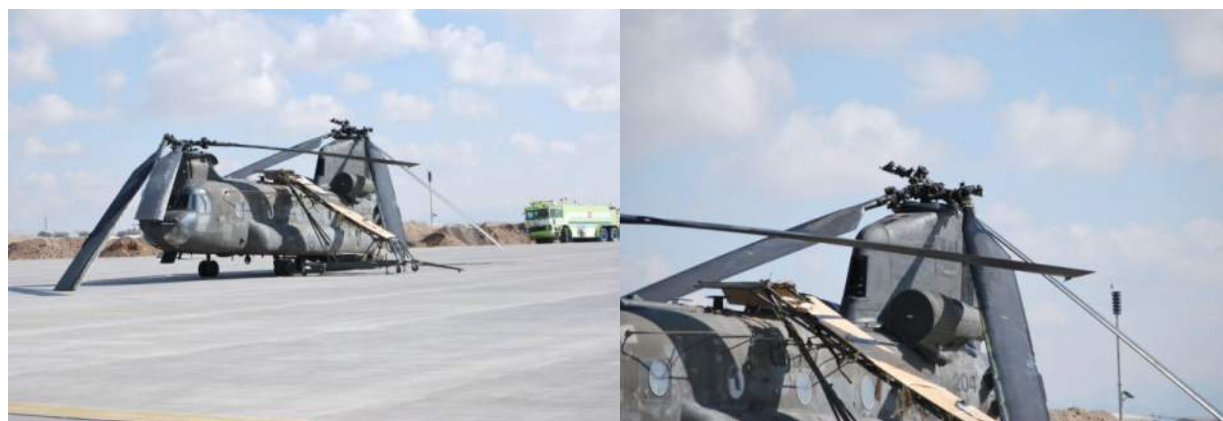
### 1.6.2.1 18 Jan 09, Chinook CH147204, Accident, Cat 'B', Kandahar, Afghanistan

Chinook CH147204 was tasked on a training mission out of Kandahar airfield (KAF) and departed for the mission. Later in the morning, while the aircraft was still on its mission, maintenance personnel found an aft rotor fixed droop stop on the ramp near where that aircraft was previously parked.

The droop restraint system has no function while the aircraft is in flight and failure of the system does not impede safe flying operations. However, the droop restraint system supports the weight of the rotor blades on start-up and shutdown to prevent them from striking the fuselage.

The maintenance personnel immediately checked all other aircraft on the ramp and determined that none of the helicopters were missing a fixed droop stop. The Ops Center advised the occurrence crew of the situation and recalled the aircraft. Once safely in KAF, the aircraft was landed at a remote location away from personnel, buildings and other aircraft. Using a procedure borrowed from a coalition partner, a ladder/ramp was put in place to protect the fuselage from damage by the drooping blade. The crew set the parking brakes, secured the flight controls in place and exited the aircraft. The engines continued to run until the fuel supply was exhausted. After the engines stopped, the rotors began slowing down until they eventually impacted the

ramp, causing very serious damage to the rotor blade system and fuselage. There were no injuries. This investigation is on-going.

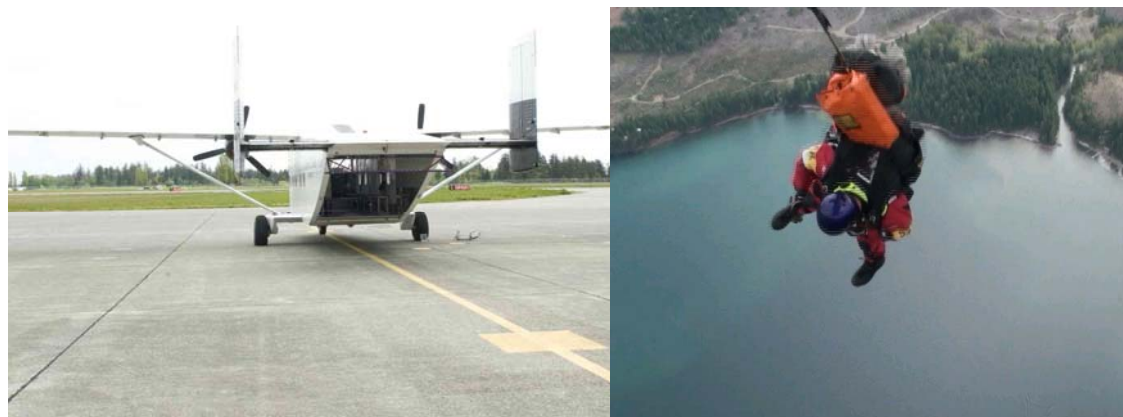
#### 1.6.2.2 8 May 09, Non-CF, Incident Cat 'D' Fouled Parachute

The Canadian Forces School of Search and Rescue (CFSSAR) was conducting a basic Search and Rescue (SAR) technician trade qualification course. The student SAR technicians were to perform their first water landing from a parachute jump commencing from 3,000 feet above the water surface. The drop zone (DZ) was at the east end of Comox Lake, located approximately 10 NM southeast of 19 Wing Comox.

As the Jumper exited the aircraft the Life Raft Survival Kit (LRSK) interfered with the normal deployment of the main parachute. During the exit, the LRSK rolled inverted and rode up over the main parachute compartment. The Jumper's static line stretched tight in a normal manner and pulled the deployment bag (D-Bag) containing the main parachute from the parachute pack tray. The main parachute D-Bag fouled under the LRSK attachment strap preventing further main parachute deployment. The Jumper was now hung up and towed behind the aircraft by the taught parachute static line.

Following reserve parachute deployment, the Jumper noted little deceleration and that less than half the reserve canopy was inflated. The reserve parachute suspension lines appeared twisted but upon further examination, he noticed the main parachute inner D-Bag with extended suspension lines had wrapped around the reserve parachute suspension lines. The Jumper retrieved the D-Bag and swung it in a direction to unwrap it from the reserve parachute suspension lines. The reserve canopy began to inflate and slow his descent. The Jumper noticed the water surface approaching and he prepared for the water landing. At first contact he skipped off the water surface and then was thrown forward, landing in the water much harder than normal. A water rescue boat was immediately on the scene and operators assisted the Jumper into the boat. The Jumper received minor injuries. The on-going investigation is focusing on the

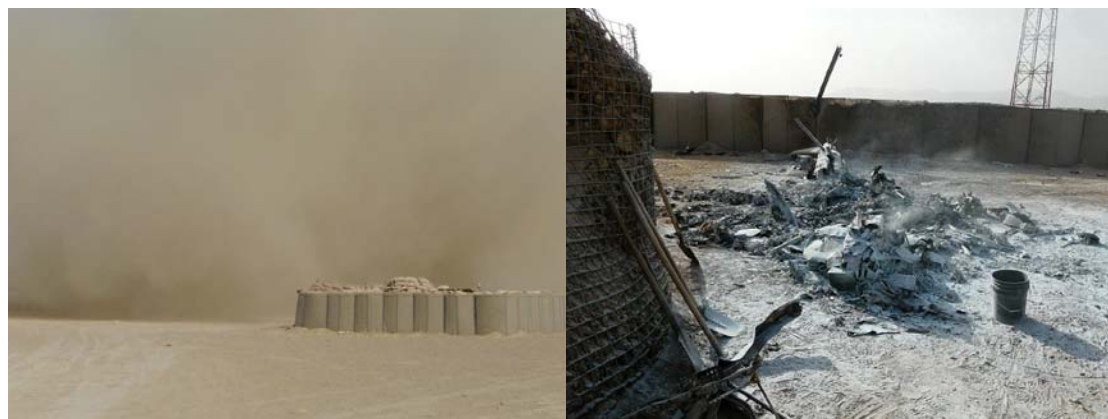
1.6.2.3 06 Jul 09, CH146434, Accident, Cat 'A', Forward Operating Base, Afghanistan

The mission was part of the Joint Task Force (Afghanistan) Air Wing. It involved two CH146 Griffon helicopters tasked to carry two passengers each for a morning insertion to a Forward Operating Base (FOB) and afternoon extraction. The morning portion of the mission was conducted without incident.

The accident occurred during the extraction and involved the second aircraft in the formation (CH146434). The crew consisted of two pilots, one Flight Engineer (FE), and one Door Gunner (DG) with two passengers; one Canadian and one coalition soldier.

The occurrence crew developed their take-off plan which would be executed in two phases: a max performance take-off to maximize vertical obstacle clearance followed by an Instrument Take-off (ITO) once visual ground references were lost. The Flying Pilot (FP) pulled collective to 95% mast torque for the max performance take-off. Conscious of the high temperature of the day, just above 40°C, the FP gave a quick crosscheck to the Inter-Turbine Temperature (ITT) gauge and noted a reading of 840-850°C. At that moment the Non-Flying Pilot (NFP) called "Drifting Right". The FP's attention was immediately redirected outside to reacquire visual ground references, but a dust ball had obscured all visual cues, so the FP transitioned to instrument flight. The NFP made a second "Drifting Right" call, but just as the word "Right" was spoken, the aircraft hit the HESCO barrier.

No pertinent aircraft technical deficiencies have been discovered to date. The on-going investigation is focusing on Human Factors, mission planning and performance limits for Desert Operations and obscuring phenomena. Rear cabin evacuation and survivability is also under investigation.

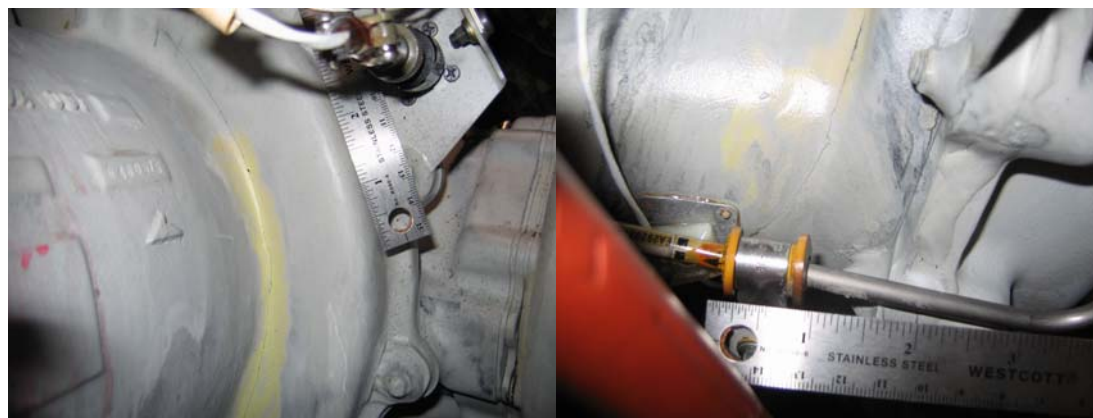
1.6.2.4 28 Jul 09, CH149910, Accident, Cat 'C', Gander, NL

The occurrence aircraft, Cormorant CH149910, landed in Port au Choix, NL after having flown a 3-hr training flight. A significant amount of oil was discovered on the starboard side of the aircraft in the vicinity of the no. three engine. After discussion between the crew and maintenance personnel, the affected area was cleaned, the engine was replenished with oil, and a ground run was conducted. On the return flight, oil was again seen leaking along the starboard side from the vicinity of the same engine, which led the crew to shutdown the engine in flight. The aircrew conducted a two-engine running landing, taxied in and shutdown. The aircraft was put in maintenance to change the no. three engine. The engine change, ground run and maintenance test flight (MTF) proceeded as planned with no abnormalities. After the MTF, upon towing the aircraft in the hangar, oil was once again noticed on the starboard side. Initial inspection revealed considerable oil near the connecting intermediate transmission casing forward of the no. three engine bay, between the engine input shaft and the main gear box. Further inspection revealed a crack approximately 18.5 inches in length on the intermediate case of the no. three mechanical drive assembly.

The preliminary investigation has revealed that the aircraft damage was limited to the no. three main gearbox power train system, specifically the intermediate case of the no. three mechanical drive assembly connecting the MGB to the no. three engine. The fracture in the intermediate transmission case outboard flange of the no. three mechanical drive assembly spanned more than half of the circumference of the casing.

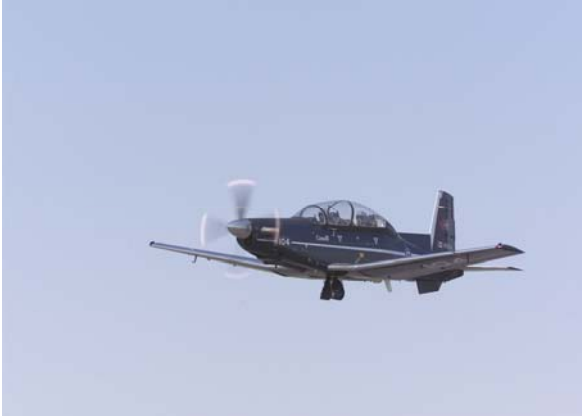
**1.6.2.5 13 Aug 09, CT156101, Incident, Cat 'E', Moose Jaw, SK**

The incident involved three CT156 Harvard II training aircraft. The first aircraft was on a clearhood dual mission with the student in the front seat. The two other aircraft were a formation, with “lead” having a crew of two and flown by an instructor in the front seat. Number 2 was a dual flight with the student in the front seat. CT156101 nearly collided with the CT156 traffic in the Moose Jaw Training Area. The aircrew assessed the miss distance at less than 100 feet.

The on-going investigation is focusing on multiple contributing factors, including but not limited to airspace management and flight operations procedures. 2 CFFTS has enhanced the role of the operations desk in assigning airspace. Other preventive measures (PM) recommended include further segregating 15 Wing Airspace and pursuing an electronic based collision avoidance system for 15 Wing aircraft.

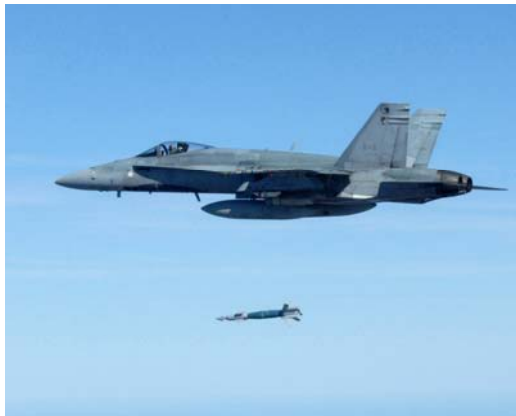
**1.6.2.7 17 Nov 09, CF188925, Incident, Cat 'E', Salina, KS**

CF personnel were conducting a Forward Air Controller (FAC) course using a ground laser designator to guide a Laser Guided Training Round (LGTR) to a range target located approximately 790 meters south. A LGTR released from Hornet CF188925 landed within 50 feet of ground personnel. The incident occurred at night on the Smokey Hills Range during the first delivery. The ground party consisted of FAC instructors and students with the instructors operating the ground laser designator and performing FAC duties as a demonstration to the students. Using standard procedures and following pilot / FAC mutual confirmation of the correct target

with infrared markers, the pilot was cleared for the attack run. However, instead of homing to the intended target, the LGTR impacted approximately 50 feet southwest of the laser designator and the ground personnel. There were no injuries and further training was terminated. The investigation is on-going.

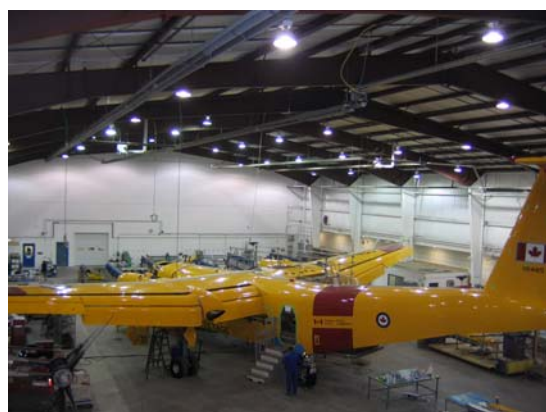
1.6.2.8 26 Nov 09, CC115465, Accident, Cat 'C', Kelowna, BC

A Buffalo aircraft (CC115465) sustained serious structural damage while refuelling at a third line maintenance contractor facility. The occurrence aircraft was undergoing a complete maintenance overhaul referred to as a periodic inspection. As part of this procedure, the aircraft exterior was to be completely stripped and repainted; which was being completed in parallel with the overhaul of mechanical systems. During refinishing, adhesive backed metal aluminum tape was used to seal the fuel tank vents, as per normal procedures. The repainting task was only partially completed and the tape had not yet been removed, when the aircraft was

scheduled for a fuel leak check as part of a parallel maintenance routine.

The Crew Chief had reviewed the Canadian Forces Technical Order (CFTO) pertaining to the fuel system and other systems, prior to commencing the leak check, which required the pressure refuelling of all tanks. The outer wing fuel tanks were filled without incident, but as the inner wing fuel tanks gauges were indicating approximately 3700 lbs of the total 4160 lbs capacity, a bang was heard, and shortly thereafter, fuel was seen pouring from the right inner-wing fuel tank trailing edge, near the retracted wing flaps. The fuel spill was contained with absorbent material but the aircraft sustained very serious damage to the center wing box assembly. There were no injuries.

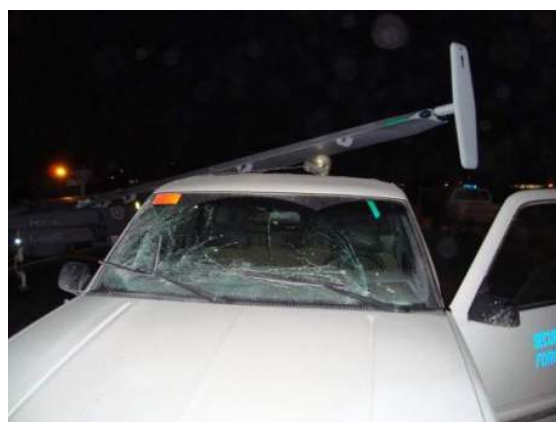
1.6.2.9 5 Jan 09, CU170251, Accident, Cat 'C', Kandahar, Afghanistan

At dusk, a Tactical Uninhabited Aerial Vehicle (TUAV) Heron was being towed eastbound on Foxtrot taxiway by a small, 4 wheel-drive, 2-passenger, mule utility vehicle. Both headlights and an amber strobe light were illuminated on the mule while the Heron's navigation, strobe and taxi lights were on. Four ground crew members were riding in the mule, two in the vehicle seats and two sitting facing backwards on the hatch of the mule's cargo bed. A Security Forces (SF) pickup truck was travelling westbound towards the setting sun along Foxtrot's Motor Transit Route (MTR). The MTR consists of two lanes on the south side of Foxtrot's

taxiway centerline and operates much like a two lane road.

The SF vehicle collided with the right wing of the Heron. Upon impact, the Heron was pushed violently to the right; the right wing rode up the truck's windshield and along its roof and the left wing approached, but did not contact the personnel sitting in the back of the mule. The Heron sustained serious damage and the SF vehicle windshield was shattered. No one was hurt in the incident.

The investigation revealed that the SF driver saw the aircraft in tow only after the impact and the mule driver did not attempt any avoidance manoeuvres as he had right of way over the ground vehicle. Safety recommendations implemented included additional light sources on the Heron during night taxi and towing operations, revised taxiway procedures, and a change in the Heron Detachment's operating location. This investigation is complete.

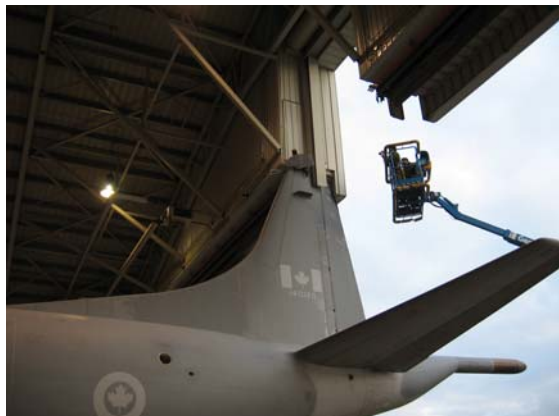
#### 1.6.2.11 28 Jan 09, CP140120, Incident, Cat 'D', Comox, BC

The incident occurred during the early morning hours as a tow crew of five personnel was pushing an Arcturus CP140 out of 12 Hangar. The tow crew supervisor took position adjacent to the tow bar on the right-hand side of the mule. There was no tail-walker assigned and the option of using one of the available personnel to cover the rear of the aircraft was not discussed.

As the aircraft began to move backward, it also drifted left undetected. The mule driver could not see the vertical stabilizer from the driver's seat and wing-walkers did not perceive that the vertical

stabilizer was moving towards the side of the "doggy door" opening. The Tow Crew Supervisor also did not notice that the aircraft was drifting off the centreline and was positioned in such a way as to be too close to the aircraft and could not see the vertical stabilizer. As the aircraft moved rearward, the rudder and vertical stabilizer struck the top of the hangar door opening adjacent to the "doggy door", extensively damaging the rudder and vertical stabilizer tip cap and causing minor non-structural damage to the vertical stabilizer.

Safety recommendations implemented include the painting of CP140 main wheel guidelines on the floor of 12 Hangar, a review of scheduling and manning practices and a general audit of Squadron procedures. It was also recommended that this occurrence be used as an educational example for other maintenance organizations / tow crews. This investigation is complete.

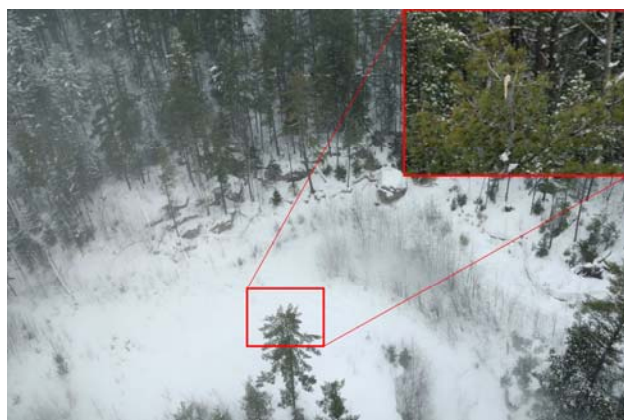
1.6.2.12 28 Jan 09, CH146470, Accident, Cat 'C', Petawawa, ON

A Griffon Helicopter sustained serious damage to its main rotor when it contacted trees during Advanced NVG confined area training in the local flying area. The landing area was nearly rectangular and measured approximately 150 ft by 120 ft at ground level and was covered with fresh snow.

During the descent the pilot allowed the helicopter to drift and believed the helicopter tail rotor may have contacted a tree. The helicopter controls felt normal. The pilot manoeuvred the helicopter so he could look at

the confined area from above. He noted a pine tree that would have been behind him in the area on the left side that had a fresh cut with the top branches missing. The helicopter was then flown directly back to the heliport and landed without further incident. A post flight inspection conducted by the FE found damage to the main rotor blades. The investigation is on-going.

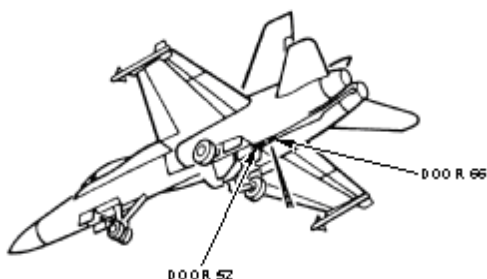
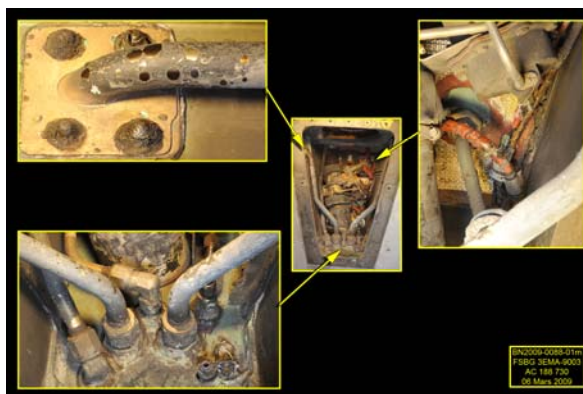
1.6.2.13 5 Mar 09, CF188730, Accident, Cat 'C', Bagotville, QC

A maintenance contractor Periodic Augmentation Team (PAT) was conducting a ground run on the ramp to operate the hydraulic system of a Hornet. The aircraft was towed outside the hangar and the Auxiliary Power Unit (APU) was started. After less than two minutes of operation, one of the technicians outside the cockpit observed smoke from the APU area, and requested an emergency shutdown. The ground run operator immediately shut down the APU. The heat from the APU caused serious damage to the surrounding structure. Safety recommendations implemented include sending technicians for simulator training, inclusion of an aircraft status board for maintenance tasks, daily safety and quality briefings, and removal of all unauthorized / temporary checklists. This investigation is complete.

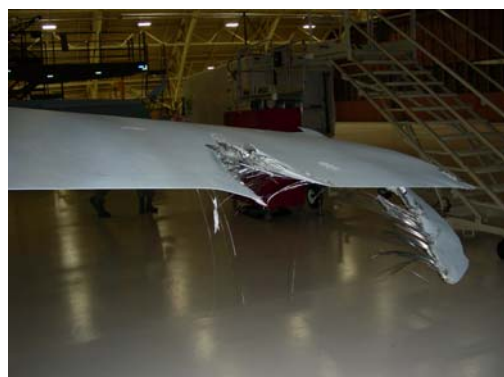
1.6.2.14 6 Apr 09, CF188762, Accident, Cat 'C', Tyndall AFB, FL

A Hornet was involved in a collision with an allied fighter aircraft. The CF188 was parked on the ramp in a host nation assigned parking spot and hit from the back/right by the other aircraft. Visible damage on the CF188 included the right hand Horizontal Stab and Station 9 LAU. The damage on the Hornet was assessed as serious. No injury was reported. The Allied Air Force is conducting its own investigation. The investigation has determined that no realistic preventive measures can be recommended to prevent this type of occurrence from happening. This investigation is complete.

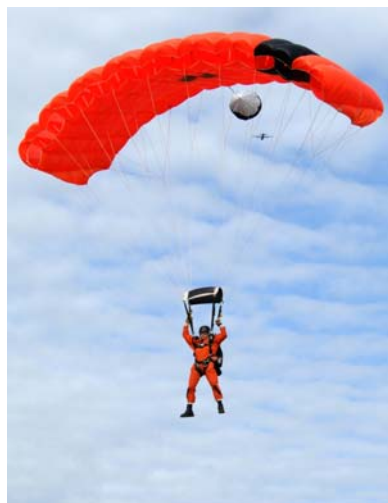
Freefall parachutist training was being conducted in the late afternoon from a CC130 Hercules aircraft for a stick of four SAR Techs. The drop zone (DZ) was a gravel surface at Baker's Island. Streamers were dropped to assess the wind before the drop and a windsock was located at the DZ. The surface wind was assessed to be from the southeast at 12 to 14 knots, well below the maximum allowable wind speed for parachute training of 25 knots.

The occurrence Jumper was the third free-fall parachutist to leave the aircraft. In descent, he established a standard downwind pattern to the DZ to permit an into-wind approach and landing. After turning onto base leg, he recognized that the effect of the wind on his movement over the ground was greater than expected. He immediately turned towards the DZ but assessed he was going to land short. The area immediately below him was unsuitable for landing due to obstacles. With some last minute manoeuvring between tall trees, he landed on the sloped, paved road surface that circles the DZ and sustained a serious injury.

The investigation focussed on the Jumper's assessment of the wind, low level canopy handling characteristics and the effect of low level winds over confining terrain on the actual landing area. Safety recommendations implemented included briefing all SAR Techs on effect of wind on descent pattern, turbulence downwind of obstacles, and importance of alternate landing areas. This investigation is complete.

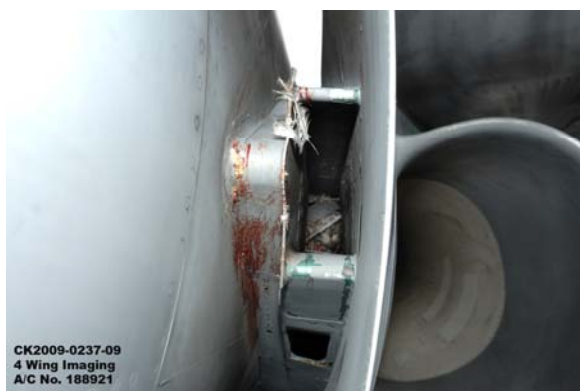
**1.6.2.17 14 May 09, CF188921, Accident, Cat 'C', Cold Lake, AB**

After shut down, bird remains were found on the left hand intake and left hand heat exchanger. Serious damage was observed in the engine and on the structure around the engine intake. The pilot did not have any indication of a bird strike at any time during the mission. Examination of the bird remains indicated that the damage was caused by high-speed impact with a Mallard Duck sometime during the flight. No bird hazard report was in effect at the time. Non-destructive testing (NDT) did not reveal any cracks. The investigation determined that no preventive measures could be

recommended from this occurrence. The investigation is complete

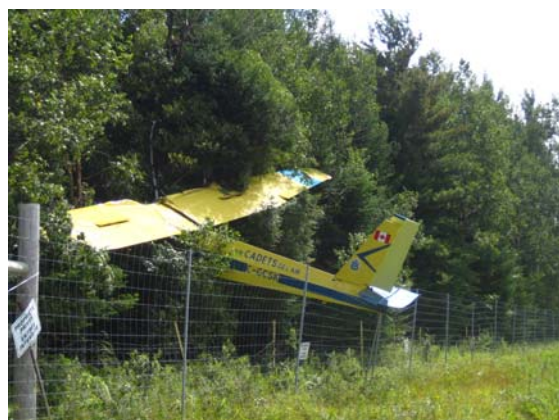
An Air Cadet glider hit trees while on final approach and was damaged beyond economical repairs. The glider took off from Runway 23 Left for a solo flight, the Student Pilot's sixth flight of the day. The turn from base to final was significantly delayed and resulted in the Student Pilot overshooting the extended centre-line and ending up aligned with the service road between the two runways. The Student Pilot attempted different Left and Right sideslip manoeuvres to regain centre line and ultimately entered the trees on the left hand side of the runway, approximately 340 feet short of the threshold. The pilot did not sustain any injury. The investigation is on-going.
