TP 185E
Issue 1/2010

AVIATION SAFETY LETTER

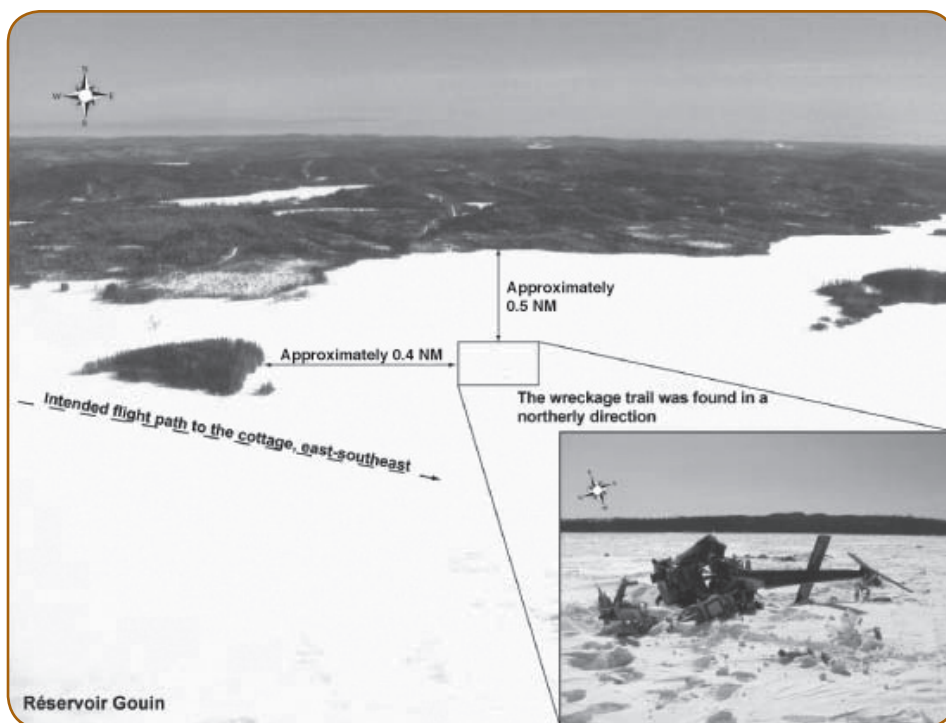
The operator uses a Guardian SkyTrax (SkyTrax) flight-following system to track its helicopter fleet, and the helicopter accident site was found at 14:09 EDT, 1.2 NM east of its take-off point on the flat, frozen, snow-covered surface of Réservoir Gouin. The pilot was fatally injured and the helicopter was destroyed.

Aerial view of accident trajectory

In its findings as to causes and contributing factors, the TSB concluded that the pilot likely encountered whiteout conditions, making it difficult to maintain visual reference and causing disorientation, which resulted in impact with the frozen snow-covered lake.

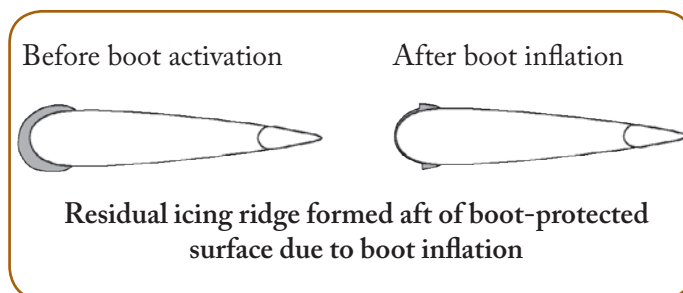
A problem has been identified in the design of pneumatic boot de-icing systems on some aeroplanes where the chord-wise extent of the boot-protected area did not consider SLD icing conditions, thus resulting in ice accretion aft of the protected area. This accretion has been particularly hazardous when a residual ridge of ice is left just aft of the boot on the upper wing after boot operation to break off ice. Flight tests on several different aeroplanes, using a tanker airplane to simulate in-flight SLD icing conditions, have shown that a ragged, span-wise ridge forms just aft of the protected area.

One effect of this ridge can be non-linear hinge-moment characteristics on trailing edge controls. For unpowered controls, hinge-moment anomalies at the surface can result in pulsing of the pilot's control, and in the extreme, a reversal in the direction of the pilot's force can occur. That is, the control can self-deflect to an extreme position, and excessive pilot effort can be required to return the control to a neutral position.

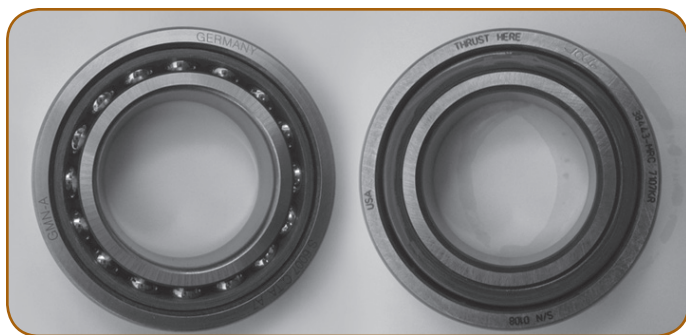
The thrust bearing on the left was determined to be unapproved during a routine inspection. The correct bearing is shown on the right.

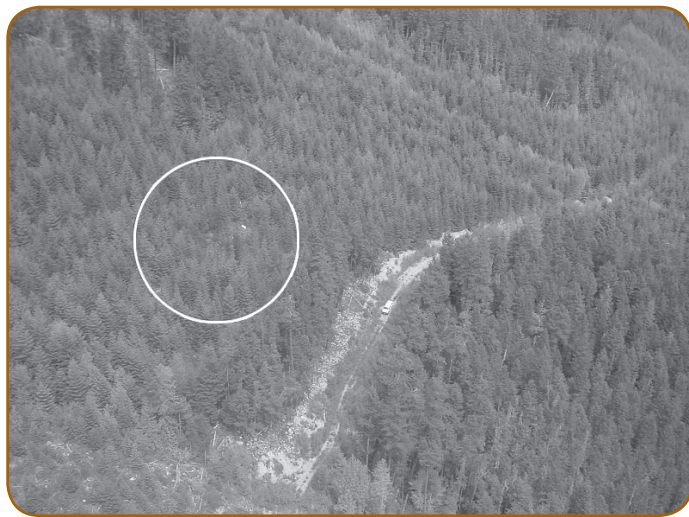
Aerial view of impact area (circle) into rising terrain. The majority of the aircraft fuselage was consumed by fire.

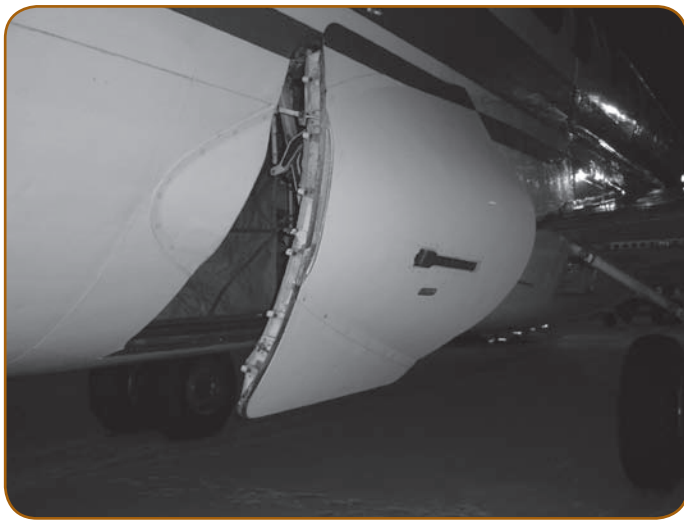
On December 13, 2006, a Boeing 727-227 departed from Regina, Sask., on a scheduled cargo flight to Hamilton, Ont. Shortly after rotation, the crew noticed that the aft-cargo-door warning light was illuminated, and irregular indications for the No. 3 engine followed. The crew decided to shut down the No. 3 engine and divert to Saskatoon, Sask., at an altitude of 10 000 ft. The aircraft landed safely at 07:10 Central Standard Time (CST) with aircraft rescue and fire fighting (ARFF) on standby. The aft cargo door was found open, with the door handle stowed in the locked position. There were no injuries. The aircraft sustained minor damage to the aft-cargo-door hinges. There was no damage to the door structure or latching mechanism.

Aft cargo door open with the handle stowed in the locked position

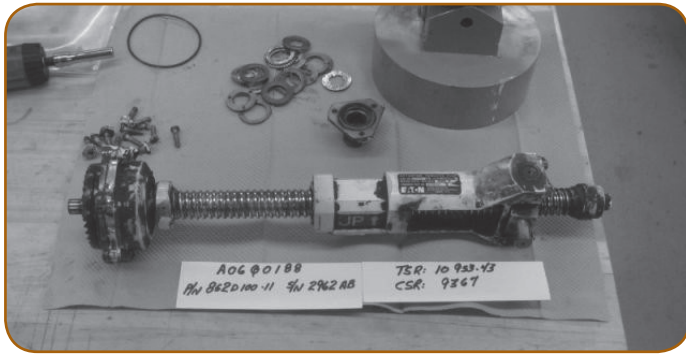
One of the flap system actuators being analyzed by the TSB

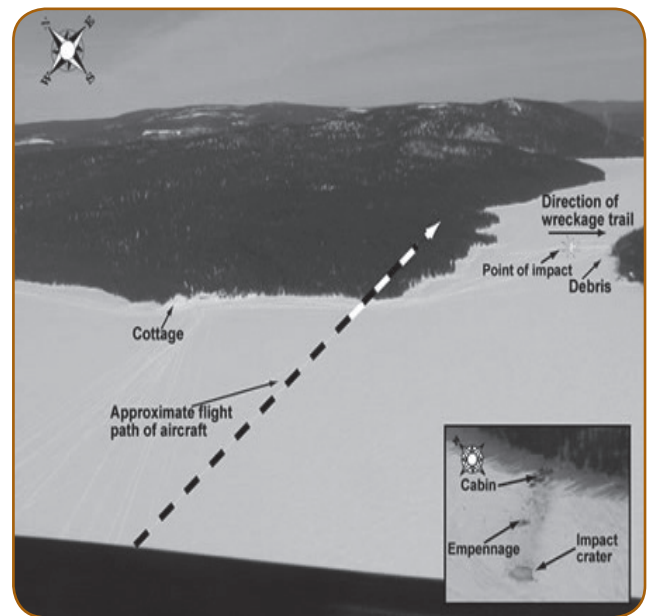
Aerial view of the accident site

1. The aircraft was flying at an altitude that could lead to a collision with an obstacle and that did not allow time for recovery.
2. The steep right bank of the aircraft considerably increased the aircraft's stall speed.
3. The form used to record the pilot's flight time, flight duty time, and rest periods had not been updated for over a month; this did not allow the company manager to monitor the pilot's hours.
4. At the time of the occurrence, the company operations manual did not make provision for the restrictions on daytime VFR flights prescribed in section 703.27 of the *Canadian Aviation Regulations* (CARs).

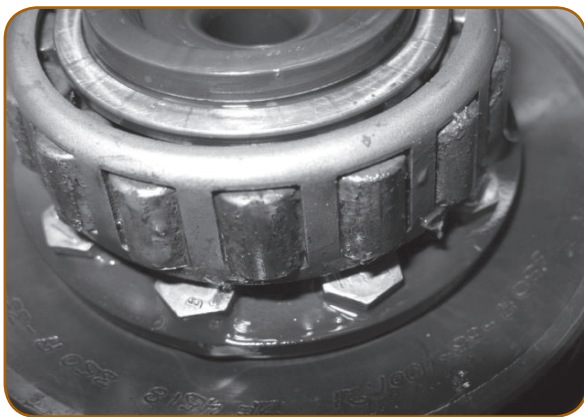
Corrosion pitting as found in No. 3 bearing (see the on-line version of the ASL for colour photo)
