TP 6980E
(03/2010)

Issue 1/2010

Canadian Aviation Service Difficulty Reports

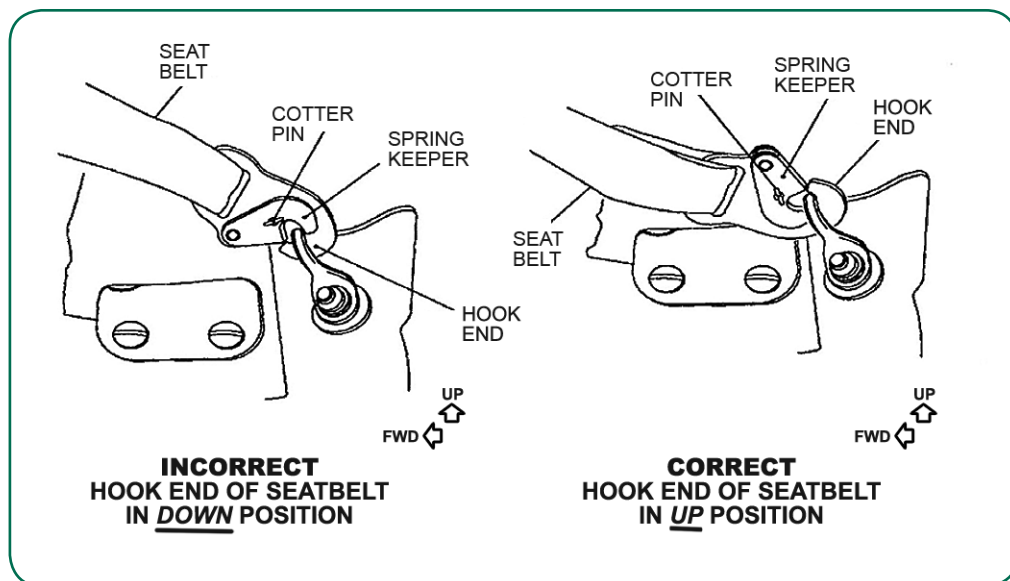
A recent event occurred during severe turbulence whereby several passengers received injuries as a result of being ejected from their aisle seats. The cause was due to incorrect positioning of the seat belt hook ends. Shortly thereafter, another separate and similar event occurred, again resulting in passenger injuries.

lodged under a plastic trim molding on the aisle side of the passenger seat. This caused the “spring keeper” to bend to the side, thus allowing the respective aisle seatbelt to become disengaged.

Transport Canada highly recommends that operators and owners comply with the above SB 8-25-349, Rev C, which provides instructions to inspect the aisle seatbelts to ensure that the seat belt hook end is in the “up” position (i.e. spring keeper facing up) ✖

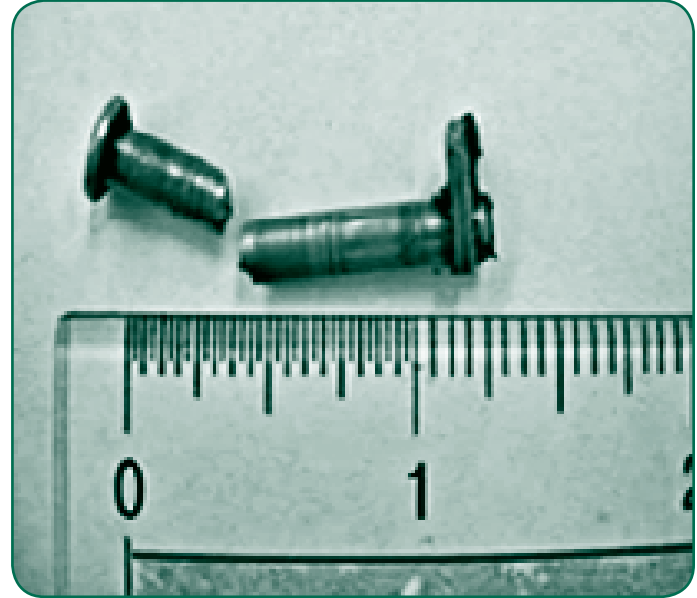
During cruise flight, the crew noted that the maximum cabin differential pressure could not be reached. Following landing at the planned airfield, the maintenance crew conducted ground tests and then discovered that both the upper cabin door hooks were turned sideways, thus preventing positive latching of the door. It was apparent that the cabin air leakage was because the door latching mechanism was not positively engaged.

This will confirm that the cabin door lock mechanism is positively engaged.

It is recommended that AMEs be particularly attentive to the maintenance instructions for proper door rigging/adjustments and lubrication. Additionally, a close visual inspection to check for wear and corrosion is required for the various parts of the door.

Flight crewmembers are required to perform several checks to ensure the door is closed and locked prior to flight. Cabin door security shall be verified before takeoff by attempting to rotate the door handle counterclockwise without depressing the release button.

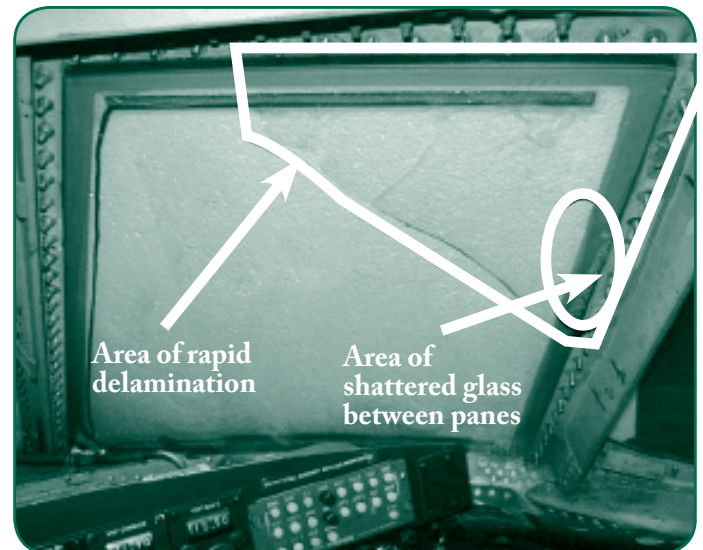
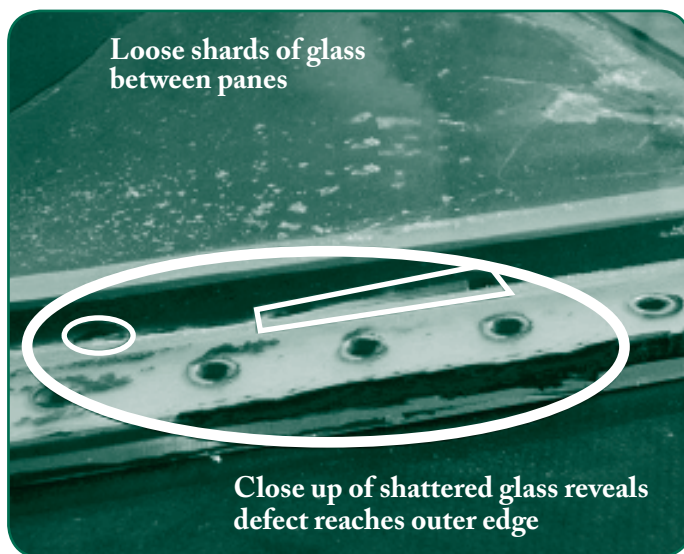
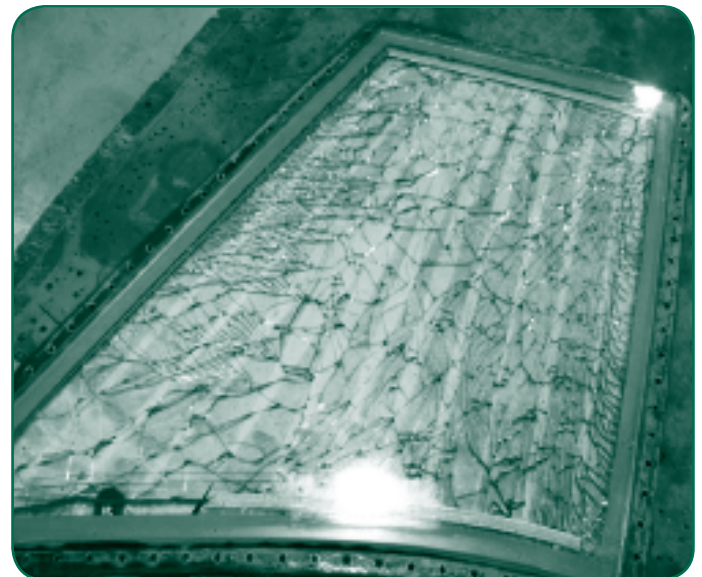
Approximately ten minutes after leveling off at 17 000 feet the crew noted that the first officer side windshield had several small cracks in the top right corner as well as one larger crack that looked similar to when a rock hits a car windshield.

Maintenance examined the windshield and found major delamination and cracks on the window. In various areas around the window the inner pane was beginning to separate from the outer pane and over time might have fallen inward.

The operator previously had a similar defect on the same part number windshield. The windshields were sent to the manufacturer for investigation and determination of failure cause. ✖

Maintenance replaced the windshield and returned the aircraft to service.

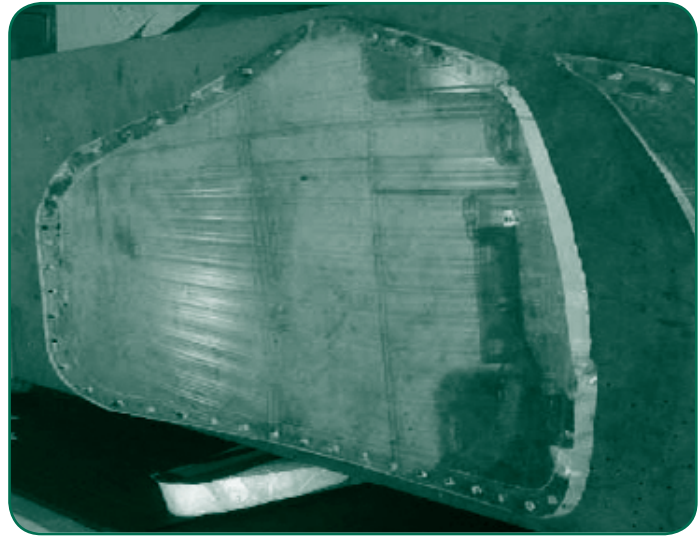
At flight level 370, the cockpit L/H side window outer pane cracked. The 7" crack was located on the forward lower corner. The aircraft returned to base without incident.

Upon removal of the subject window, significant corrosion was found in several of the fasteners. It was also noted that the window had developed smaller cracks emanating from other screw holes.

Prior to operation by the new owner, the aircraft had been repaired due to an impact with a flock of birds in this same general area. The aircraft was parked outside for 3 months awaiting repairs and it is believed that rain/moisture may have migrated into this area and promoted corrosion around the fasteners.

Follow up investigation with the FAA and Cessna revealed other similar failures. Cessna stated that there have been no previous defect reports related to corrosion around the L/H or R/H side windows. The prism inspection is designed to find small cracks in the window

originating from the fastener holes. It is not designed to detect corrosion. Cessna will continue to monitor any future Service Difficulty Reports (SDR) defect reports. It is recommended that maintainers and operators continue to closely examine windshields, cockpit side windows and cabin windows for evidence of cracks, scratches, discoloration, crazing and other deformations. Please note that Cessna Aircraft had previously issued Service Bulletin (SB) 560-56-01 on this subject matter. ✖

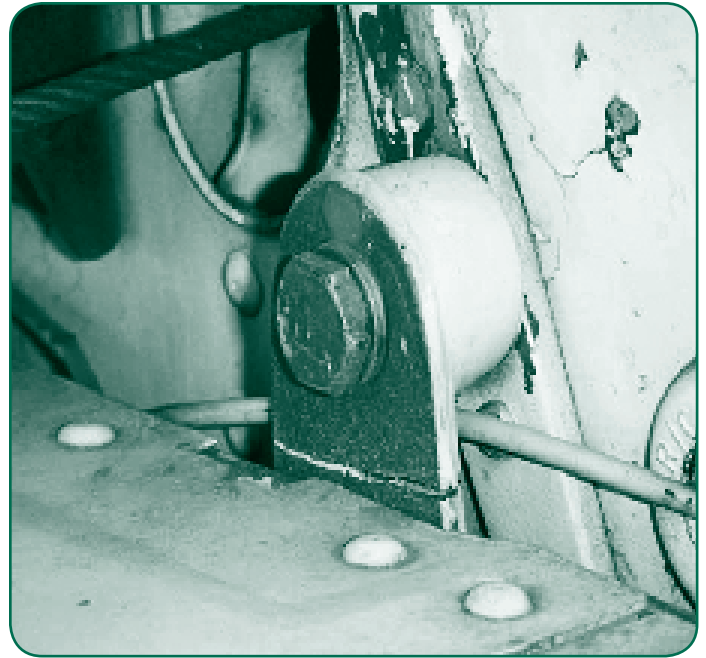
While carrying out a routine inspection in the immediate area, excessive play was noted while manually moving the horizontal stabilizer. While inspecting more closely, the AME noticed that the R/H forward horizontal stabilizer bracket was cracked all the way through. The crack was located just below the bolt hole.

TCCA has reported this event to both the FAA and the Type Certificate Holder. Additionally, the SDR database revealed numerous defect reports related to the front stabilizer attachment fitting P/N 1232013-1.

In order to improve the service life of these fittings, TCCA recommends that operators comply with Service Bulletin (SB) 88-3 and Cessna Service Kit (SK) 207-8. Incorporation of the aforementioned SB and SK is highly recommended if loose rivets or cracks in the stabilizer attach bulkhead, cracked doublers or fittings are discovered in the immediate area. ✖

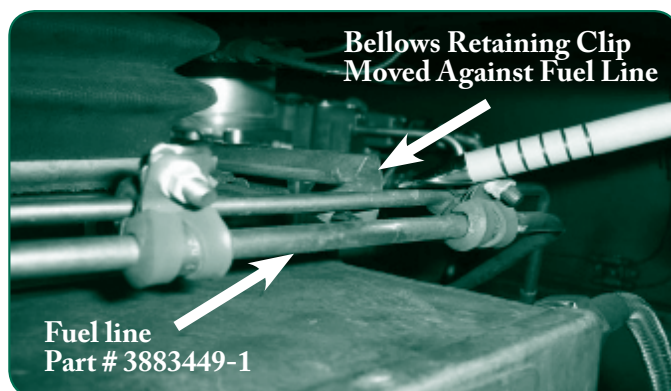
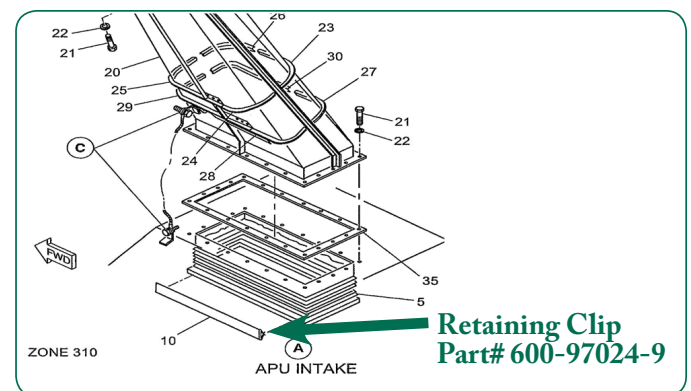
Crew reported that they had an oil smell from the APU when air conditioning system was selected. It was discovered that the APU fuel line Part Number (P/N) 3883449-1(FCU to nozzles) was found chafed thru due to the migration of the APU inlet bellows retaining clip P/N 600-97024-9 (ref CRJ 200 IPC 49-14-00 Fig 1 Item 10).

The SDR submitter states that this type of defect could potentially occur again due to the fact that the retaining clip is not secured (not clamped), allowing it to vibrate

Transport Canada recommends close examination of these components at the next APU air inlet assembly inspection. Always ensure that fuel and oil lines are properly clamped and are adequately separated to prevent rubbing and chafing. The submitter is currently inspecting these at intervals of 2 000 airframe hours and 300 APU hours. ✖

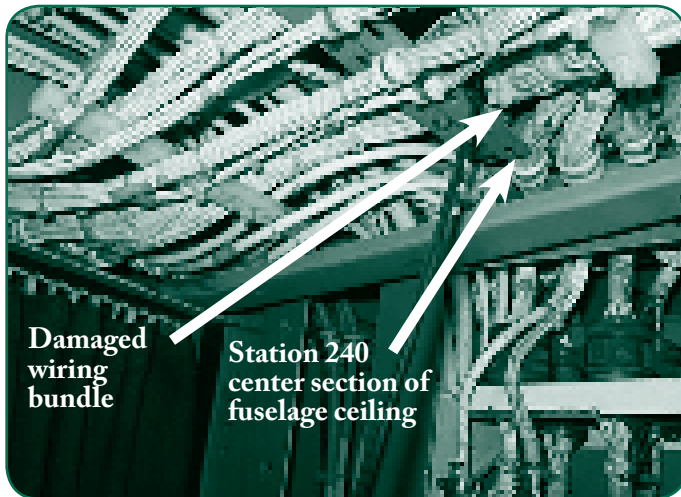
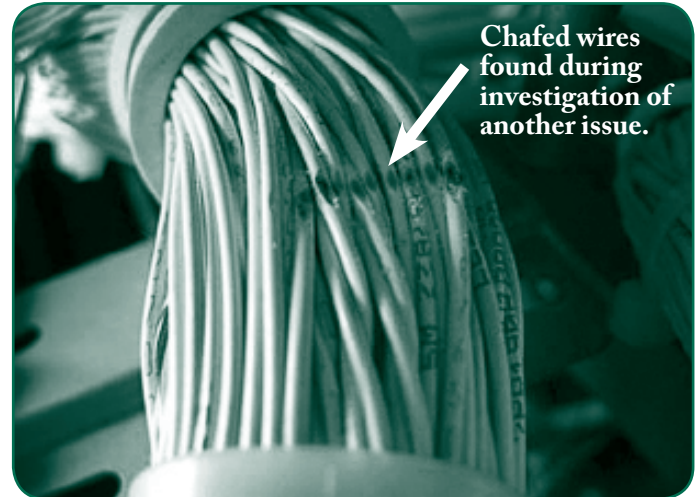
While troubleshooting the R/H engine tail pipe overheat system “failed to test” problem which was found during the preflight check; the avionic technician found 7 to 8 wires in an unrelated wiring bundle chafed and damaged. These electrical wires are located at fuselage station 240 in the ceiling of the aircraft. It is noted that these wires had nothing to do with the issue that was found during the preflight check. All other systems were functioning correctly.

The wire bundle has not been replaced since its original installation.

Good find by the Avionic Technician. In this case, being diligent paid off. Good work. Always ensure electrical wires are adequately secured and separated from adjacent structure to prevent rubbing and chafing which may lead to possible system malfunctions. ✖

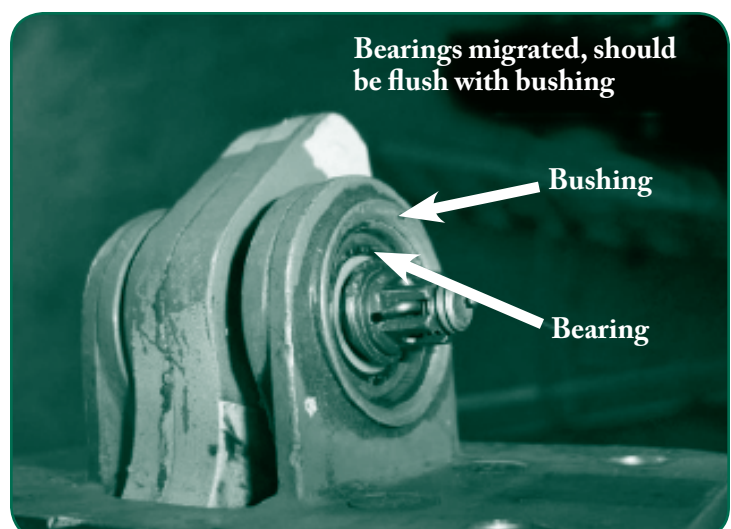
During the cleaning of the R/H wingtip navigation lights, it was noted that the #4 aileron hinge arm had a fresh sign of impact in the grease. The outboard portion of the aileron had approximately 1 inch of play in the up direction and ¾ inch of play in the downward direction.

Following removal of the aileron access panels, it was apparent that the bearings were out of their normal position. Removal of the aileron confirmed that the bearings had migrated out and also damaged the respective fitting. Minor fretting damage was also found to both the inboard and outboard side of the #4 hinge arm/bushing.

A precautionary inspection of the L/H aileron revealed worn bushings but fortunately no bearing migration had occurred. The pilot had not felt any control column vibrations or aileron flutter.

Any mechanical defects occurring on a primary flight control is of significant concern. It is recommended

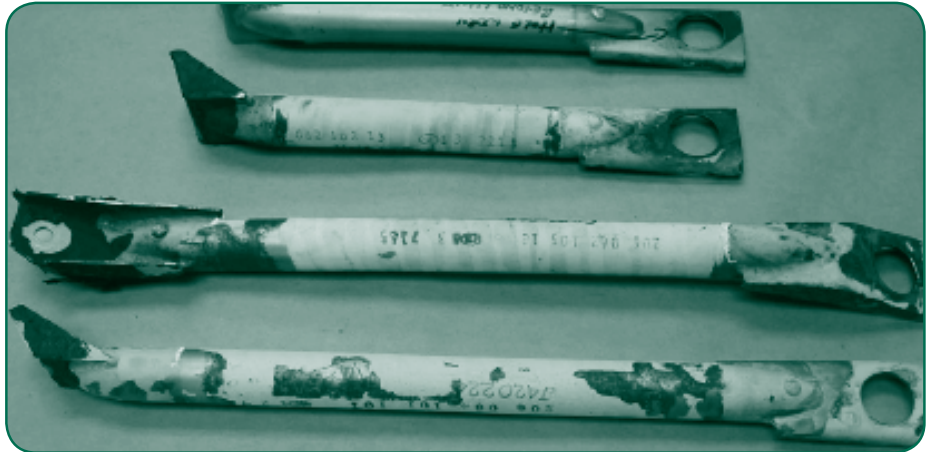
It was noticed after removal of the clamshell dampers and their packing material, during compliance of TB206-89-129 (removal of engine mount leg clamshell dampers), which is a customer option, that extreme corrosion was forming under the primer, which was found to be beyond limits.

All six engine legs were found corroded or damaged beyond limits. This was due to the engine mounts not being installed properly, which allowed the mount to become loose in the bushing bores and caused the clamshell to contact the engine leg.

The damage on five of the legs would not have been found if the Technical Bulletin TB206-89-129 had not been carried out. There is no scheduled maintenance required by the manufacturer on the engine leg assemblies. ✖

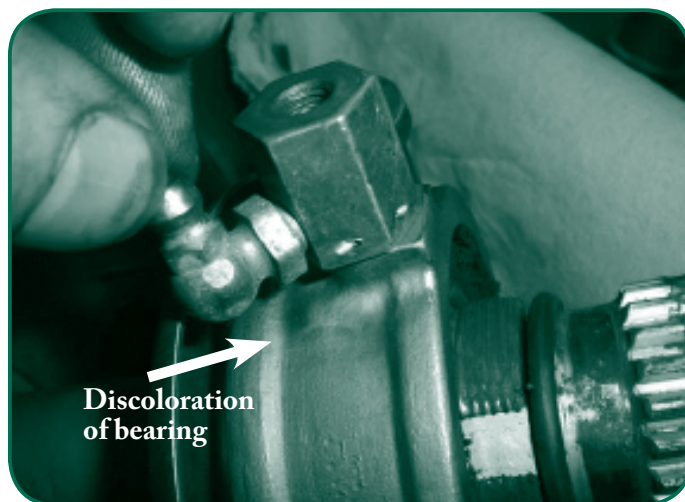
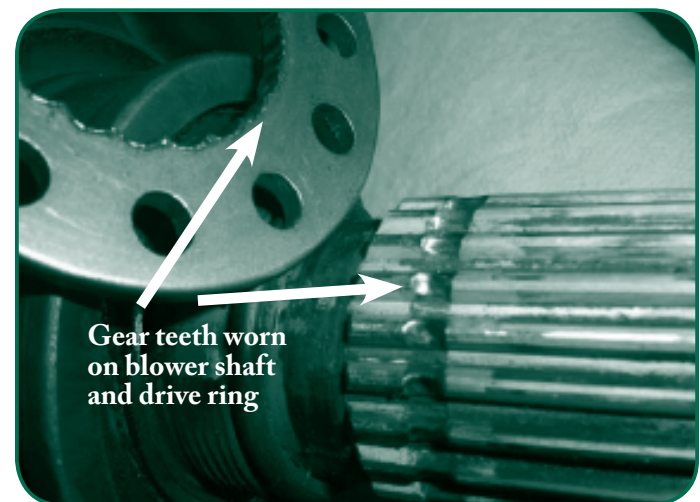
On a daily visual inspection of one company's Bell 407, the No. 1 T/R drive bearing hanger was found to be overheated with signs of blue discoloration.

The aircraft was removed from service. On further inspection the No. 1 and No. 2 bearings were found to be overheated and the root cause was found forward of the bearings, with the aircomm A/C pulley drive ring

P/N S-3532EC-5 (STC No. SR00222DE), which had worn ninety percent of the drive ring and Bell T/R blower shaft P/N 407-040-320-101 mating teeth material away.

Due to the condition of the material the initial problem was not discovered but incorrect belt tension was questioned since all the other components to the system were serviceable.

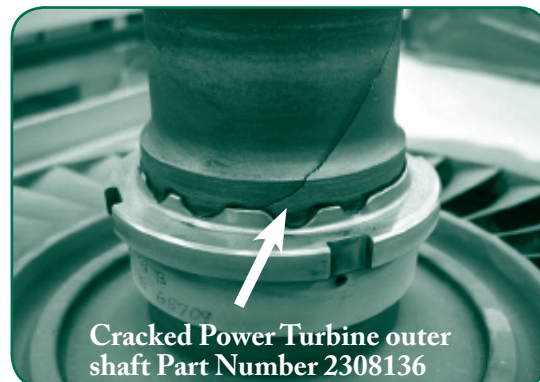
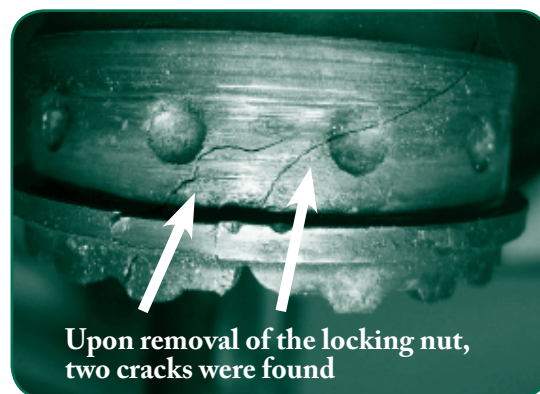
Engine noise was noted at ground idle. The noise was reduced when in hover but consistently appeared during spool down to ground idle. The engine was removed and returned to the overhaul shop for repair. The noise was confirmed during an engine test with vibration measurements. The engine was dismantled and inspection revealed a cracked power turbine outer shaft (Part Number 23038136). The crack affected the fit at the turbine 4th wheel curvics coupling, causing fretting and the loss of a coupling tooth.

Summary of the investigation noted "Previous engineering investigation into cracked Power Turbine Outer Shafts has determined that the most likely cause of the fretting that induces these cracks is loss of the clamp load between the curvics of the Power Turbine Outer Shaft and the curvics of the Fourth Stage Turbine Wheel". In this case, the cause for the lost torque of the spanner nut could not be identified. ✖

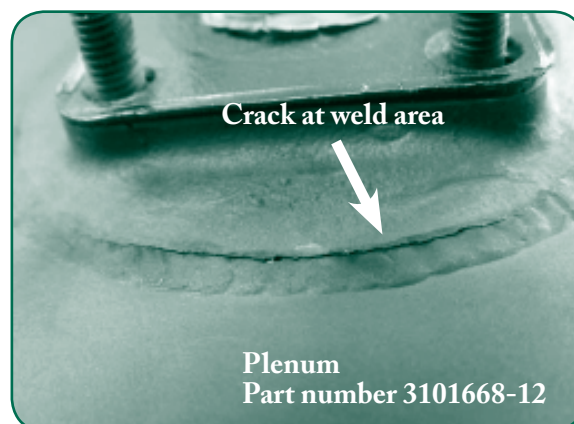
While conducting a major aircraft inspection, the Aircraft Maintenance Engineer noticed a crack on the plenum around the bleed air port of the R/H engine. The engine was removed and forwarded to the engine shop for repair. The part was replaced and the engine was reinstalled on the original aircraft.

Other cases were reported through the Transport Canada Service Difficulty Reporting System. The Submitter noted that the plenum is not life limited and remains in service as long as it passes the visual and Non Destructive Testing inspection at overhaul. Honeywell has issued Service Bulletin (SB) TPE331-72-2014 to introduce an improved version of the plenum. Transport Canada recommends that maintenance personnel be extra attentive to this area of the TPE331 series engines and

that owners and operators consider the incorporation of Honeywell SB TPE331-72-2014 at the next engine overhaul. Reference Service Difficulty Advisory AV-2006-07 issued 8 September 2006. ✖

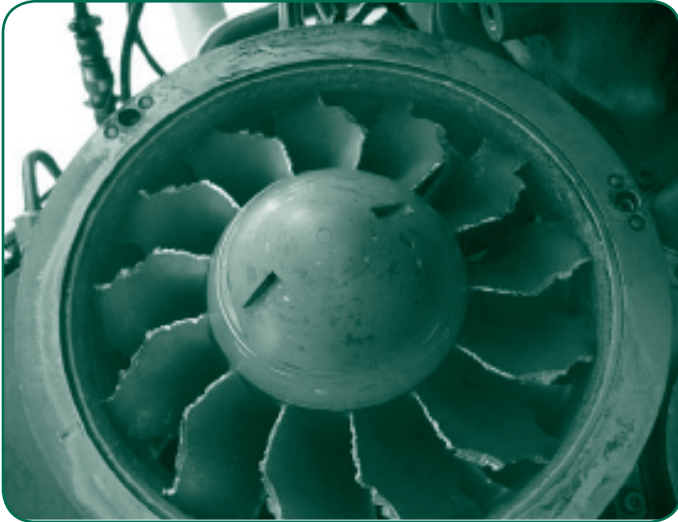
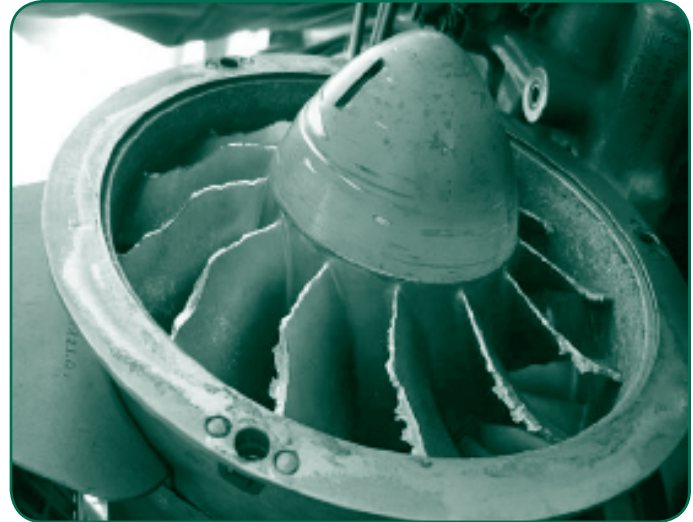
Pilot was taking off from base, reported hearing odd whining from engine during takeoff and power changes. Aborted takeoff and returned to staging area. Opened engine cowl, noted aluminum shavings on engine deck. Visual inspection identified the compressor wash union Part Number (P/N) 350A54-1112-20 welded boss on intake assembly P/N 350A54-1080-04 had broken off

and become ingested into the engine. Aircraft had been subject to scheduled inspection less than 10 hours prior, with no defects noted at that time. Aluminum shavings from welded boss were found ejected out of the bleed valve and out of the exhaust. The steel union did not get ingested, but bounced around in the intake plenum causing substantial damage to the axial compressor.

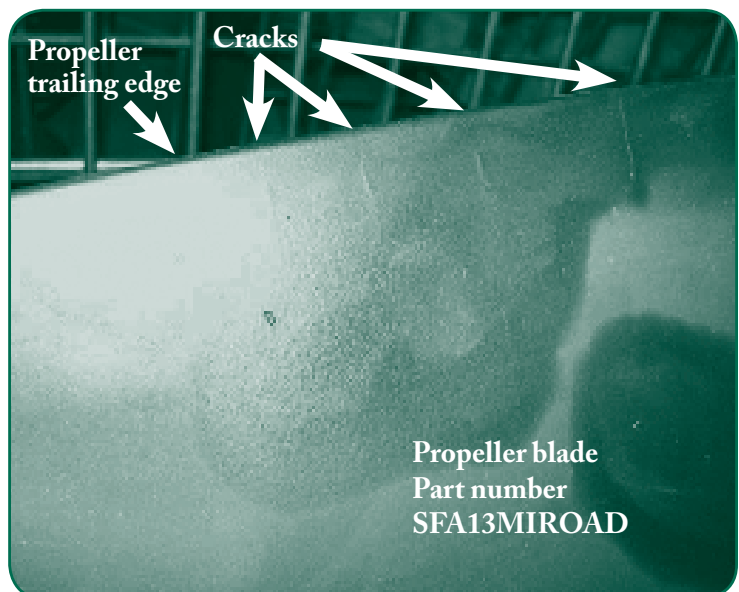
During walk around, flight crew noticed an anomaly with the trailing edge of the #3 propeller blade on the L/H propeller. Maintenance was advised and inspected the propeller and determined that the trailing edge contained about 8 small cracks midway between the blade root and tip. When inspected further, what appeared to be moisture was noticed to seep from the cracks. When wiped away, moisture again would seep out.

The submitter has updated the Service Difficulty Report indicating that the cracks were in the paint only. ✖

Maintenance replaced the propeller blade and has contacted the overhaul/repair facility for possible causes for the cracking. A complete report on the nature of the defects has been requested from the repair facility. Company will review these findings and attempt to mitigate any re-occurrence, which may be associated with operational conditions.

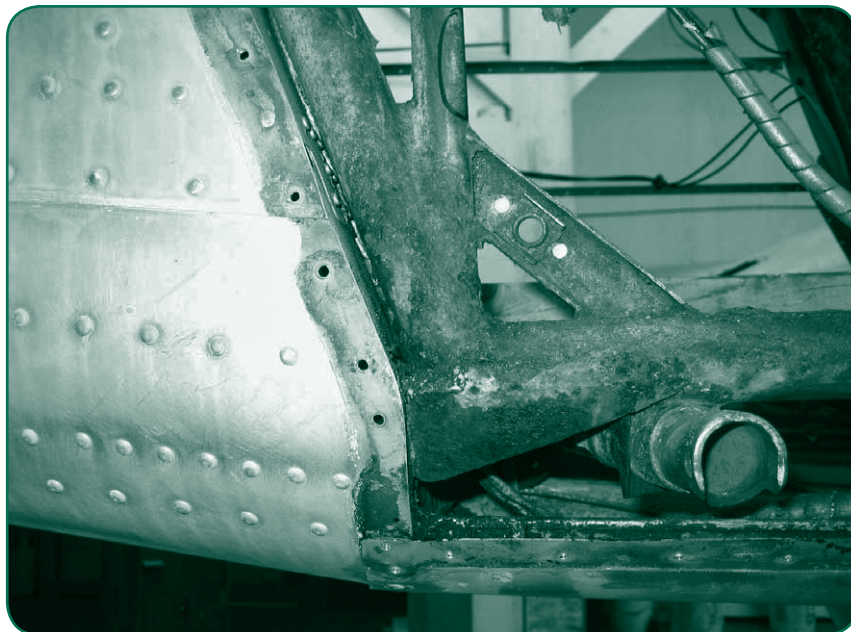
During an AMO maintenance inspection, technicians noted external corrosion on some of the fuselage frame tubes, specifically at the lower longeron tubes.

Initially, corrosion was found around the perimeter of the L/H (modified) cabin entry metal step plate. When the step plate was removed, deep corrosion pits were also noted in the fuselage skin. Significant exterior corrosion was found on several of the frame tubes. When removing the surface corrosion on frame tubes, a tube drain hole was unplugged and lots of rusty, sludge water drained out of the inside of the tube. This prompted the technicians to remove the fuselage skin in that area in order to inspect the outer (hidden) side of the frame tubes. The outer side of the tubes were found to be severely corroded and obviously beyond repair.

The fuselage frame tubes are the principal load carrying members of this aircraft, thus this particular aircraft was no longer airworthy. It is undetermined at this time if the aircraft is economically viable to repair to an airworthy condition due to extensive rework/jigging requirements.

Almost all metals used in aircraft construction are subject to corrosion. This metal degradation is especially problematic when operating in a coastal environment as the aircraft is exposed to salt water/air spray. Areas around the windows must be properly sealed to prevent water/moisture from infiltrating and then migrating into the aircraft fuselage. Badly fitting doors and seals

can allow water/moisture to enter the aircraft. In particular, the lower fuselage areas and any insulation blankets must be kept clean and dry. Additionally, ensure that all lower fuselage water drains are kept free to drain fluid overboard.

Transport Canada Civil Aviation (TCCA) reminds all aircraft owners/operators to take all preventive corrosion precautions in accordance with the respective manufacturers' instructions. The corrosion that was found on the subject aircraft was so pronounced that the structural integrity of the principal load carrying fuselage tubes was compromised. Fortunately, the maintainer took the responsible steps to expose and then inspect the hidden (inaccessible) areas and then carry out Eddy Current inspections to verify the problem. This work is commendable.

TCCA is in the process of requesting that the FAA advance our concerns to Piper to have the requirement for repetitive inspections added to Piper Service Letter (SL) 629, titled Fuselage Frame Tube Corrosion Inspection. ✖
