AVIATION INVESTIGATION REPORT
A05P0189

COLLISION WITH TERRAIN

NORTHERN THUNDERBIRD AIR
RAYTHEON BEEHCRAFT KING AIR 200 C-FCGL
SHOVELNOSE CREEK, BRITISH COLUMBIA
28 JULY 2005

Report Number A05P0189

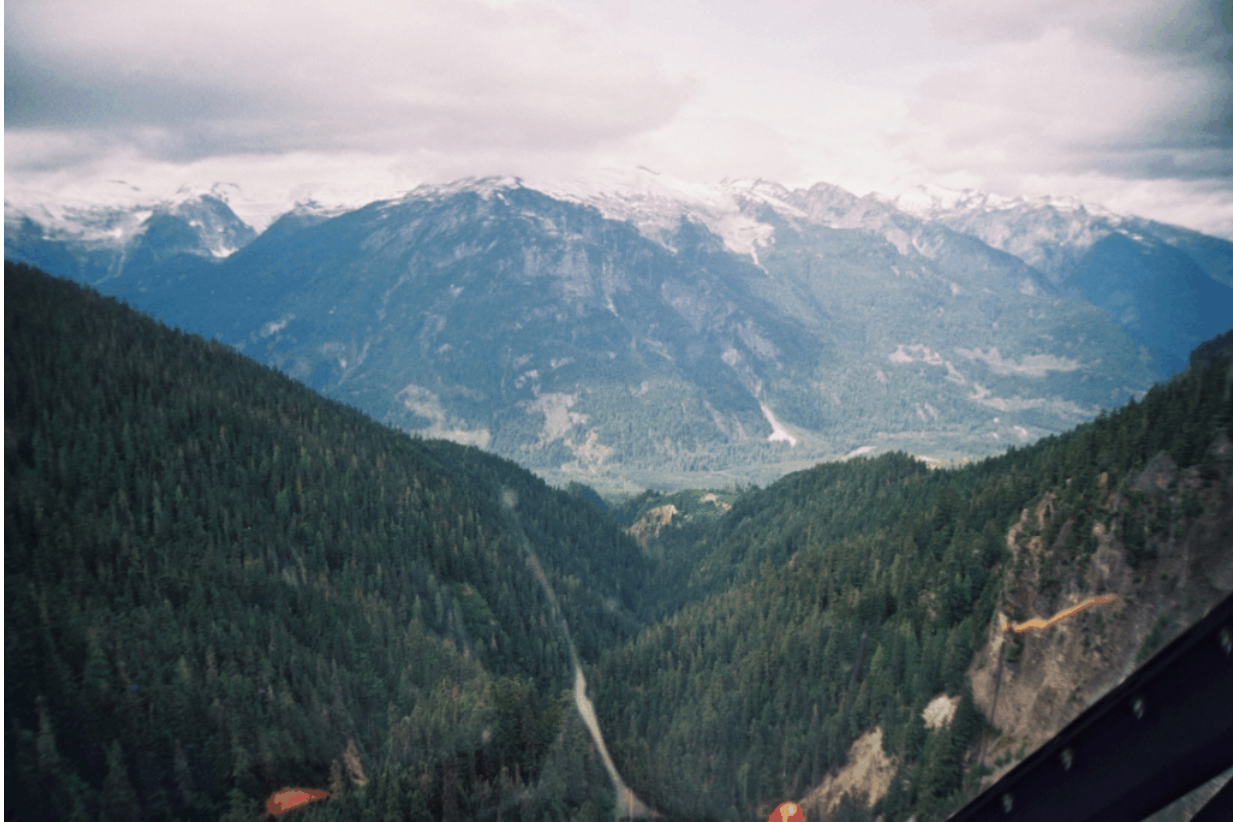
Appendix A – View Down the Valley from Above the Accident Site

The wreckage was found in the Shovelnose Creek valley at an elevation of 3900 feet asl. The aircraft had clipped the tops of two trees before contacting the 33° slope at about a 33° pitch angle. Measurements of the angle and direction between the two clipped tree tops indicate that the aircraft was climbing at an angle of about 12 or 13° when it struck the two trees, and was flying on a track of 038° M. The average slope was 11°, but it was much steeper at the accident site.

It could not be determined why the pilots turned northeast and flew up Shovelnose Creek at a low altitude. It is possible that this was a navigational error. This canyon narrows quickly, the terrain rises very steeply, and the slope exceeds the climb capability of the aircraft. The pilots' attention was probably focused outside of the aircraft and, by the time they realized they were reaching the aircraft performance limits, there was not enough room to reverse course and their only option was to out climb the terrain. Information from the aircraft manufacturer indicates that the aircraft, with specification performance, would be able to climb at an angle of 13°; however, this was insufficient to clear the steeply rising terrain.
