AVIATION INVESTIGATION REPORT

A05W0160

LOSS OF CONTROL

LANCAIR IV-P N750F

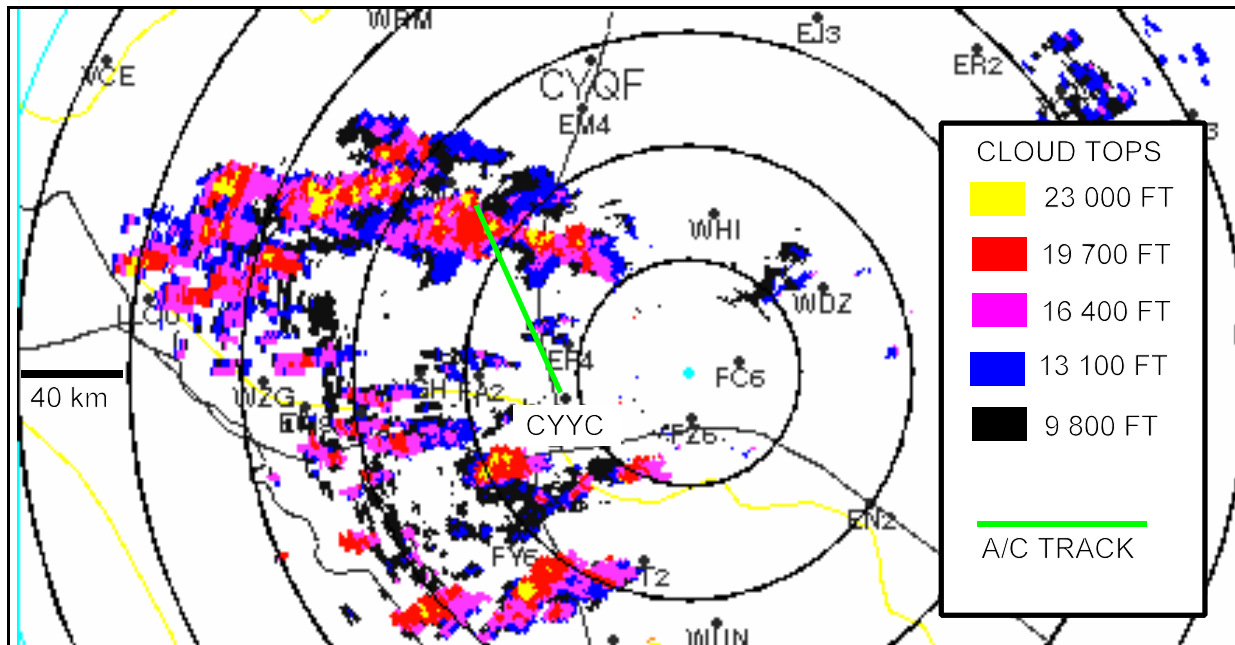
Figure 1. Weather radar image recorded at 1920 with aircraft track

Weather radar, airport weather observation, and a pilot report from an aircraft flying 30 minutes ahead of the occurrence aircraft indicated an overcast cloud condition with tops at about 10 000 feet for most of the Calgary area. The weather radar images of the TCU cloud 40 nm northwest of Calgary Airport showed they were intensifying and moving eastward. The TCUs had variable tops to 23 000 feet. A transmission by the pilot to ATC at 1912 included the remark that he had lost his WSI capability and wanted information about the weather ahead.
