AVIATION OCCURRENCE REPORT

RISK OF COLLISION

CANADA 3000 AIRBUS SA320-212 C-GVXF

SEMITOOL INC. ROCKWELL INTERNATIONAL 690C N48BA

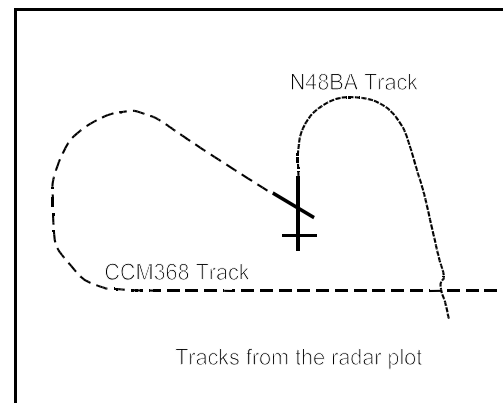
Figure 1 - Calgary Airport and aircraft radar tracks

At 1939:50¹, 1 minute 20 seconds before CMM368 communicated a TCAS descent, CMM368 was about 10 nm south-west of the airport in a left turn climbing through 10,100 feet at 230 KIAS and N48BA was about 4 miles north-east of the airport in a right turn climbing through 7,200 feet. The air traffic controller assessed that the vertical and lateral spacing would remain adequate for the intended tracks. He then turned his attention to other aircraft under his control. He recalls that it was not until CMM368 called a TCAS descent that he looked at the two aircraft targets on his radar screen.
